DANIELA BRACCHITTA K.^{1*}, ROXANA SEGUEL Q.^{2.}, DIEGO SALAZAR S.^{3.}

SOMEWHERE OVER 4000M ABOVE SEA LEVEL

WHAT SEEMED TO BE THE PROBLEM...BACK IN 2009

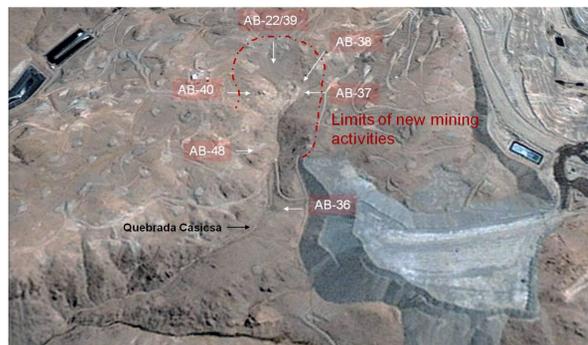
The company needed to expand its extraction area. Pit limits of the new expansion would be close to the old mining complex, especially to the sites AB-39 and AB-38, with a projected limit distance of 55 and 70 m respectively (Figure 1). The company's geomechanical department developed a theoretical damage model that showed a potential risk for the structures of the mentioned sites. The peak particle velocity (PPV) calculated for the new limit would be 248 mm/sec, slightly over the threshold for absence of damage, which according to international standards is 204,33 mm/sec [1]. This was considered the main risk factor at that time.

Figure 1. Archaeological area and limits established for the new expansion of mining extraction activities. (Google earth archives, 2007)

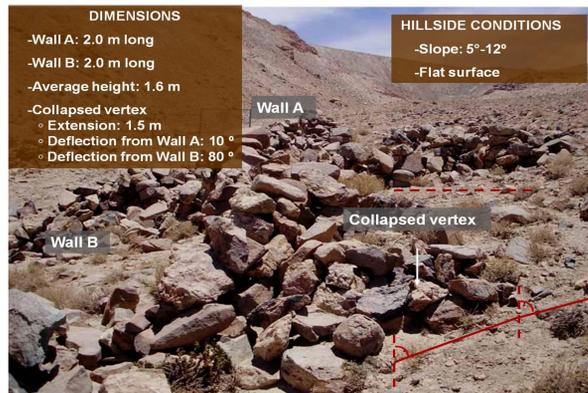
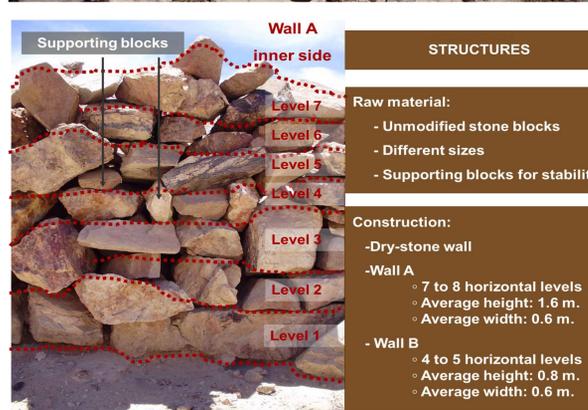
Figures 2-3. Details of the landscape and structure considerations to replicate Walls A and B from site AB-38. Northern slope of Quebrada Casicsa (Seguel, R. 2009).

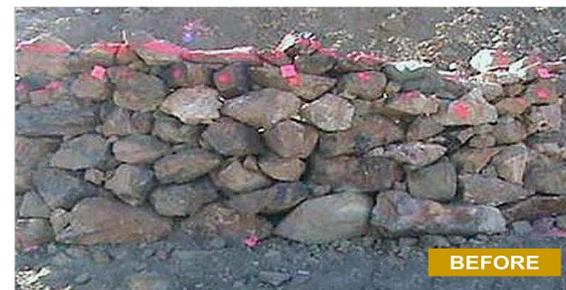
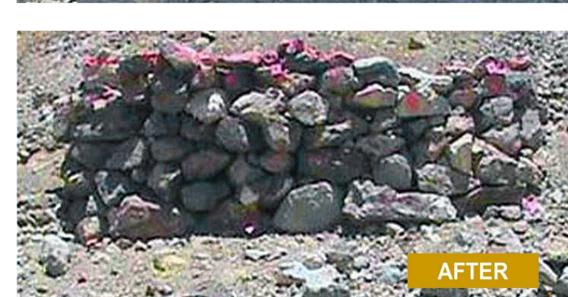
3 replicas of the most exposed walls were built at 52, 55 and 62 m from the limit of the future pit. They represented the most susceptible walls to collapse by blasting. Raw materials, technical construction, length, height, inclination, orientation and site conditions were matched with the archaeological ones (Figures 2 and 3). In addition, planimetry of the replicas was established in order to assess any changes. In addition, the Geomechanical department worked on decreasing the PPV below the critical level. Data monitored during the controlled blasting at 52 and 55 m, were 120 mm/sec, equivalent to a level 0 in damage. That was corroborated by the archaeologist Diego Salazar, who was present during of the detonations (Figures 4 and 5). The mine extension is currently 50-70 m from the archaeological structures (Figure 6), none of which show any alteration related to blasting.

Figures 4-5. Replica of the wall M3 from site AB-39A. It was located 52 m from the experimental blasting. No painted stone fell down during the process (Salazar, D. 2009)

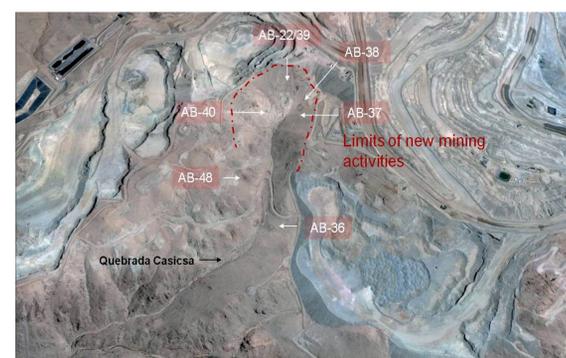
Figure 6. Archaeological area and current expansion of mining extraction activities. (Google earth archives, 2015)

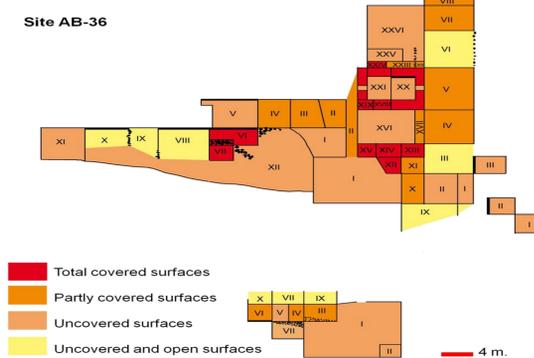
Figure 7. Enclosures diagram of AB-36 site. The different colors indicate the degree to which floor surfaces are covered by collapsed walls (Bracchitta, D., 2009).

Along with the experimentation, baseline work for the conservation of the archaeological complex was elaborated. It included a full study of structures, slopes; indicators, agents and factors of alterations; completed with the evaluation of the integrity of the enclosures (Figures 7 and 8). The study pinpointed that the greatest risk for the collapse of the structures was linked to prehispanic mining activities. Large areas of land clearing and gathering of unconsolidated sediments produced a modification in the topography of the area. In addition with a steep slope (between 23° and 38°), environmental agents such as rain and wind generated an intensive erosion of the land, forming gullies and dragging sediments (Figures 9 and 10). The halt in the prehispanic production and the lack of maintenance due to the withdraw from the area, intensified the erosion processes causing the collapse of the walls and sealing of the shafts (Figures 9 and 10)

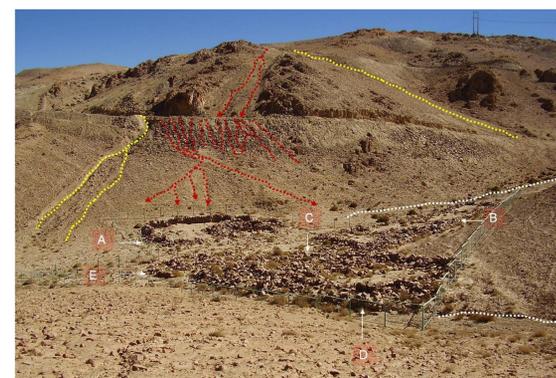
Figure 9. General view of AB-36 site. In white letters are pointed the 5 units of AB-36 site; each one have several enclosures. Dotted white lines show natural runoff and the yellow one those with an anthropogenic origin. In red dotted arrows it is observed minor furrows on the ground (Bracchitta, D., 2009).

- Carrying out a photogrammetric study of the complex, in order to systematically detect the transformation processes, projecting in time its speed and dynamics.
- Studying the rainfall regime of the area, so as to establish an ordinal scale that would evaluate the intensity of geoclimatic events
- Stabilizing unconsolidated sediments using geotextiles and eventually managing rainwater runoff
- Rebuilding collapsed walls to safeguard vulnerable structures

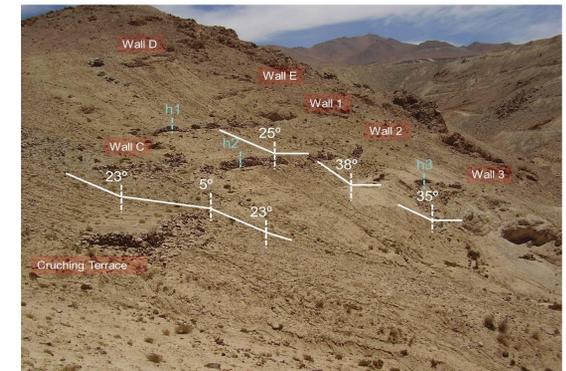
Figure 8. Side view of site AB-39A. Wall structures in association with wall heights and slopes (Bracchitta, D., 2009)

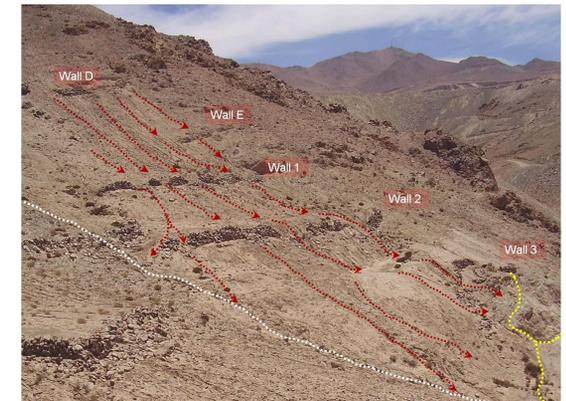
Figure 10. Side view of site AB-39A. The red dotted arrows indicate the main furrows caused by surface runoff, and its consequent domino effect on the walls. Dotted white lines show natural runoff and the yellow lines show runoffs with an anthropogenic origin. (Bracchitta, D., 2009)
