When Modern Materials Fail: Rehabilitation of a Taxidermy Orangutan

Fran Ritchie, Graduate Student, Buffalo State College; Jonathan Thornton, Objects Professor, Buffalo State College; Dr. Aaron Shugar, Conservation Scientist, Buffalo State College

Introduction: This juvenile female orangutan died at the Buffalo Zoo in 1966 and was mounted by an amateur taxidermist. The specimen was given to the Buffalo Museum of Science in Buffalo, NY, where it was on display until 2002. Damage occurred during de-installation due to the failure of non-traditional materials added to the mount. The specimen was conserved in the Spring of 2012 at Buffalo State College.

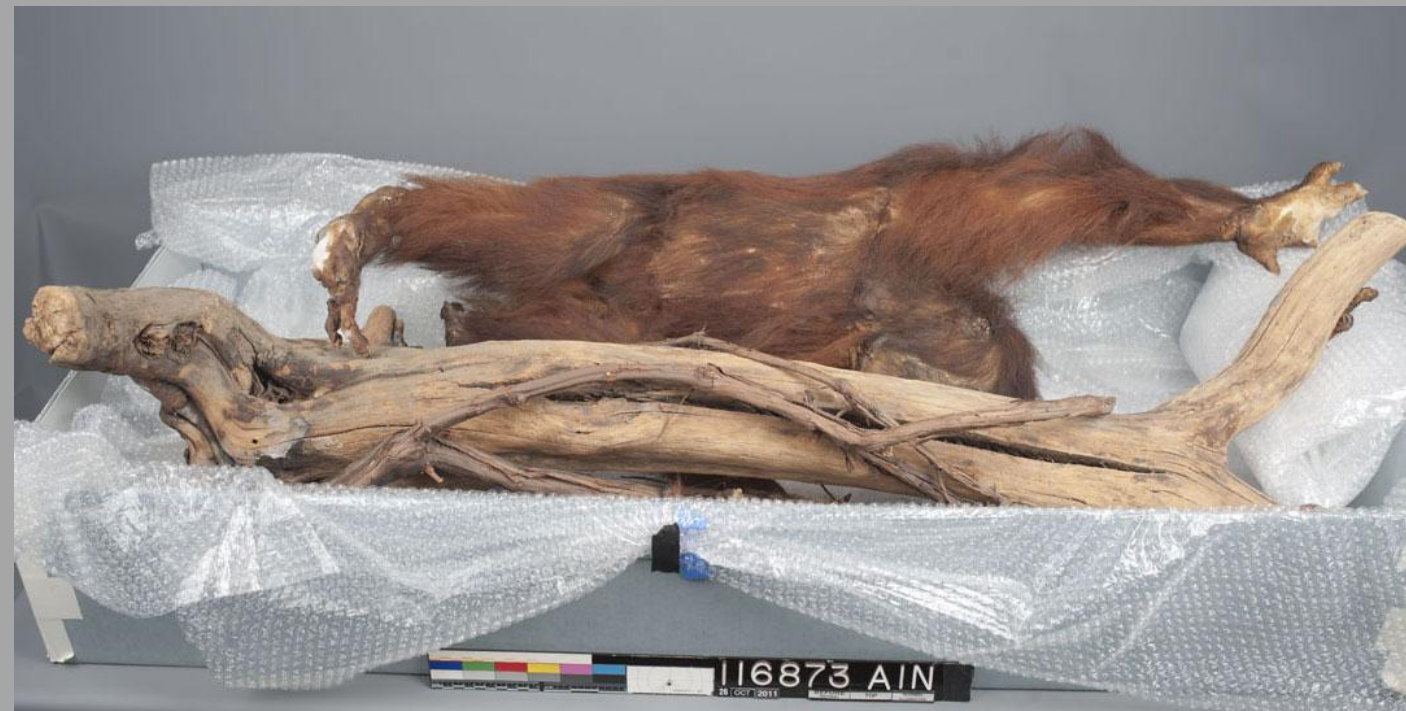
Investigation: The original display mounting method failed causing extensive damage to the joining features. The specimen required removal; the materials and construction required investigation prior to treatment.

Left: Specimen on original driftwood display mount; Right: Proper left hand torn and pulling from mount.

Response: The specimen was removed from the display mount by prying out nails and collecting broken finger fragments. Running ATR-FTIR on skin samples confirmed that the taxidermist replaced the palm skin and pads of feet with latex rubber. X-radiography revealed the internal support.

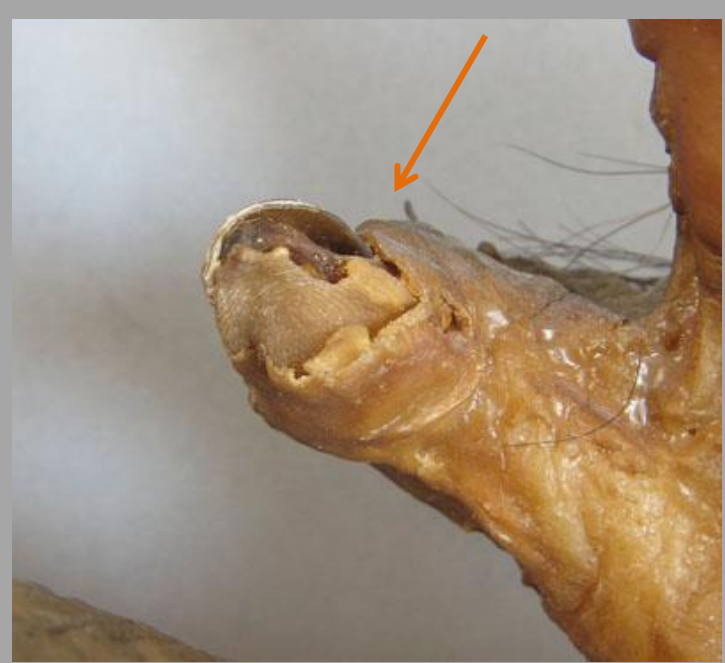
Above left: Rubber pulling away from original skin

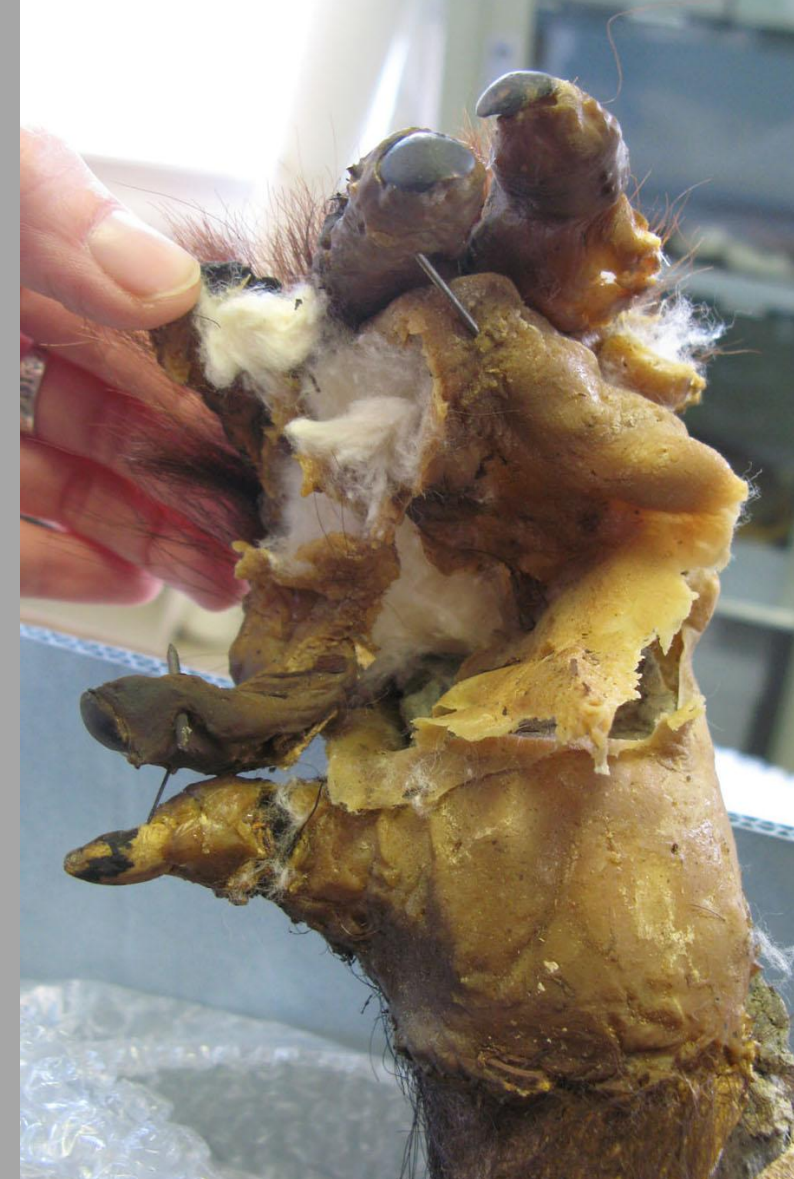
Left: Proper left hand

Damage and repair: The hands and feet were ripped and torn with several fingers broken or detached due to poor mounting.

Response: Tears were repaired and fingers reattached using toned Japanese tissue infused with BEVA film on the rubber, and spun polyester flocked with BEVA on the thicker leather pieces (tops of hands and feet).

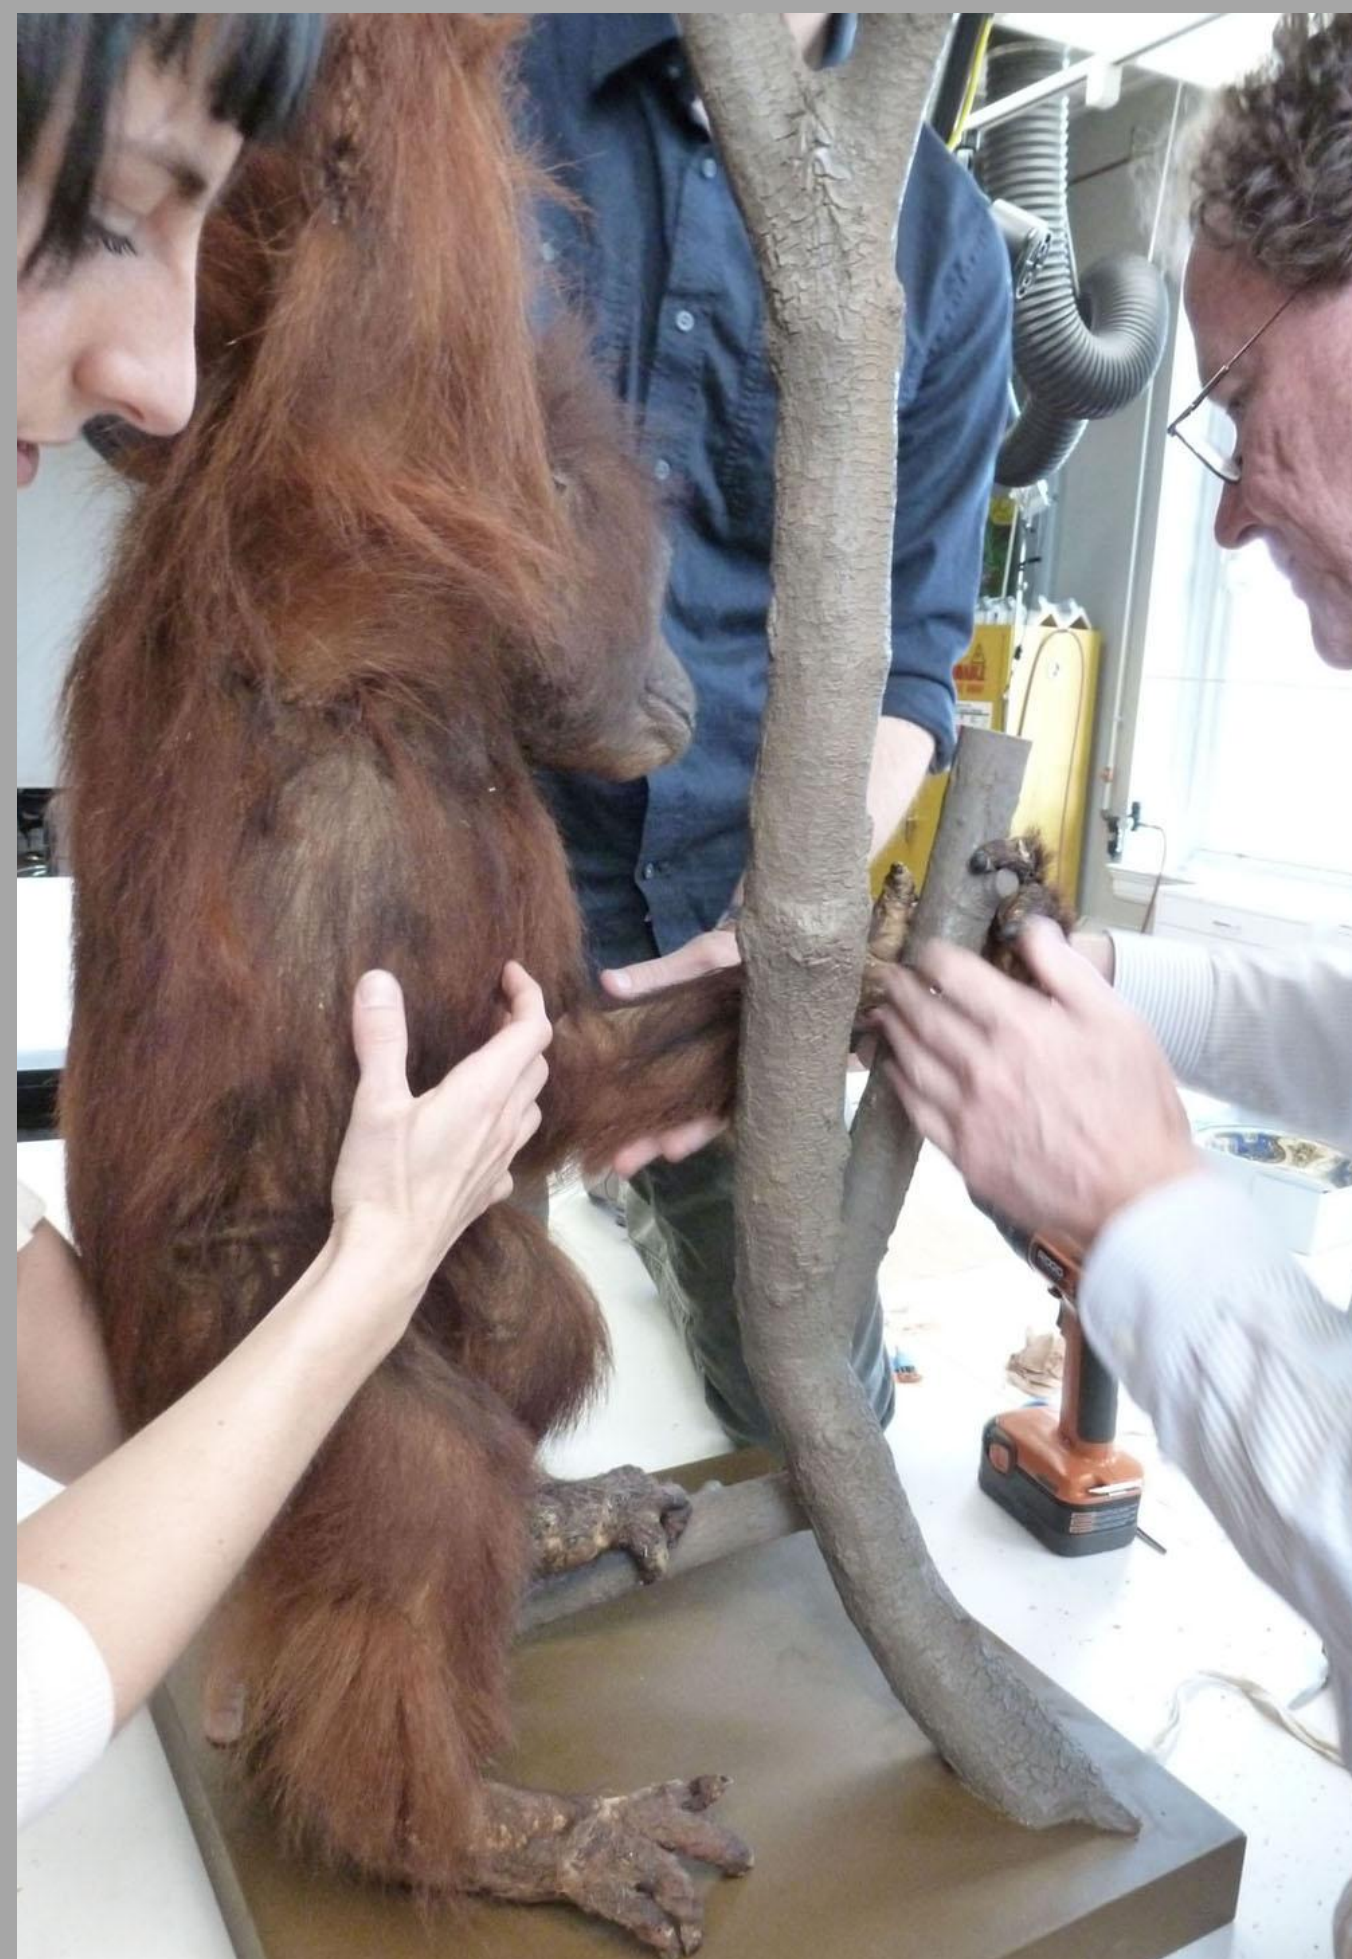
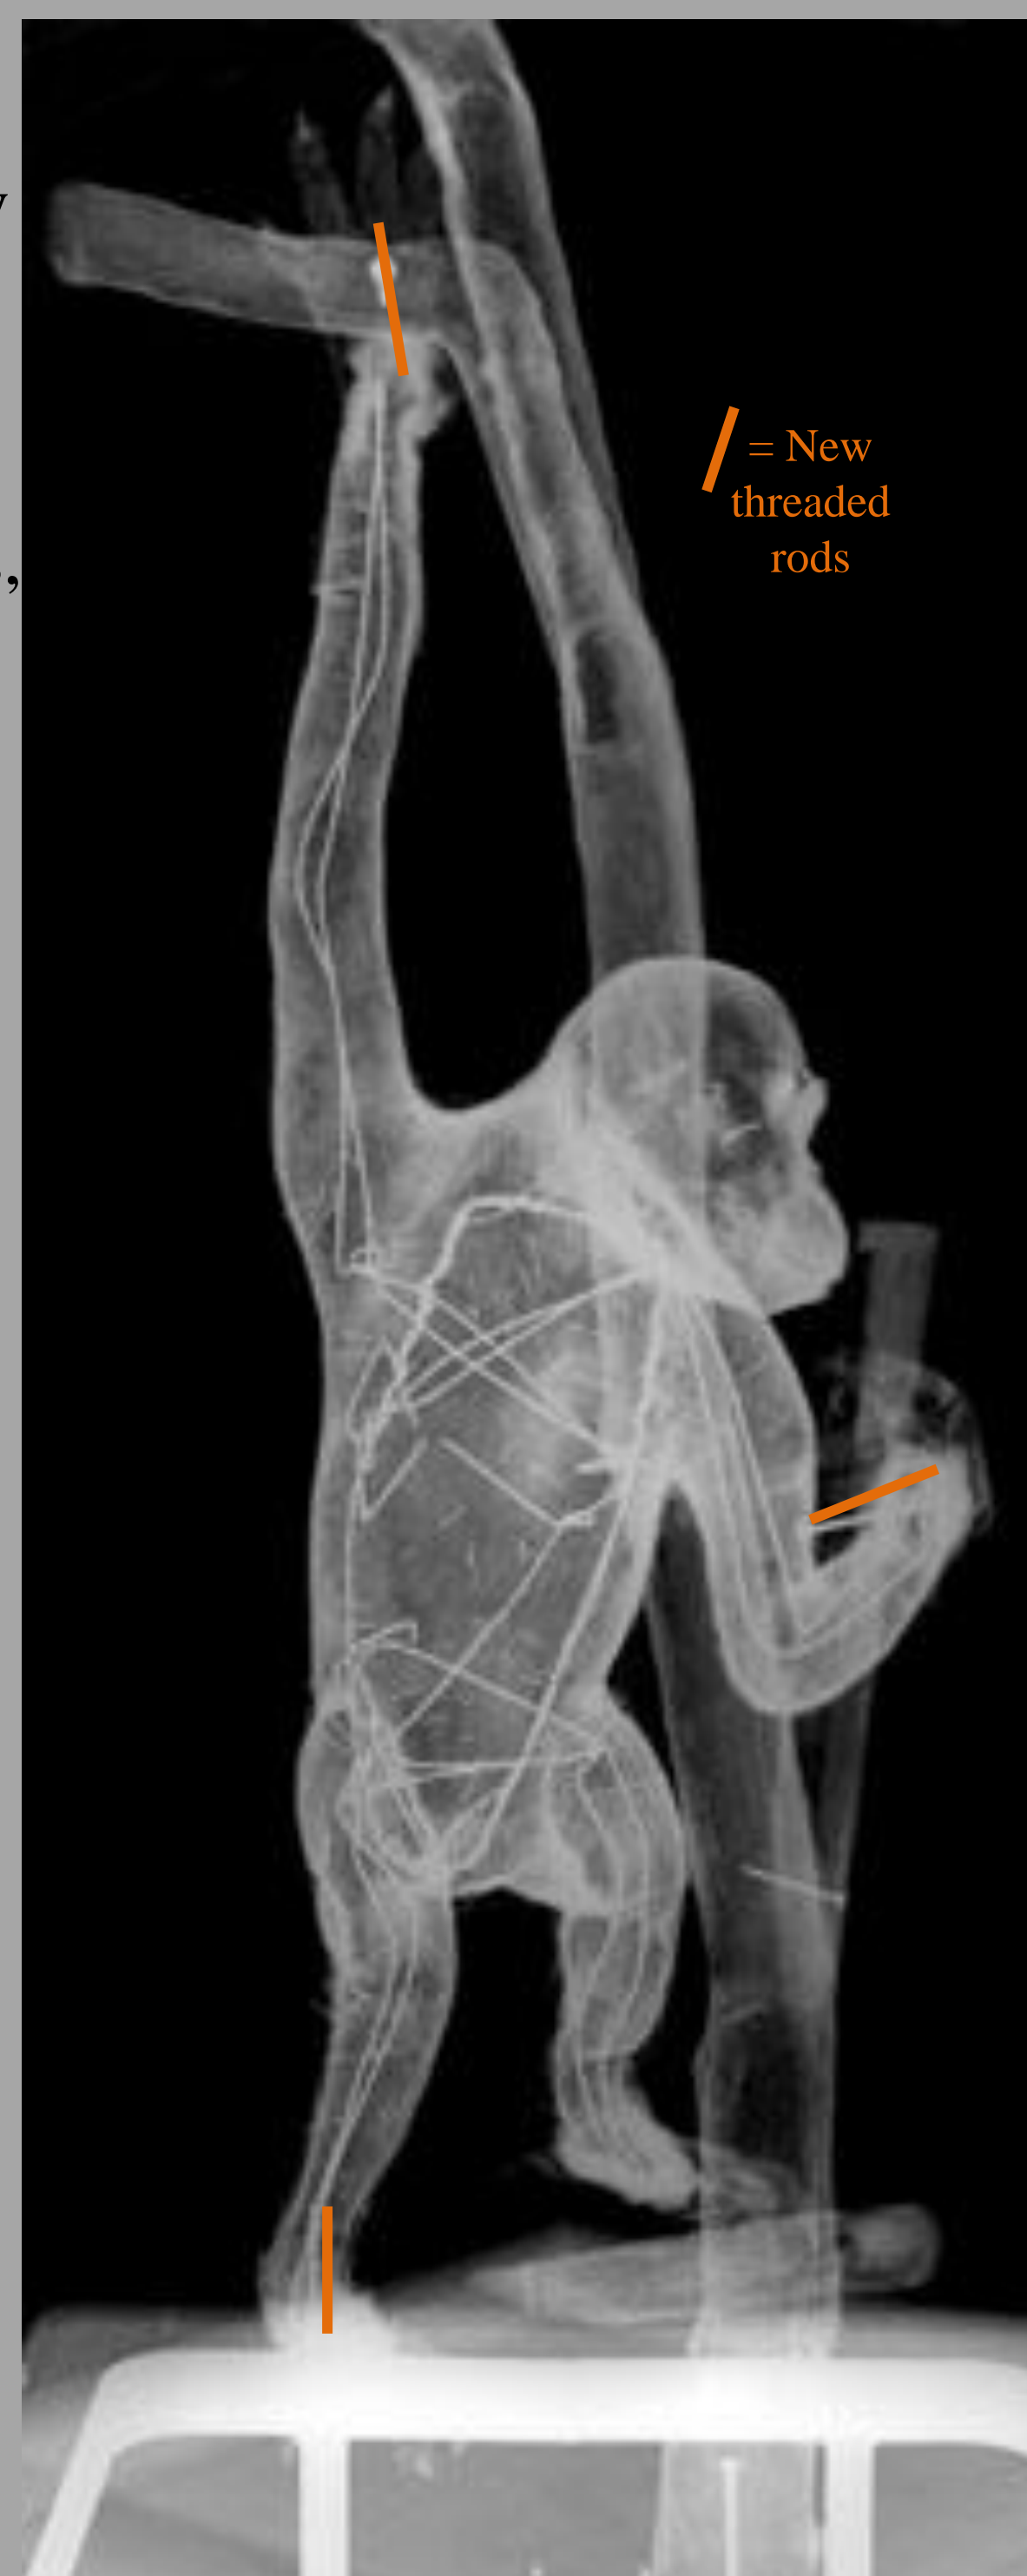
Repairing Mount: The specimen needed a new display mount that could support it without further damaging the deteriorating latex rubber.

Mounting Response, cont.: A new display support mount was constructed from a prefabricated polyester resin branch and by casting additional epoxy branches to fit the specimen's limbs. The threaded rods from the specimens were inserted into the new mount (see photo below), secured with nuts, covered with lightweight spackle, painted, and documented in an X-radiograph (see photo to the right).

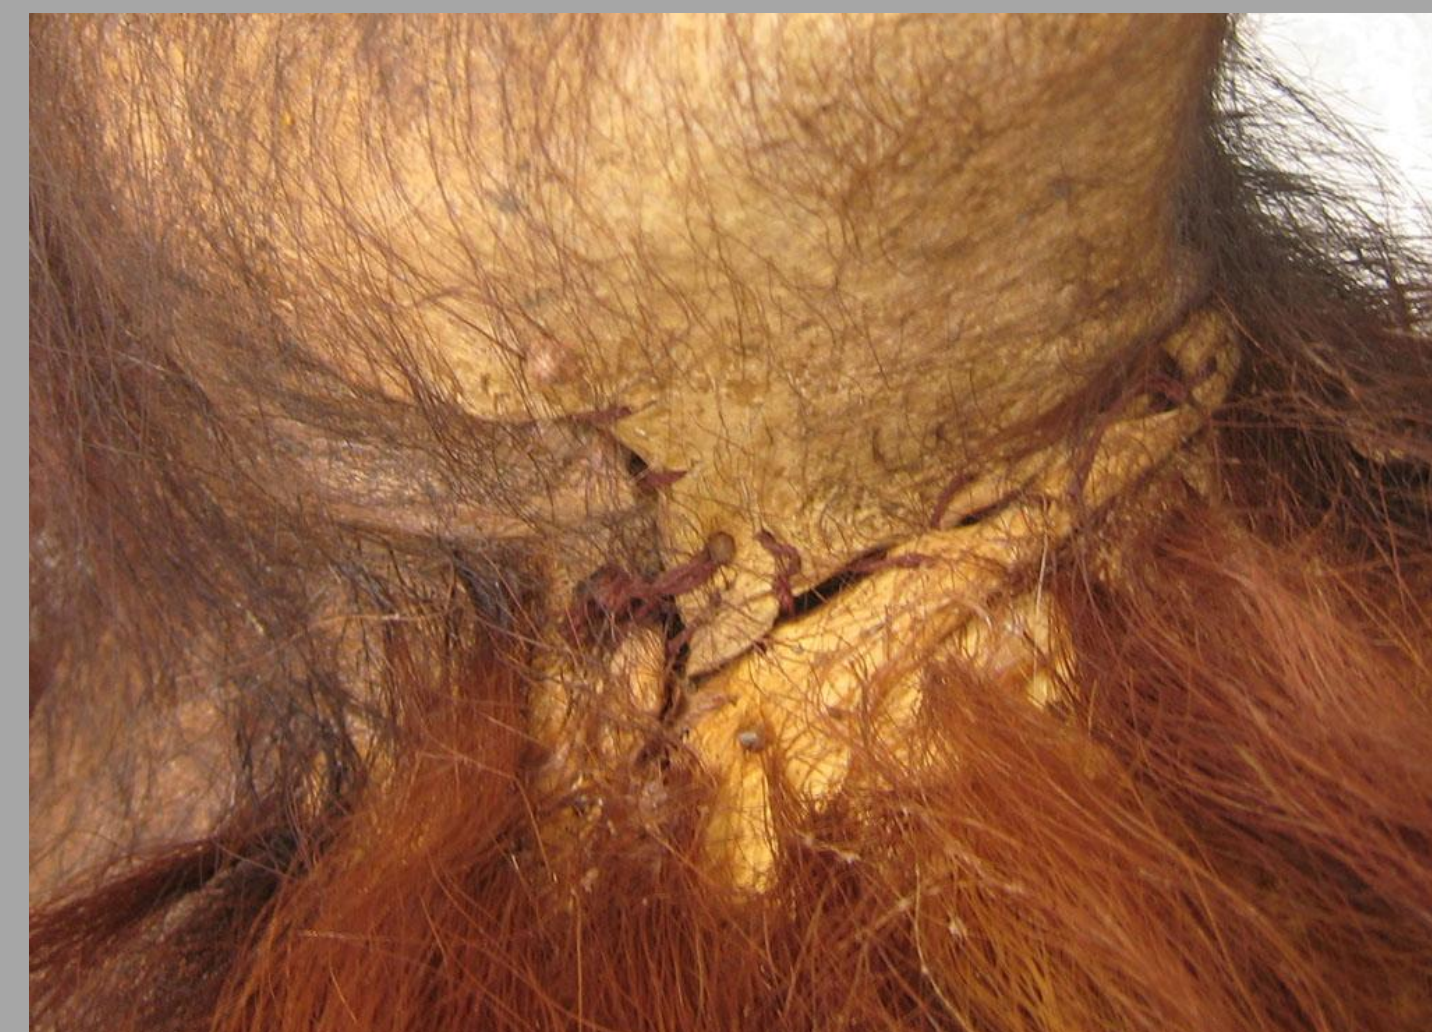
Seam and Loss Repair: The amateur taxidermist mounted the orangutan with misaligned hide and wide, obvious seams.

There were areas of skin loss throughout, present as lighter areas in the dark skin. The aesthetic value was compromised.

Before Treatment under the chin seam.

Response: Toned Japanese tissue was applied using BEVA film or wheat starch paste throughout the specimen, as well as in-painting, for visual compensations.
