# Assessing the Damage; Strategies for Approaching the Conservation of Fire-damaged Stained Glass

Alexandra Wysopal Sherman Fairchild Fellow, Objects Conservation, The Metropolitan Museum of Art

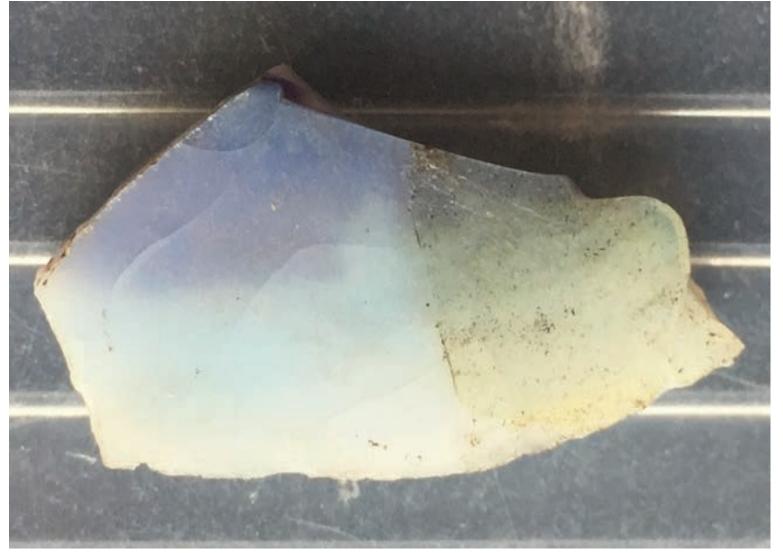
Initial examination of sample 5S shows internal crazing. Yellow accretion on right side known to be adhesive residue from tape.

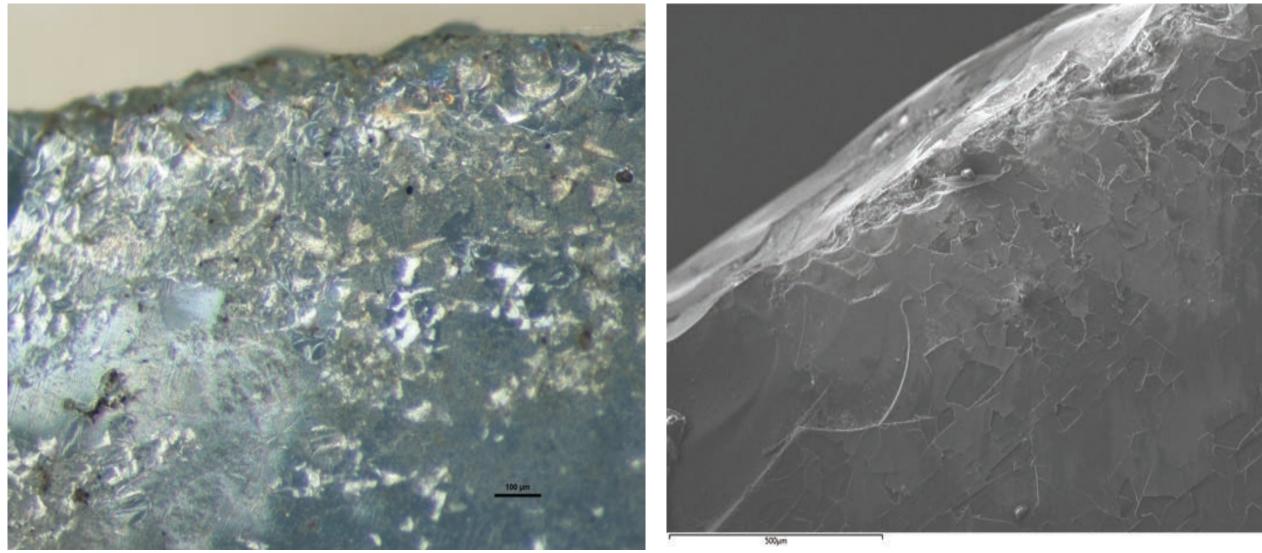
Stereo microscope photomicrograph (x63) of sample 5S shows a fine network of surface cracks and irridesence.

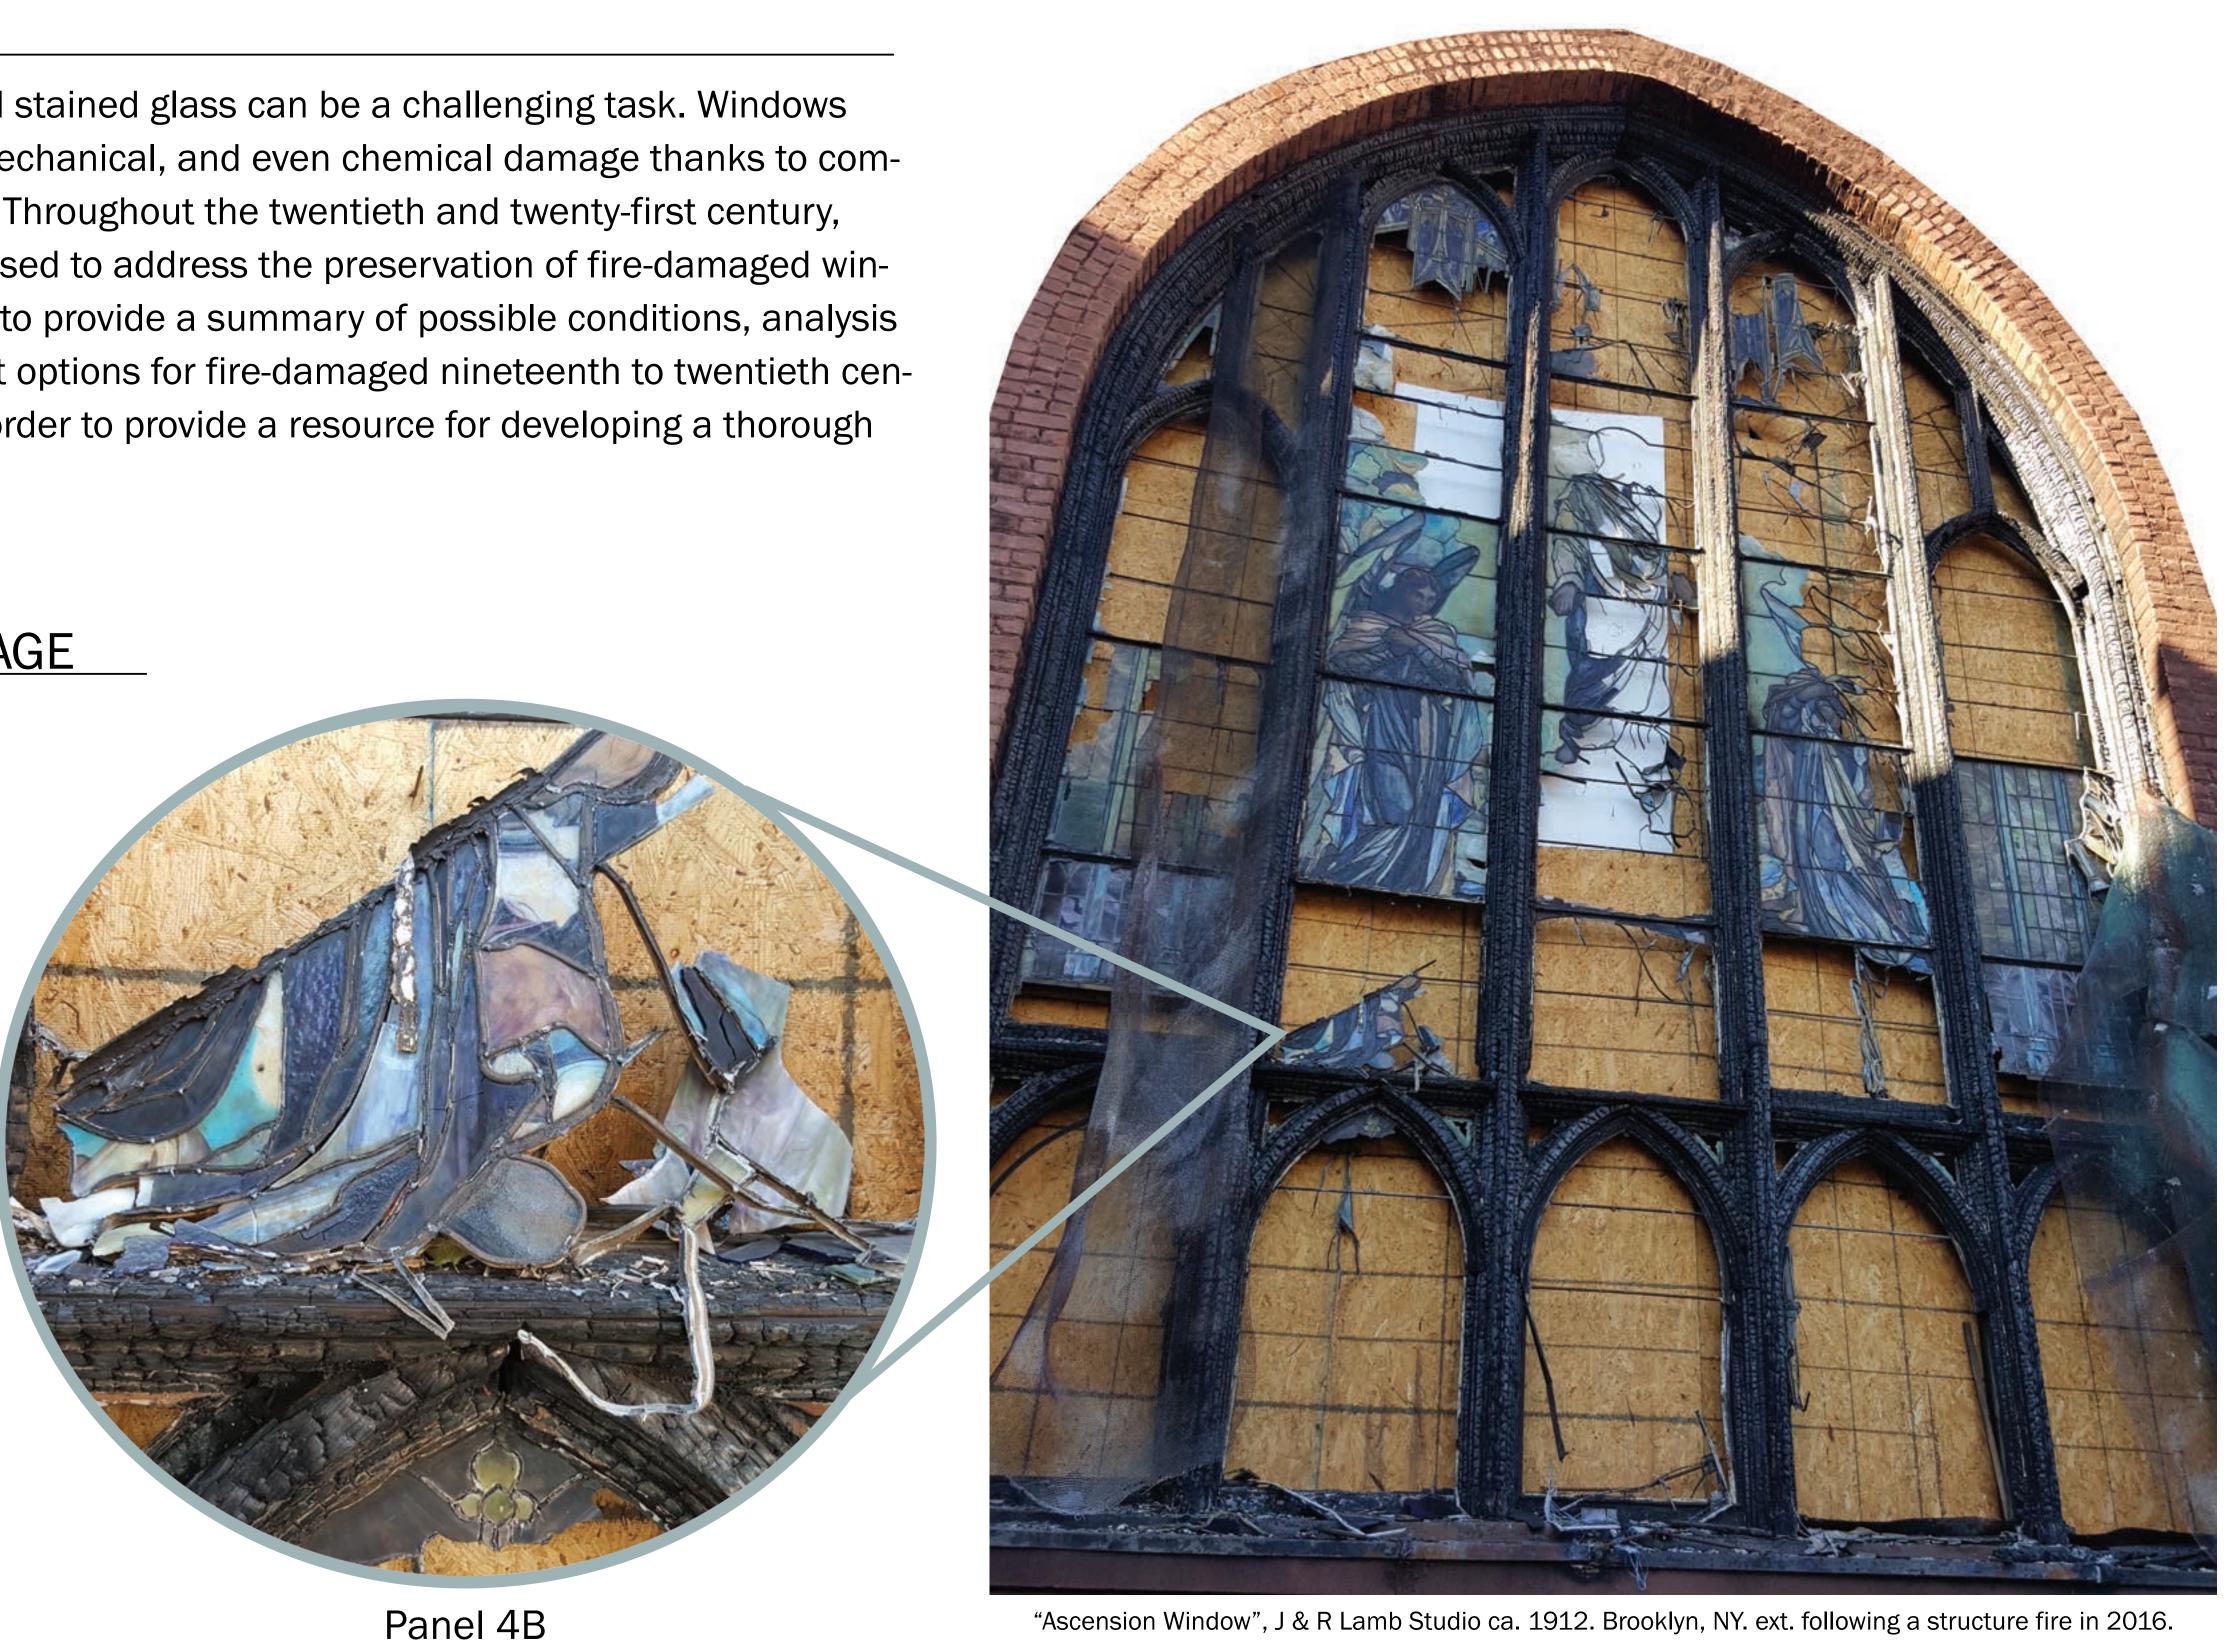
"Ascension Window", J & R Lamb Studio ca. 1912. Brooklyn, NY. ext. following a structure fire in 2016. Image courtsey of Bovard Studio, Inc.
