# Blinking Outside the Box: The Treatment of Sol LeWitt's *Wall Structure in Nine Parts, Each Containing a Work of Art by Other Artists*, 1963

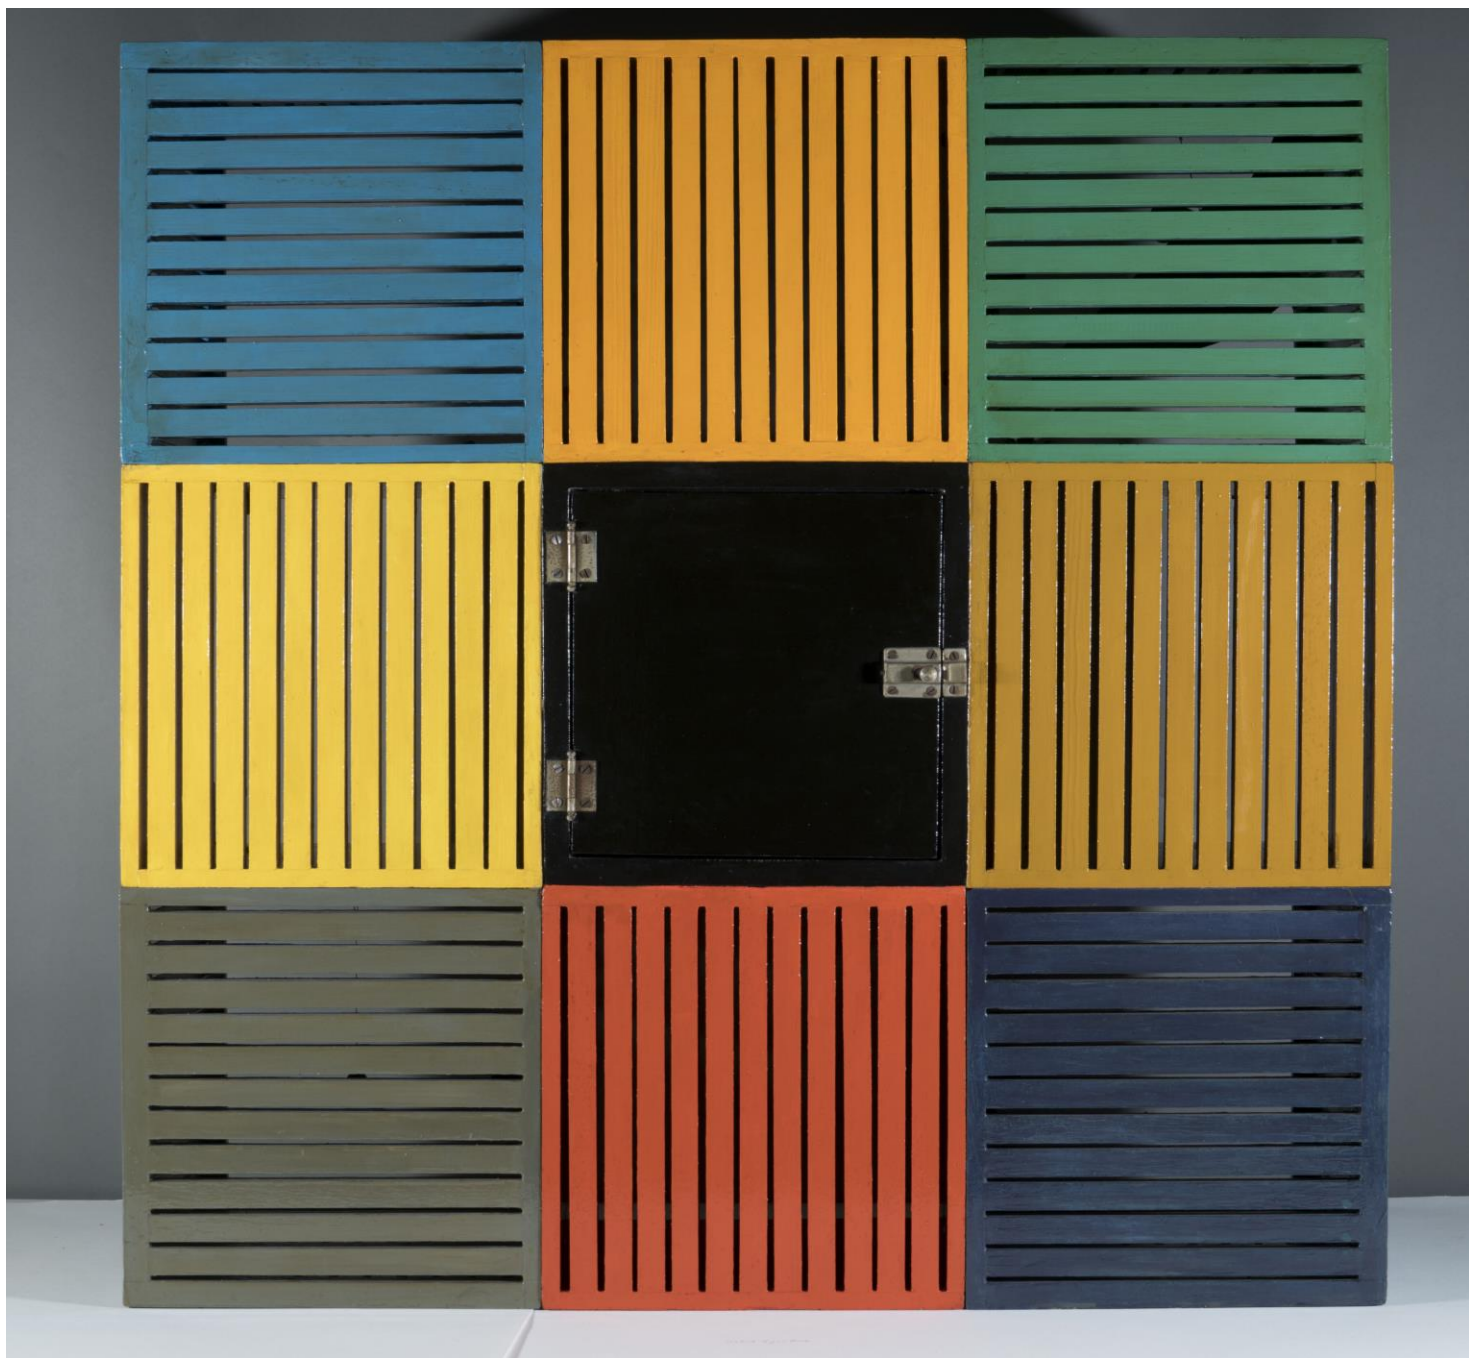
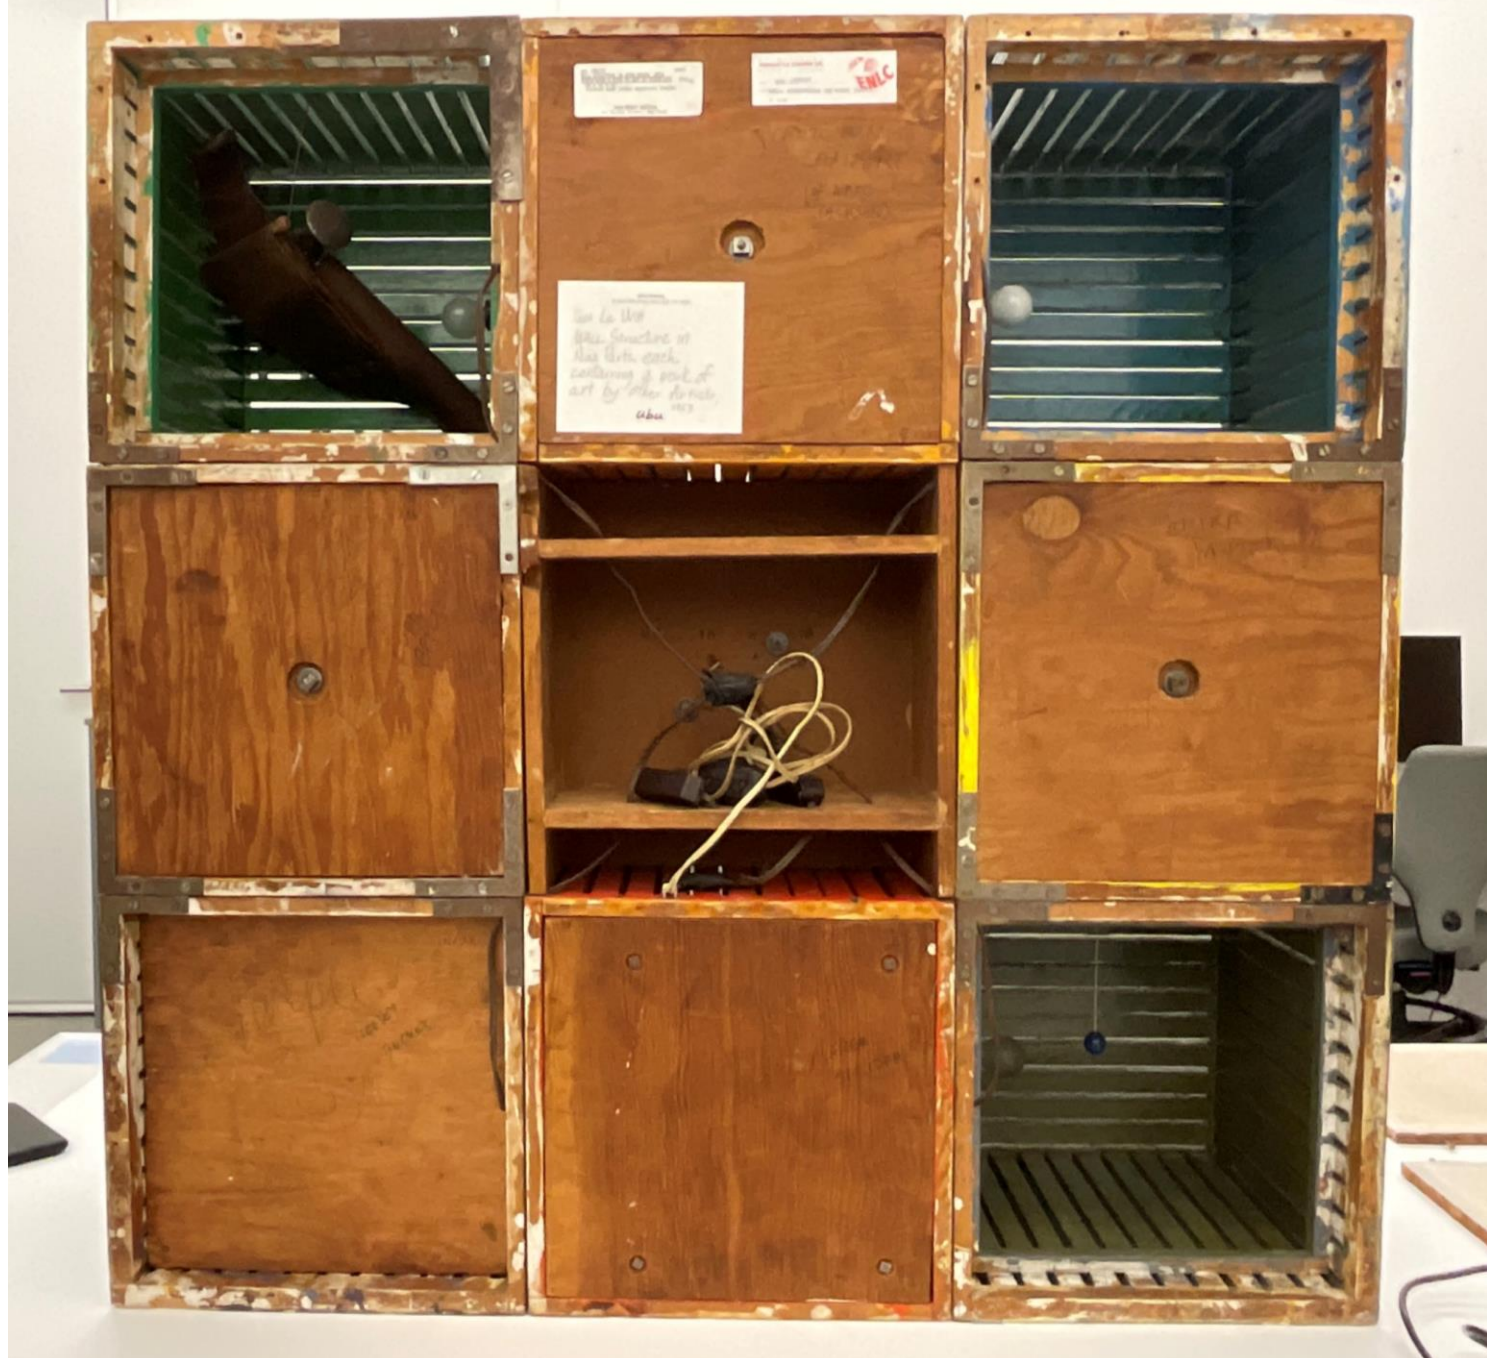
FIGURE 1 Front (left) and back (right) of *Nine Parts, Each Containing a Work of Art by Other Artists*, 1963, before treatment. Note: Back panels of top right, top left, and bottom left panel removed for condition assessment.

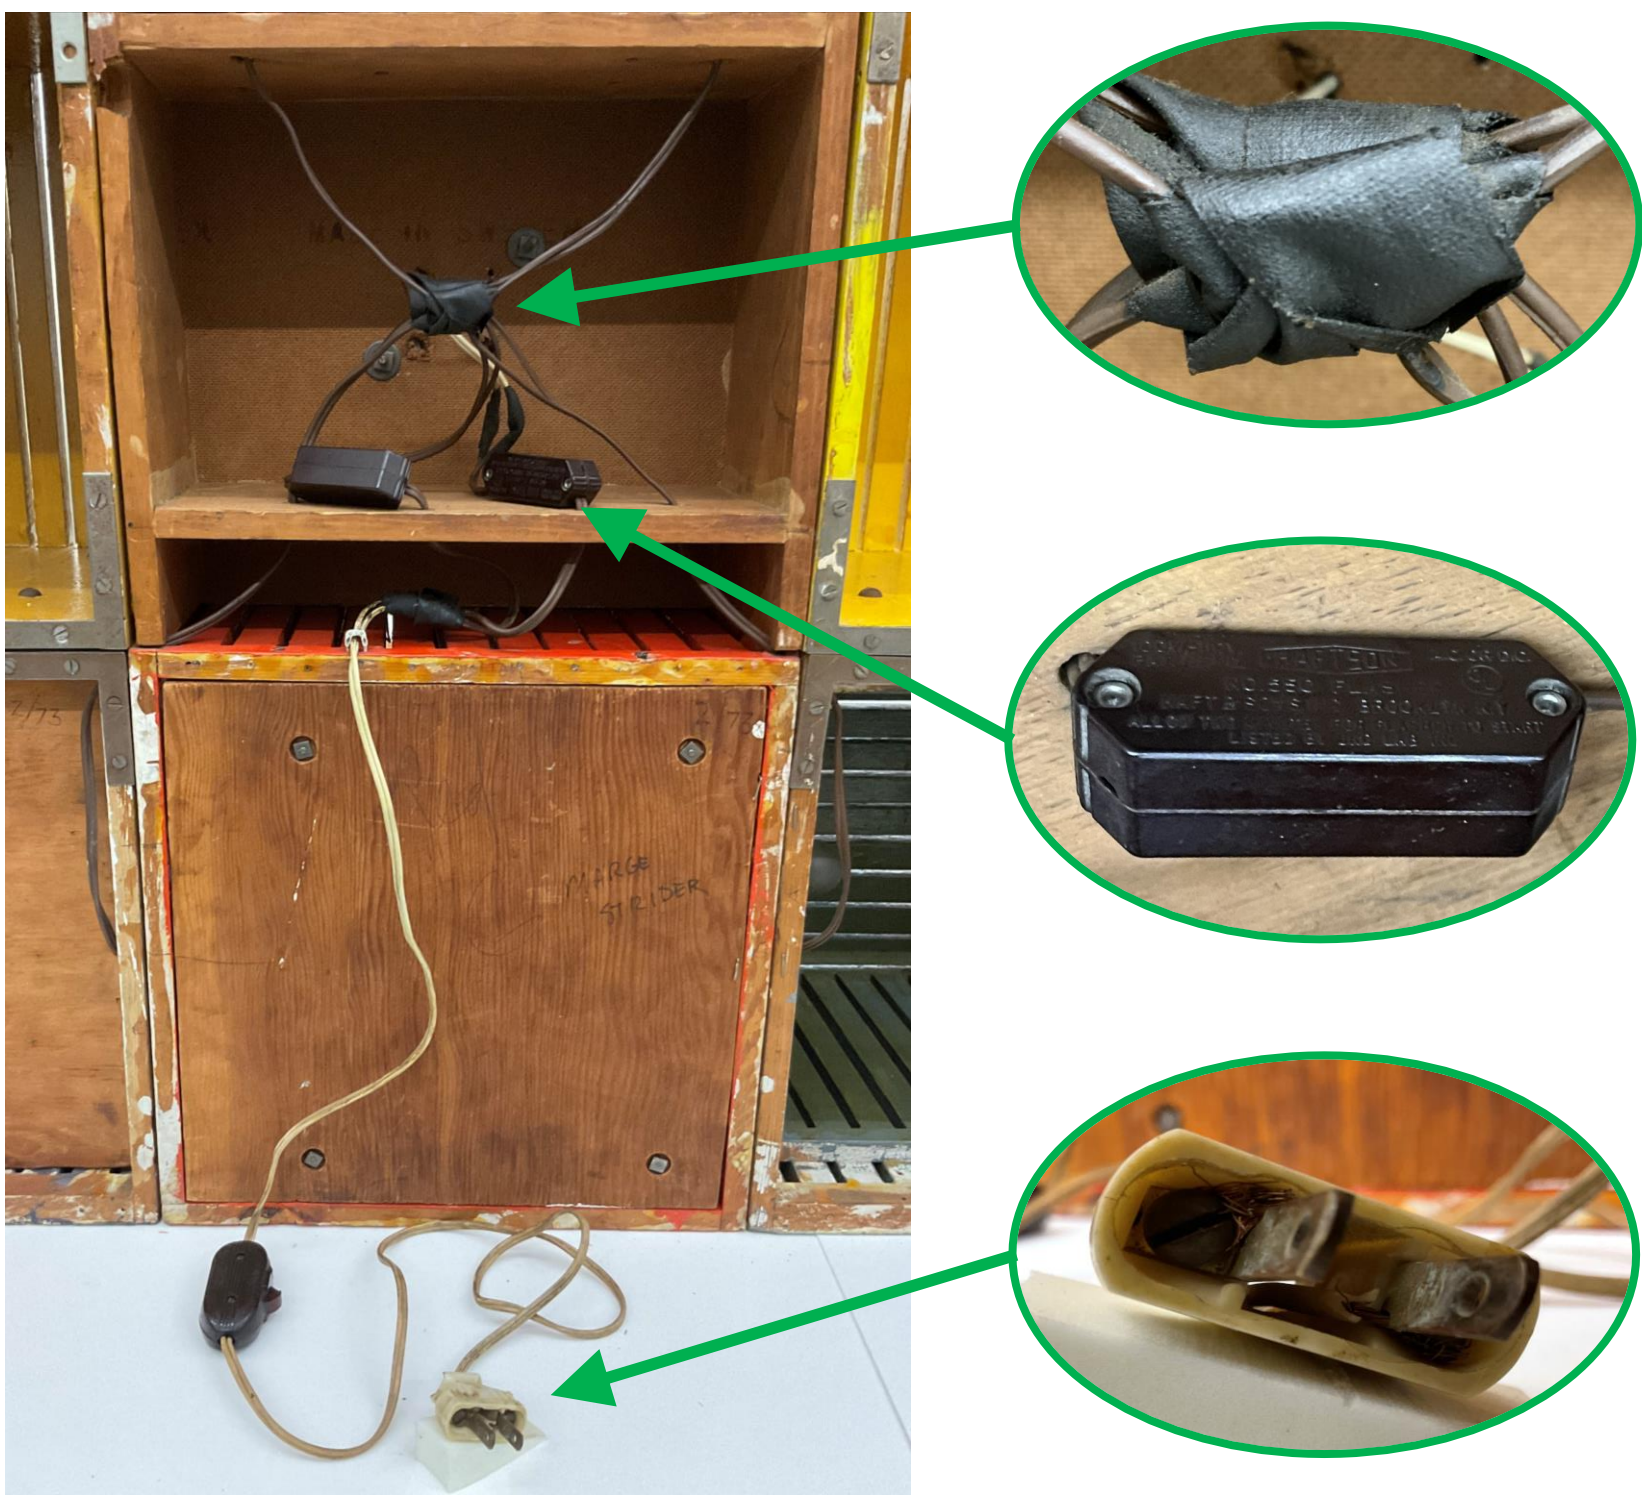
FIGURE 2 Detail of original electrical components at back. Top: degraded black electrical tape around wires; middle: thermal flasher; bottom: plug with corroded wire and screws exposed.

The sculpture could still be turned on, but the original electrical components (Figure 2) were in various states of degradation.

**Flashing:** The relays (flashers) were causing the lights to turn on and off sporadically and inconsistently. There was concern about the possibility of electrical arcing or an electrical fire when the relays ultimately fail, as the mechanics of thermal flasher relays leave them prone to gradual degradation over time.

**Wiring:** There was concern about yellowed wires and splices held together with degrading electrical tape. The plug was also yellowed with exposed wires.

1. Photo documented before, during, and after treatment
2. Removed existing electrical components from the artwork
3. Re-wired with new, appropriate materials
4. Inserted new relays (flashers) into relay bases
5. Set new relays to reflect the existing timing
6. Replaced lightbulbs with modern equivalents
7. Created custom storage trays for the back corner plates
8. Accessioned all original materials in the Artist Material Archive
9. Updated installation instructions

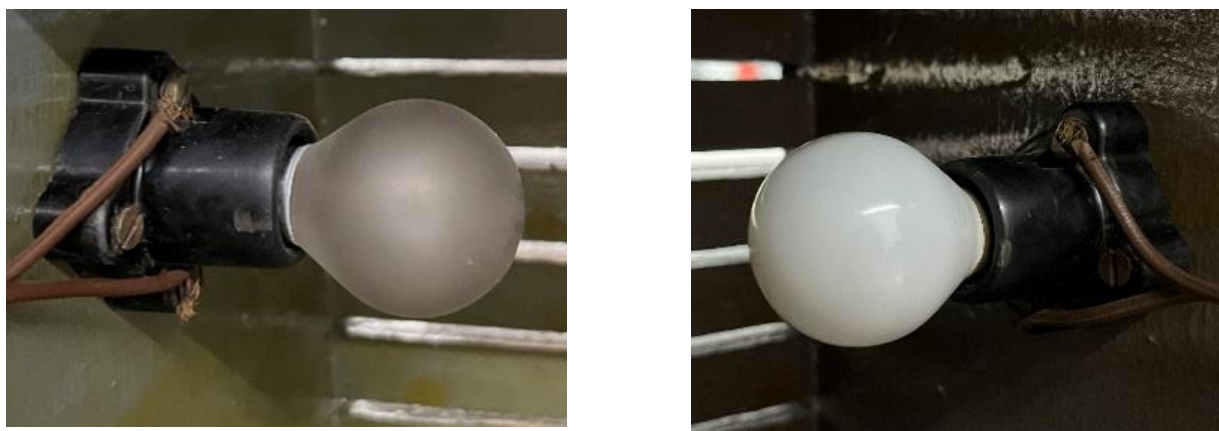
**Lightbulbs:** The age and origin of the lightbulbs were unknown. Each of the four corner boxes had a different lightbulb, but they were all approximately the same size/shape (Figure 3).

Figure 3 Two of the existing lightbulbs: box 7 (left) and box 9 (right)

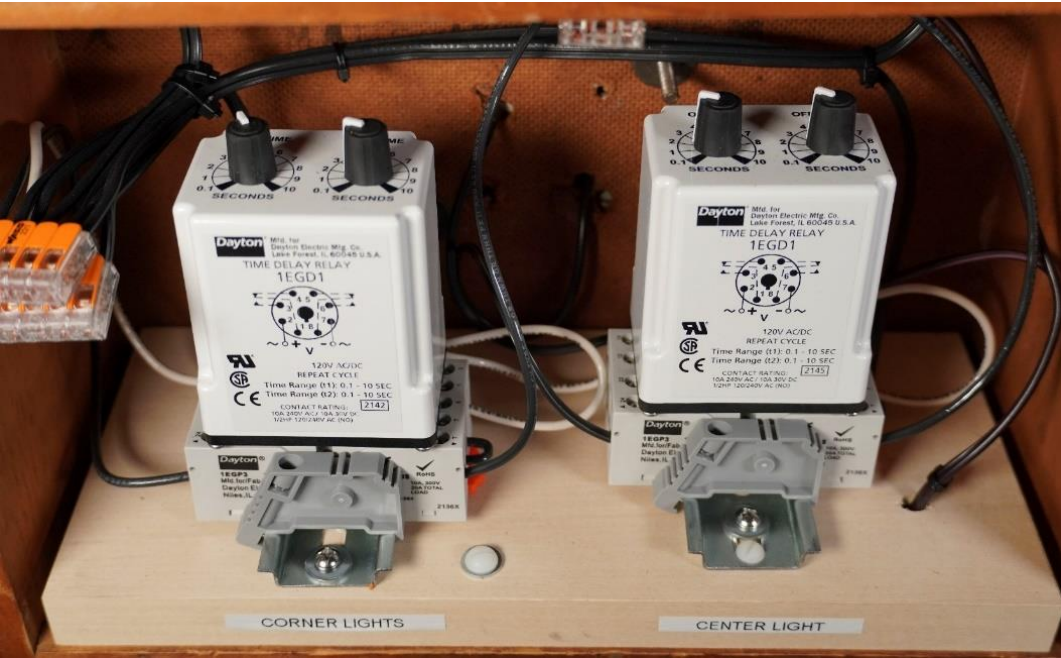
FIGURE 6 Detail of new relays and wiring.

**Programmable Relays:** Modern mechanical time-delay relays replaced the original thermal flashers as they can be programmed to reflect the existing timing (Figure 6). The function of the relay (light on) starts when voltage is applied to the coil inside the relay, and after the set time, the armature contact is released (light off), (Figure 7). The relays fit into bases secured in place, to prevent jostling and unnecessary wear on the components. No new holes were created in the artwork, and the relays can easily be removed.

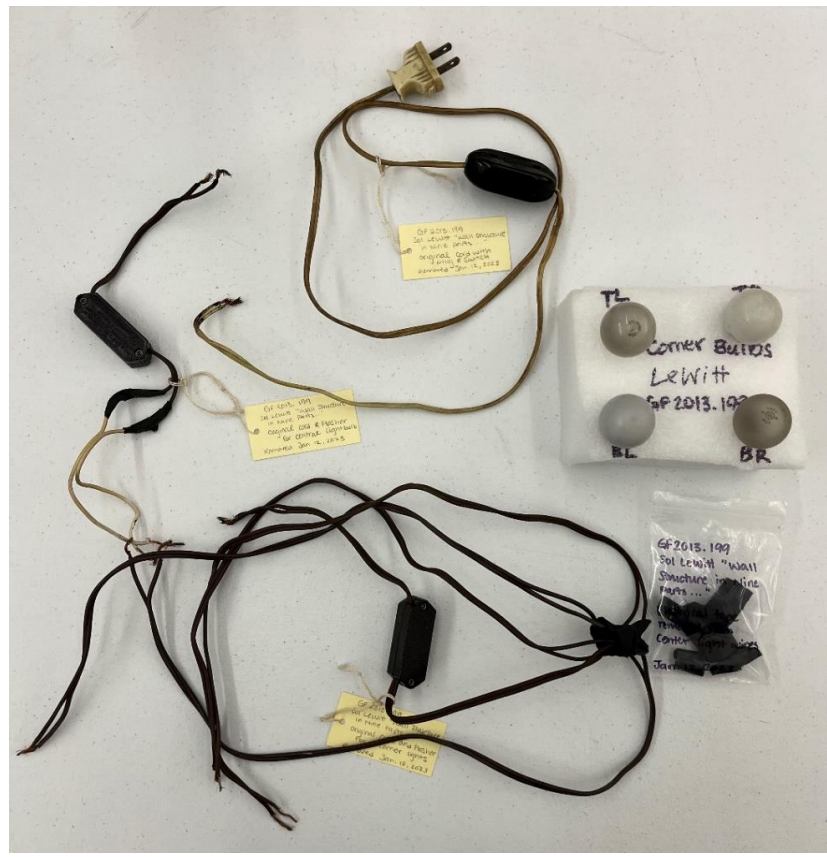
FIGURE 8 Original electrical components saved for Artist Material Archive (right) and back panels stored on trays (left).

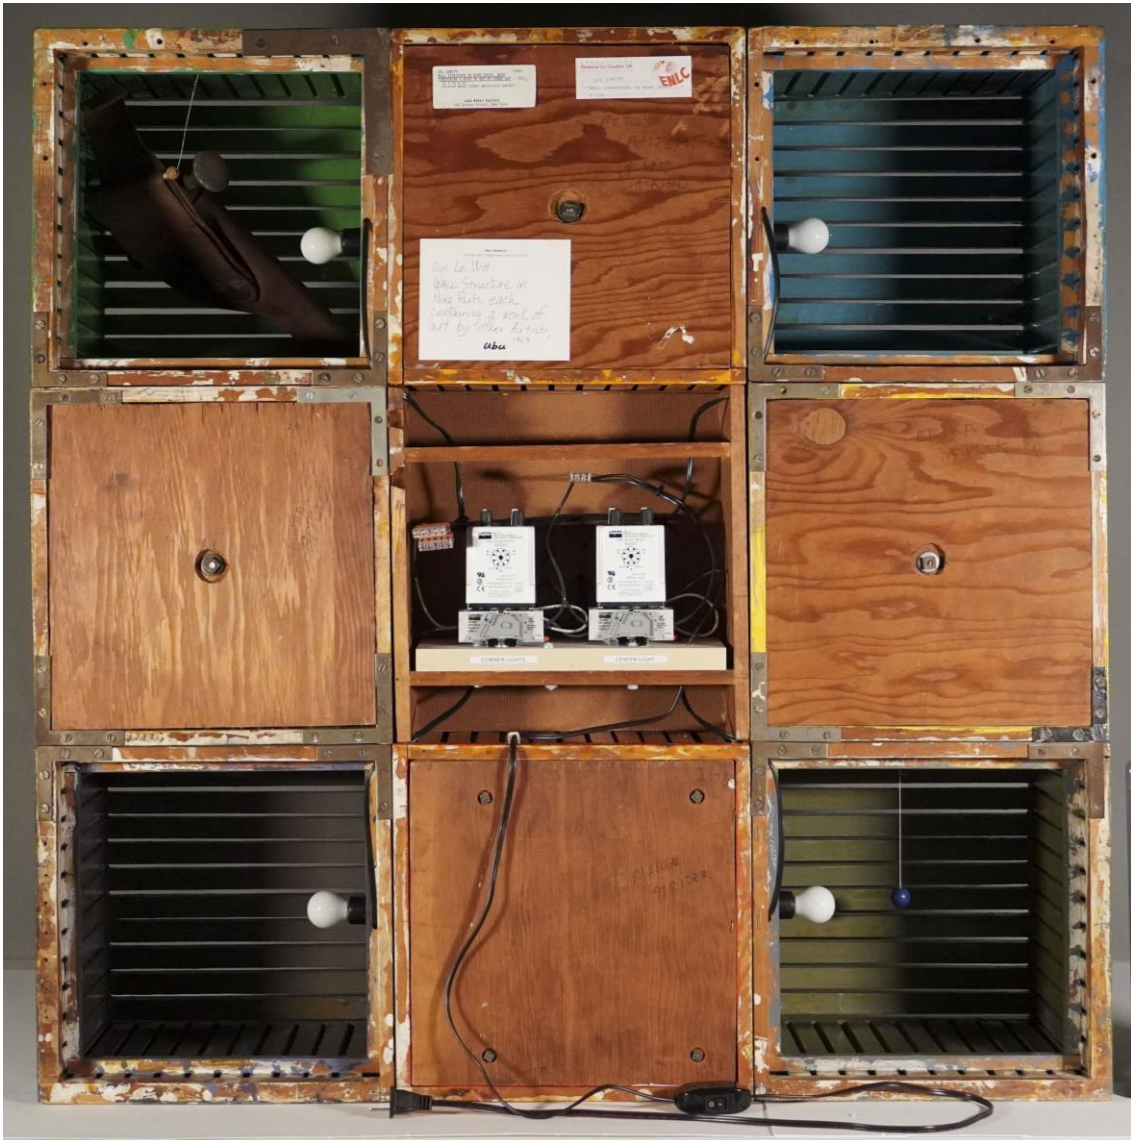
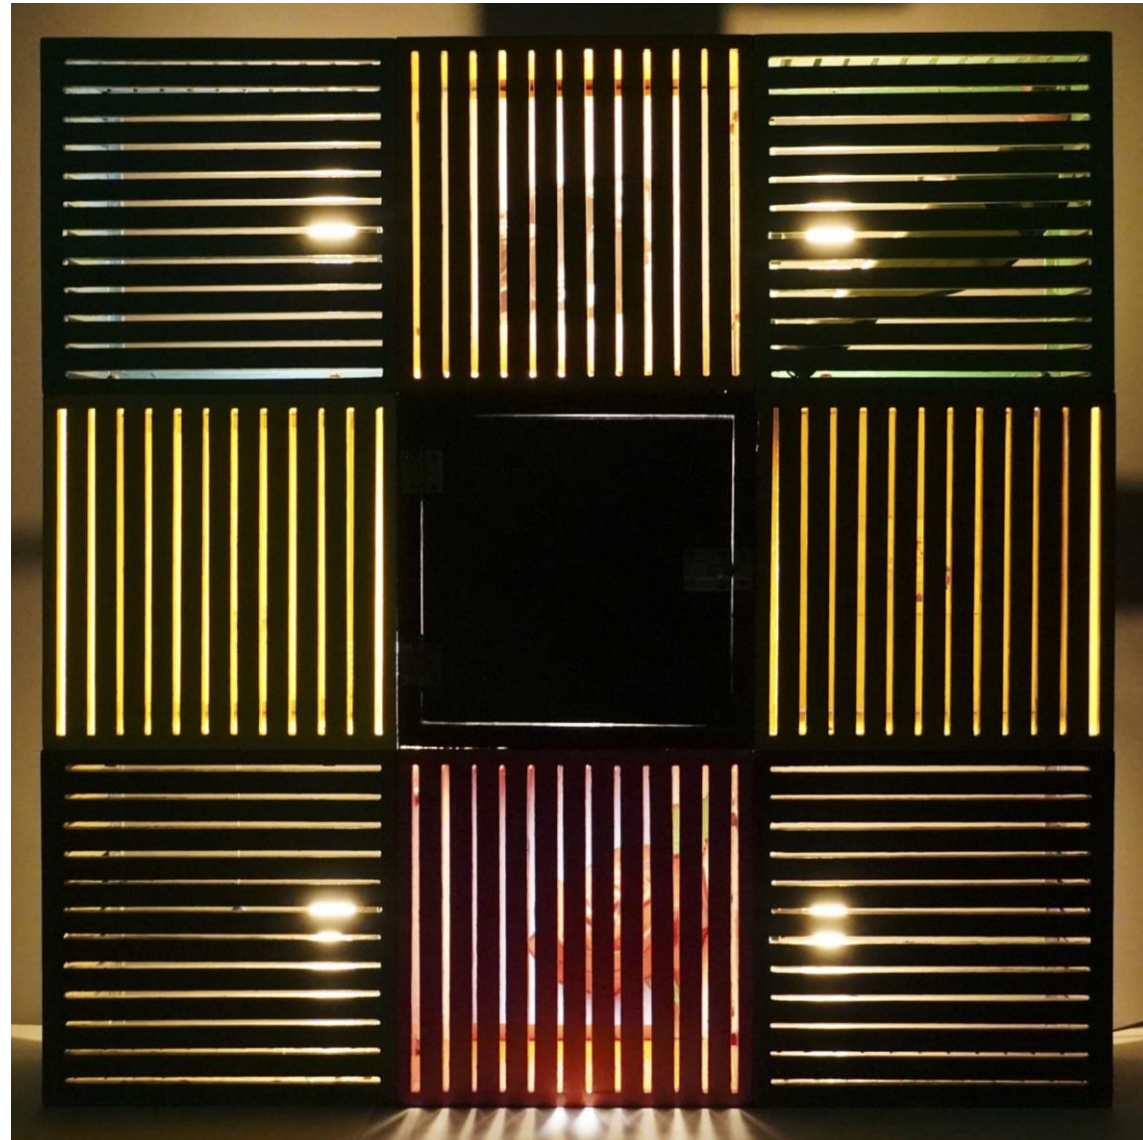
FIGURE 9 Back, after treatment (top); Front, all lights on (bottom)

*Wall Structure in Nine Parts, Each Containing a Work of Art by Other Artists* can now be exhibited without fire risk. The updated electrical components allow for the work to be enjoyed safely, as LeWitt intended. All original electrical components were saved, and the updated electrical elements can be safely removed.
