Structural Treatments of Textile Supports: Tear Repair of A Church Painting In 1889 -- The Use of Low-Cost Heated Needle

Wing yi Cheung, Master of Cultural Materials Conservation, University of Melbourne

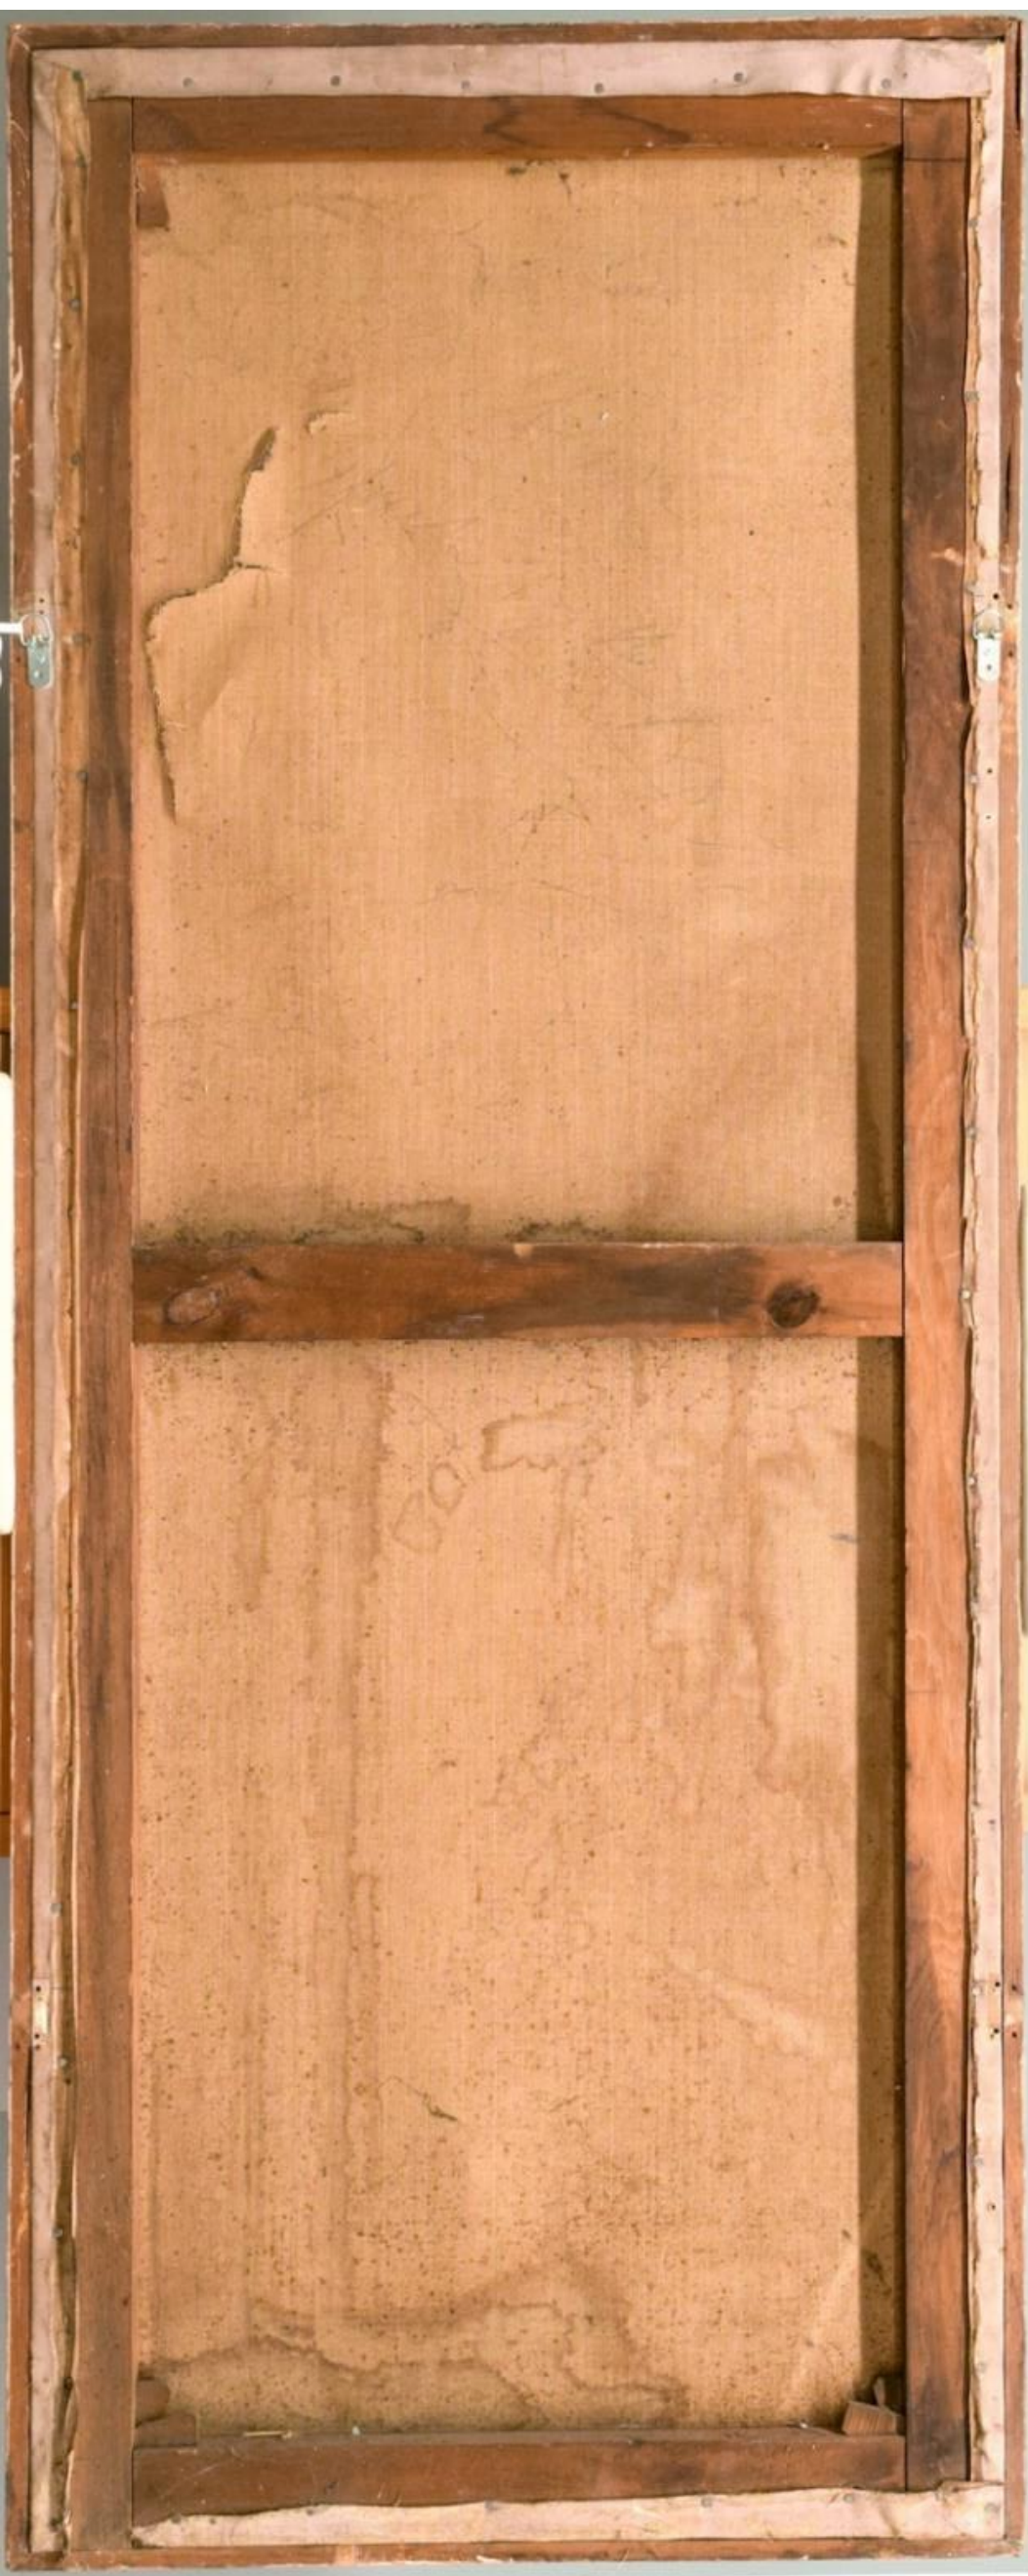
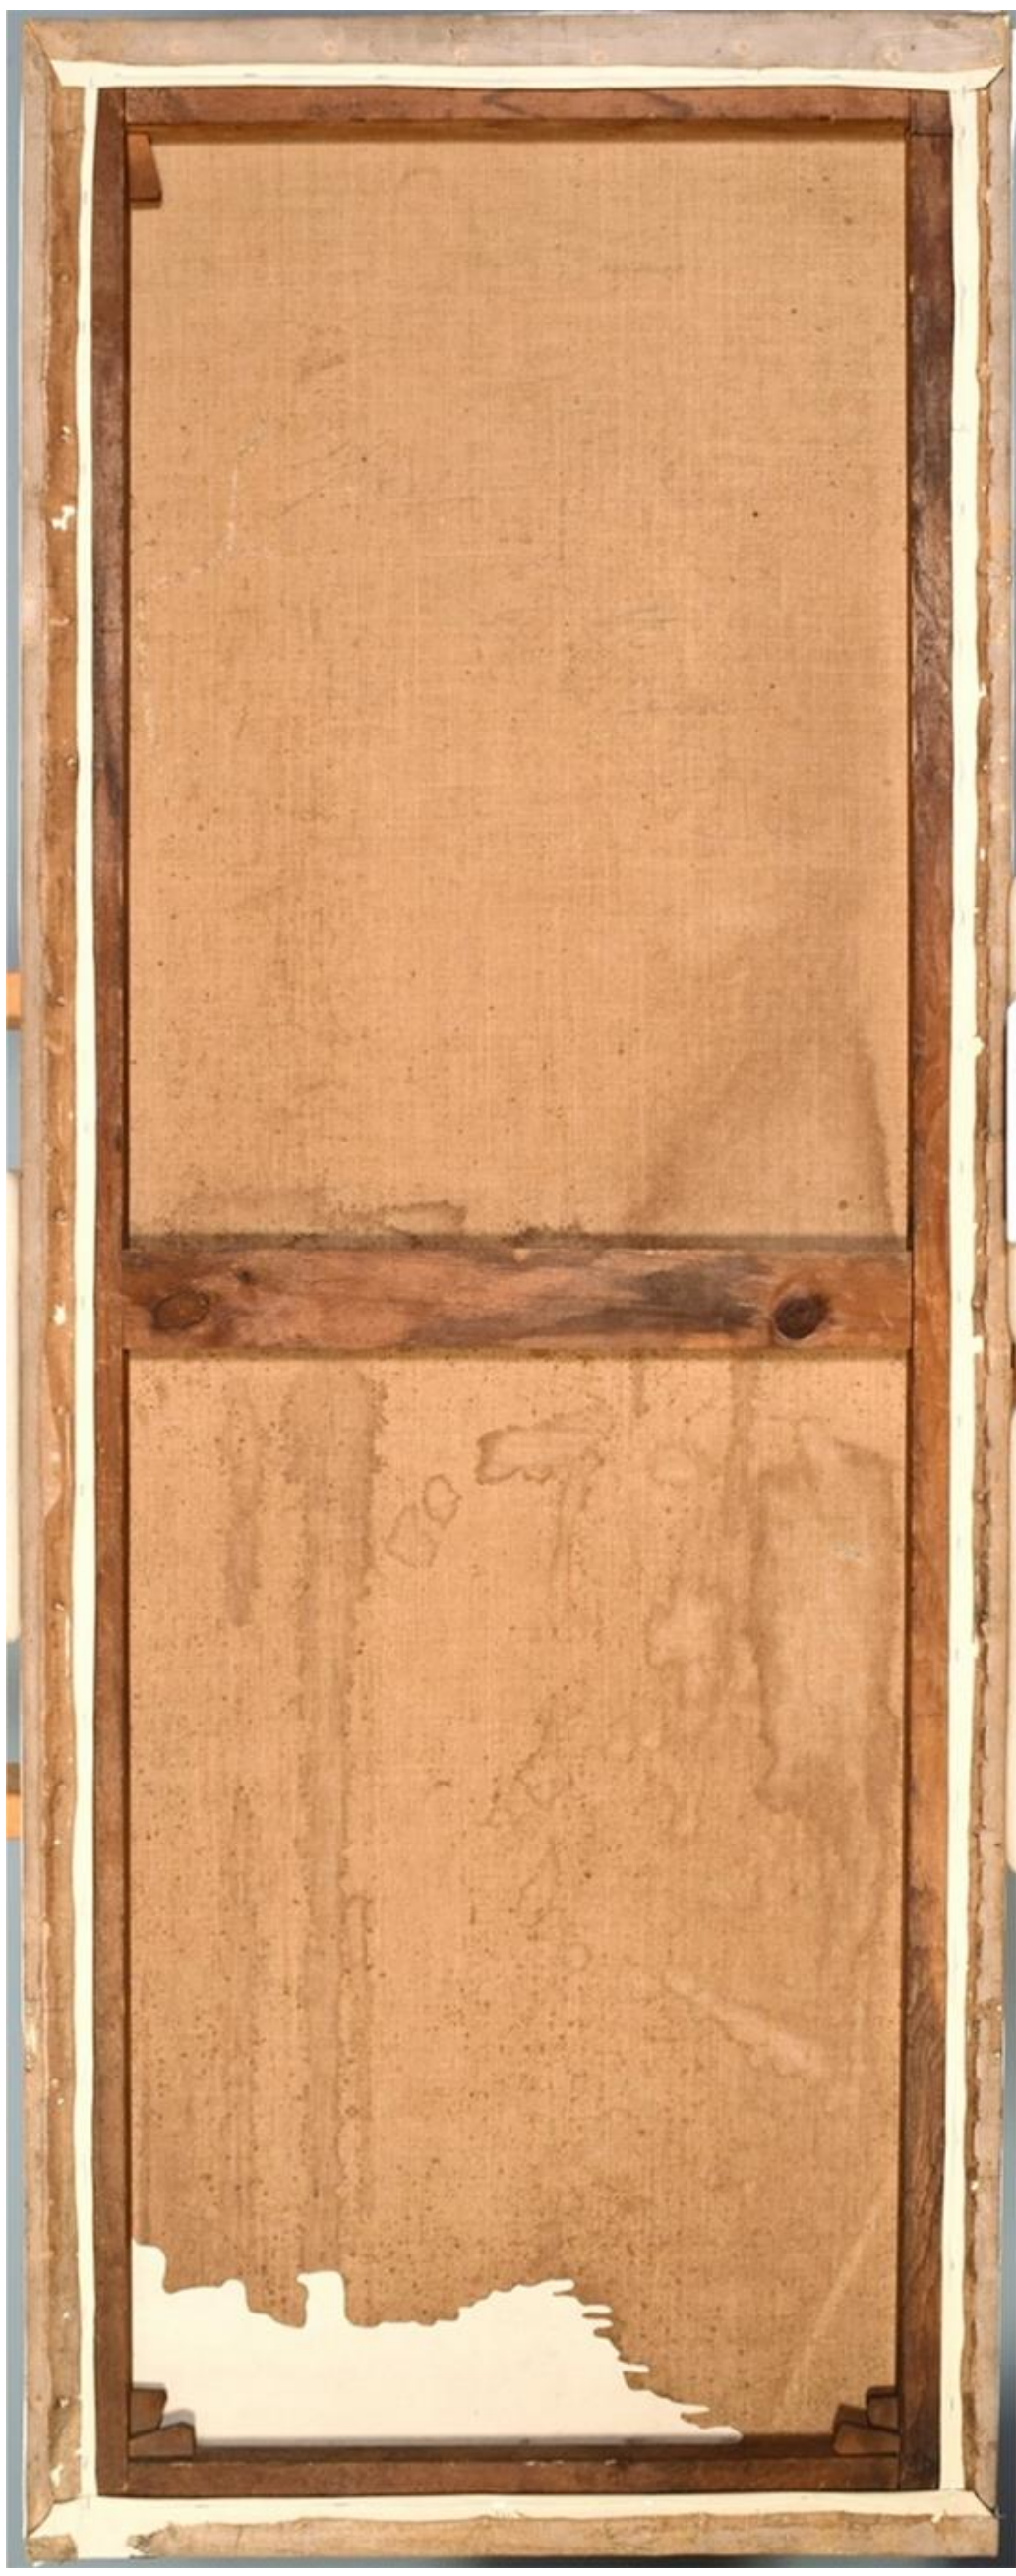
Figure 13

The Church Painting 1, possibly painted in 1889 by an unknown artist, is framed with a four-membered wooden frame. Together with Church Painting 2 is the collection of St Columb's Church Hawthorn. The owner sent the painting to the Grimwade Centre of the University of Melbourne as a teaching and research object. The painting was in poor condition, with a major tear of approximately 300mm noted at the top right of the canvas.

The painting experienced overall water damage with loss of paint and fragile of canvas, full lining was the choice for canvas treatment. However, an inscription, '19th april 1889', possibly marked by pencil, is noted at the back of the painting next to the major tear. Therefore, full lining methods were ruled out so as to retain the historical information of the painting. Only the heavily water-damaged canvas bottom was lined with additional canvas along with the bottom strip lining (method suggested by John Hook).

Figure 13, 14: Verso of the Church Painting 1 before and after structural treatments

The tear and the hole were treated by a mixed thread – by – thread and bridging method. Owing to later environmental concern, synthetic adhesive was chosen. Polyamide welding powder was selected as it has great tensile strength [1]. A mixture of original fibre extracted from the canvas and new linen fibre were used as the threads.

1. Dry cleaning, testing (solubility, pH and conductivity) and consolidation.
2. Unframing and Stretching bar detaching.
3. Humidification and flattening of tacking edges.
4. Local humidification and flattening of the tear and hole by sandwich approach.
5. As the tear located too close to the stretcher, the 'Trecker' was not adoptable. The position of the tear was fixed by sandbags and weights. Masking tapes helped to hold the gap on areas that were not marked with inscriptions.
6. A minimal amount of molten polyamide was applied to the original canvas, which was attached to one end of the foreign thread.
7. Tightened (tensioned) the thread with a micro point tweezer and applied the molten adhesive to the other end of the thread.
8. The threads were then immediately left dried under weight.
9. Continued steps 6 to 8 until the tear and hole were completely treated.

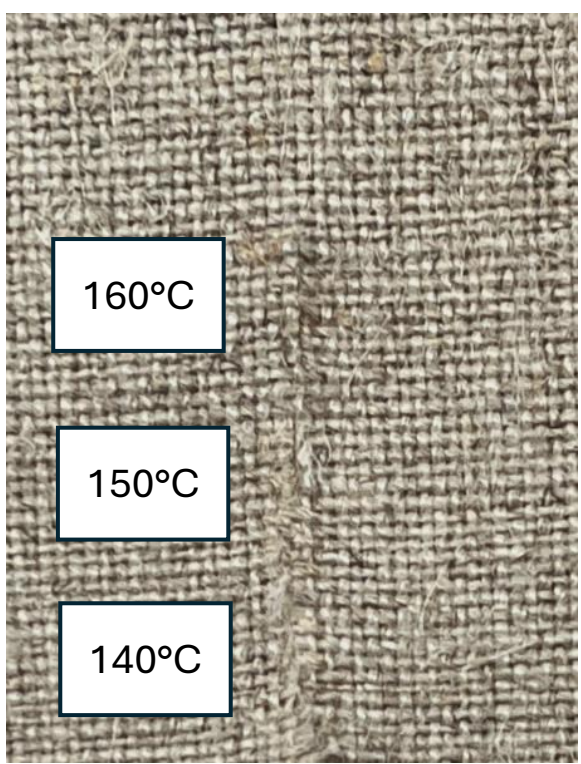
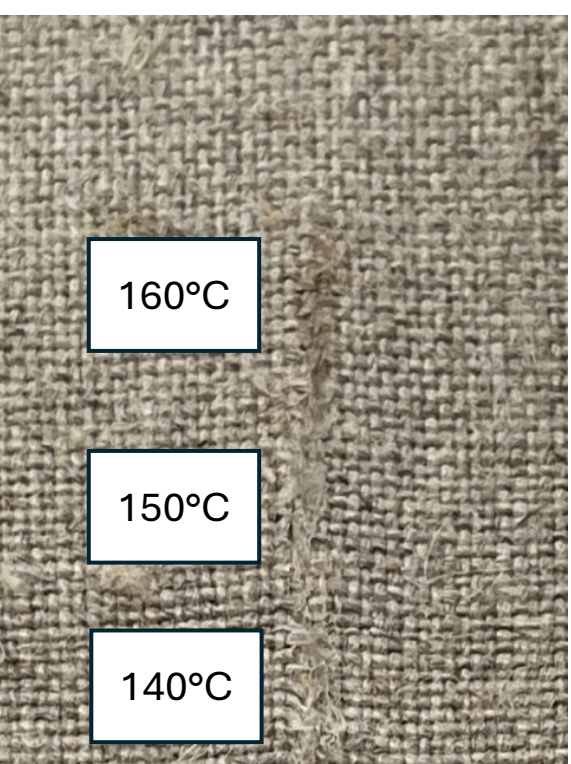
Figure 7

The polyamide powder was first applied to the mockup canvas with the heated needle set at different temperatures. The testing interval was 10 °C, and the testing started at 100 °C (marked temperature on the screen of the soldering iron). According to the mockup test results, the soldering iron set at 140 °C gently contacted the back of the tacking edge. No observable change in the paint surface was noted after the testing. Therefore, a set temperature of 140°C for the needle would be safe and workable for the treatment.

Figure 7, 8: Mockup test, Tear, before and after

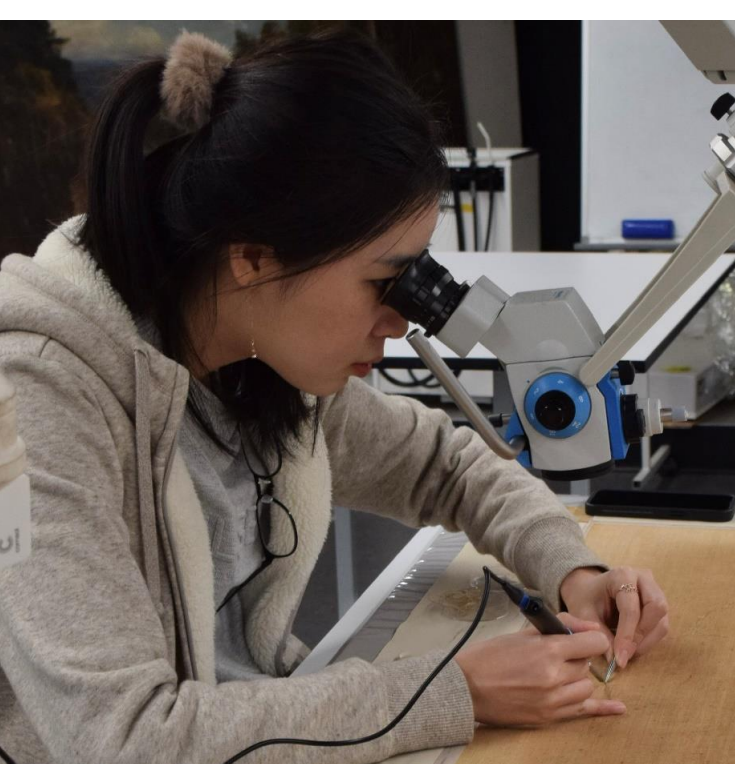
Figure 9

Figure 9: Working photo for the tear repair

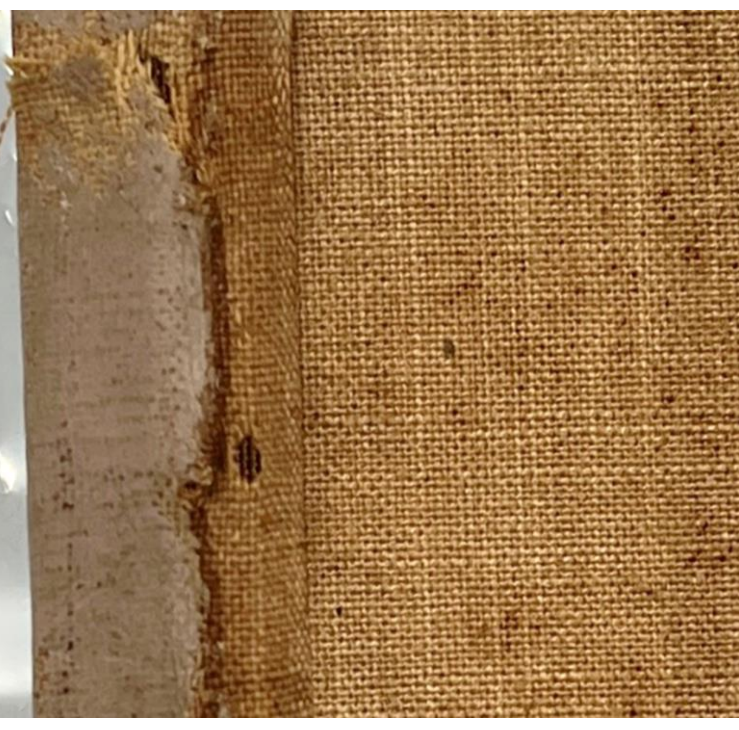
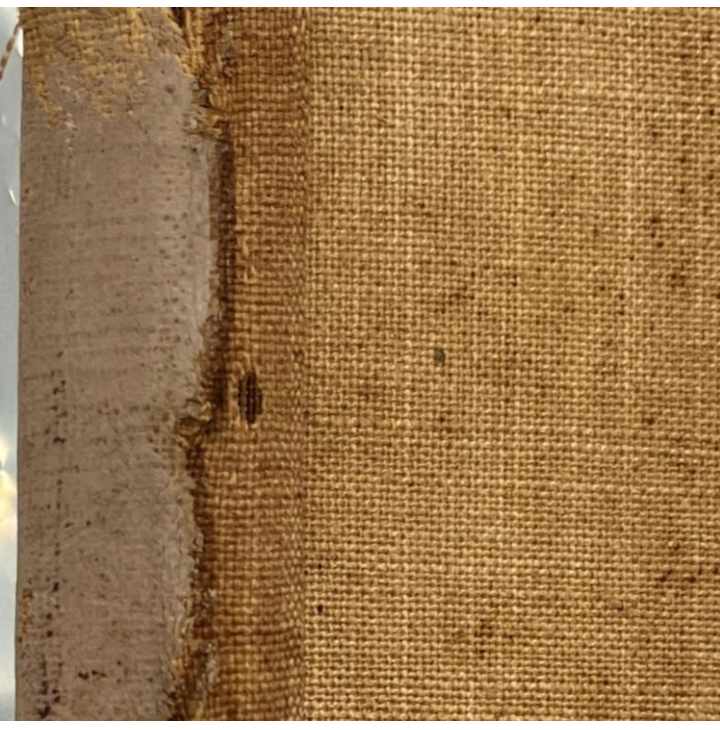
Figure 10

Figure 10, 11: Temperature test on the verso of the tacking edge, before and after
