Source: *Objects Specialty Group Postprints, Volume Fifteen, 2008*

# FROM MARBLE TO MUSSELS: A SIMILAR TREATMENT APPROACH TO DISSIMILAR MATERIALS

JUDY OZONE AND ABIGAIL MACK

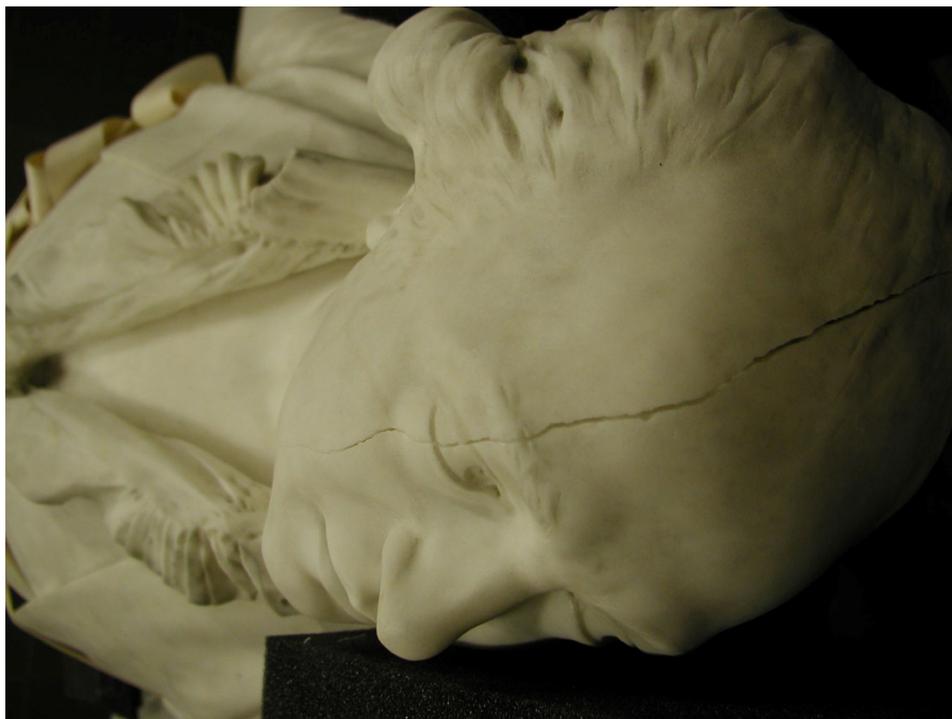
The Houdon marble was severely damaged when it fell from a lift during transport within the museum. The top-heavy sculpture landed head first onto a concrete floor, resulting in fragmented and crushed marble, as well as a series of deep cracks and fissures. The most serious damage emanated from the point of impact at the top of the head. A deep and wide crack bisected the head - from the front neck, across the right side of the face, and down to the collar at the back - such that each end of the crack was only inches away from the other within the neck. This primary crack measured 20 inches in length (51 cm) (fig. 2).

Fig. 2. Detail of damage: Houdon, Giuseppe Balsamo (Photograph by Abigail Mack)

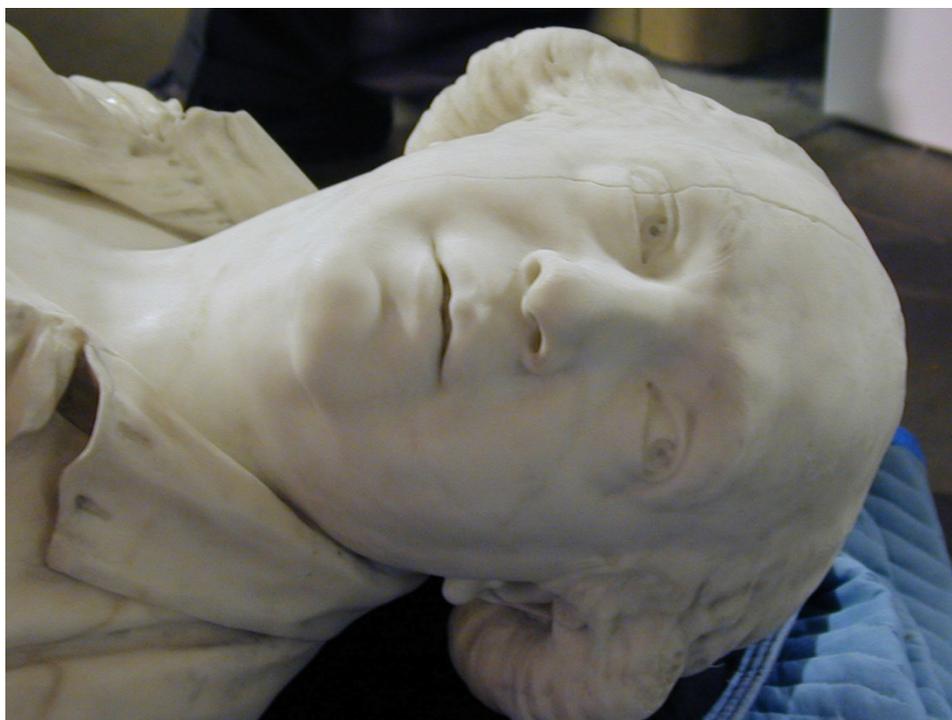
The resulting crack was also over 1.0 mm at its widest point, and tapered off through most of its length into a network of hairline fissures that branched up to 10 cm away from the main crack. What made this crack even more troublesome was that, in addition to its substantial width, the marble had sprung, that is, the stone's inherent internal stresses were released, creating a permanently stepped and misaligned surface. This misalignment was especially apparent across the right eye (fig. 3).

Fig. 3. Detail of damage through right eye: Houdon, *Giuseppe Balsamo* (Photograph by Abigail Mack)

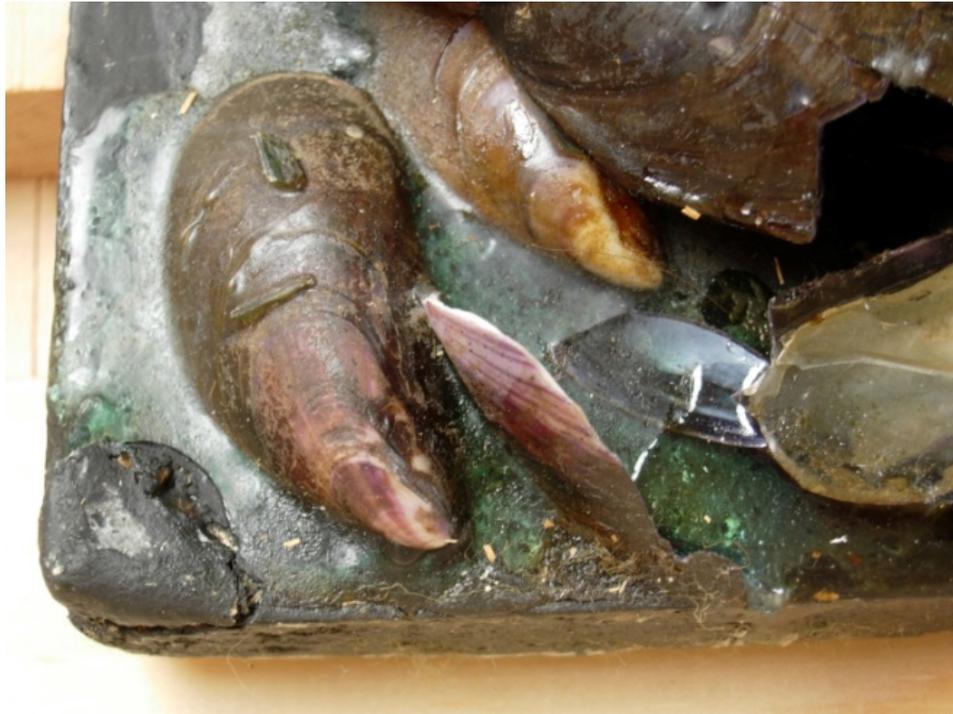
Fig. 4. Detail of surface loss: Marcel Broodthaers, *Panneau de Moules* (Photograph by Judy Ozone)

The fragile condition of the Broodthaers work was evident immediately when the object arrived at the museum for purchase consideration. Taped along the inside edges of the packing crate were little packets of detached mussel shells. Many of the shells were broken, lost, or actively separating from its particleboard backing (fig. 4). More seriously, the friable particleboard was prone to flexing and was inadequate to support the weight of the thousands of shells held together in a matrix of clear and tinted polyester resin, all of which is meant to be viewed vertically. Between the shells, it was apparent that the resin was not a continuous film. Also visible were remnants of old paint on the board, along with leaves and other detritus among the shells, which gave evidence to the swift and spontaneous application of shells on a recycled board. The many detached and insecure shells as well as gaps along the edge of the panel called attention to the fact that both the resin and particleboard had shrunk appreciably (and at different rates) in the 40 years since the piece was made, and raised serious concerns about the overall structural integrity of the work (fig. 5).

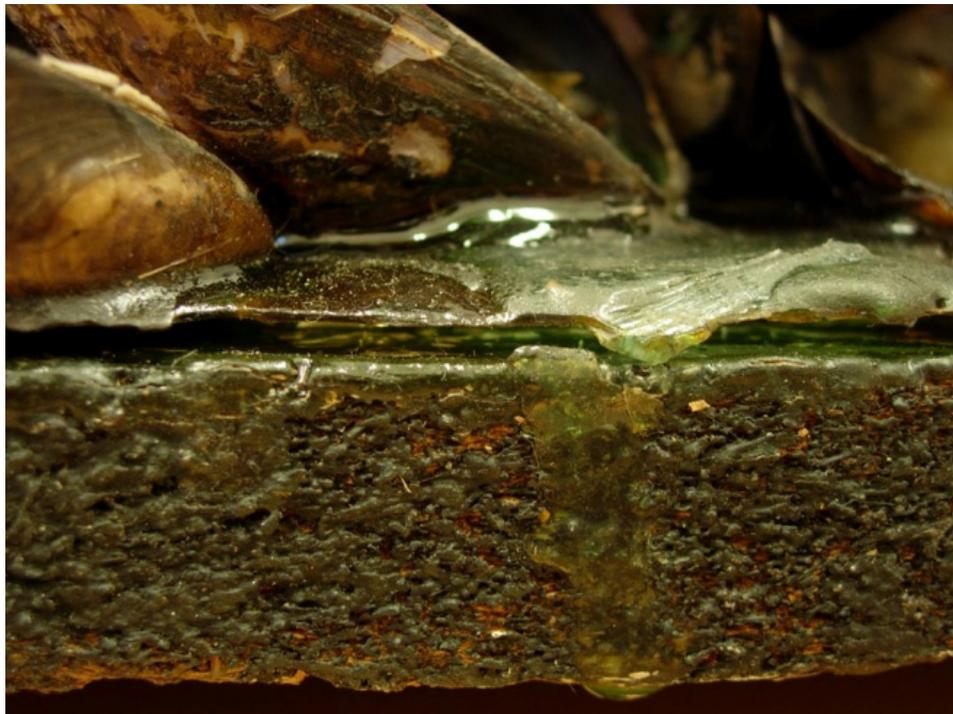
Fig. 5. Detail at of resin separation at panel edge: Marcel Broodthaers, *Panneau de Moules* (Photograph by Judy Ozone)

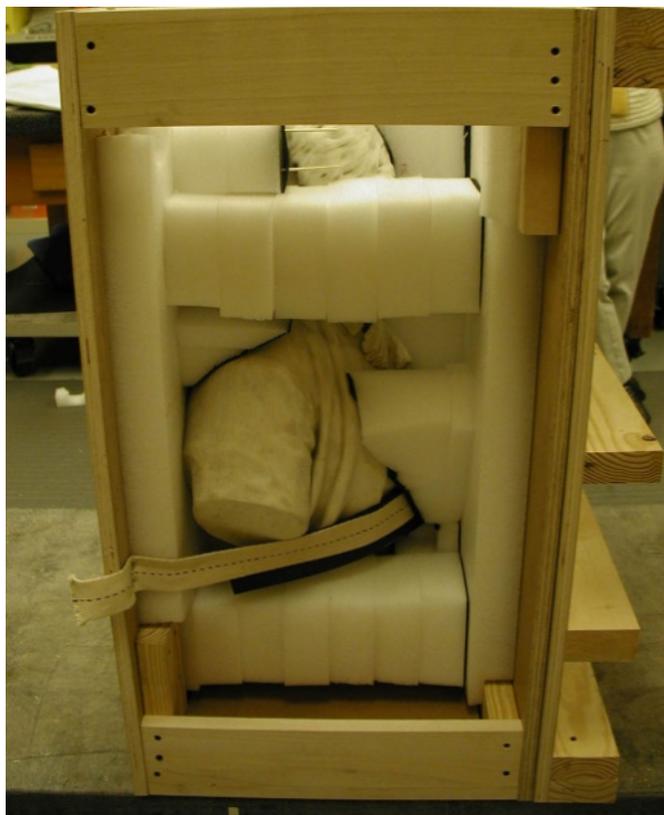
Fig. 6. Wooden cradle for Houdon marble (Photograph by Abigail Mack)

sculpture's contours was fabricated to secure the sculpture during treatment (fig. 6). It should be noted that the marble weighs over 300 pounds, and the cradle was designed so the immobilized sculpture could be turned over in order to access the full circumference of the crack.

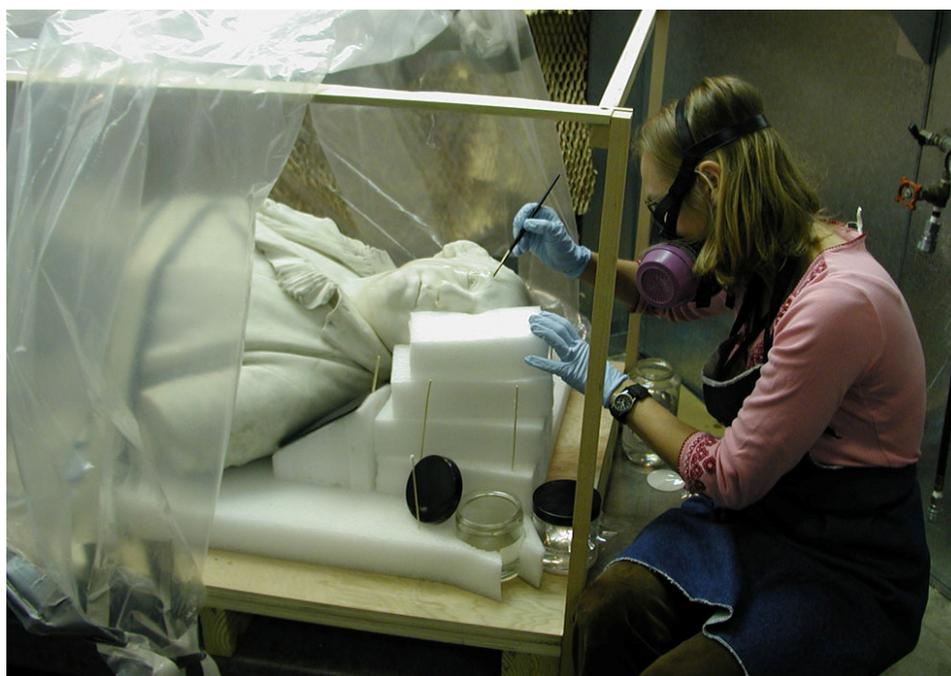
Fig. 7. Fume chamber for marble consolidation (Photograph by Judy Ozone)

To increase the penetration and distribution of the resin throughout the marble matrix, the entire consolidation procedure was done in a DEB fume-saturated chamber, after which the marble was kept in isolation in the spray booth for over six weeks to allow for the slow dissipation of solvent (fig. 7).

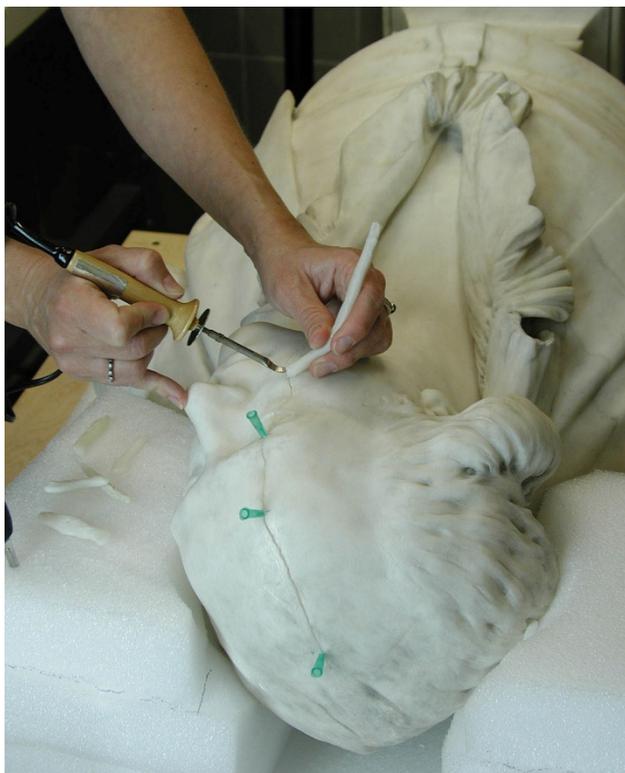
Fig. 8. Applying wax-resin dam material around injection ports (Photograph by Judy Ozone)

The extremely limited access along the length of the crack required the use of an adhesive with the lowest possible viscosity in order to reach into the depths of the crack. For this reason, Hxtal NYL-1 epoxy was chosen following considerable testing. In order to avoid staining the surface, medical syringes were used to inject the epoxy deep into the crack. Because the crack traversed the entire head, any application of adhesive from one side would likely flow out through the other. To contain the flowing epoxy as it was introduced into ports at the front of the head, the crack at the crown was dammed with a wax-resin mixture (fig. 8).<sup>6</sup> The same procedure was used when the sculpture was turned onto its back.

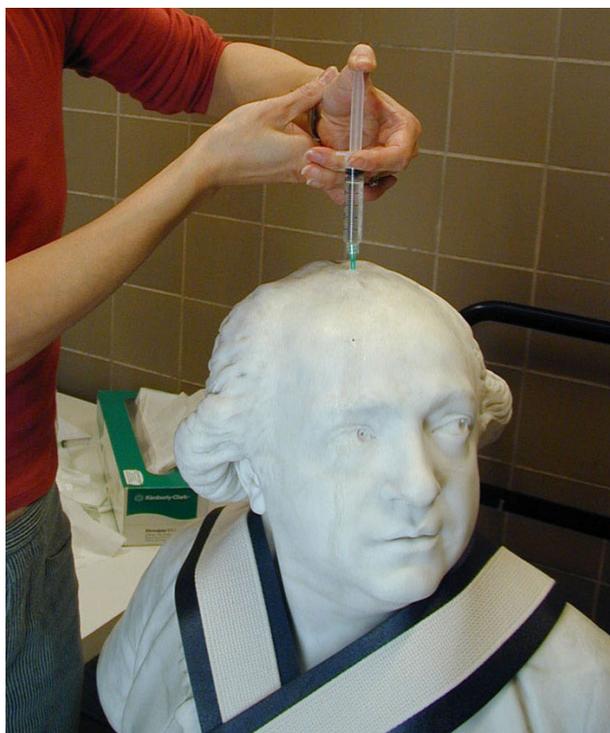
Fig. 9. Injection of epoxy into crack (Photograph by Abigail Mack)

To control its movement within the marble, the Hxtal epoxy was applied in small increments and allowed to cure in successive stages until the built up layers of epoxy could be seen within the crack (fig. 9). The last half-inch of the gap was underfilled with the slightly more viscous Akepox 5000 epoxy which has less creep, more body, and could also serve as a gap filler. With the primary crack stabilized, the remaining gap was filled level with the sculptural surface using the same wax-resin mixture as was used to dam the crack, tinted to match the adjacent marble surface (fig. 10).

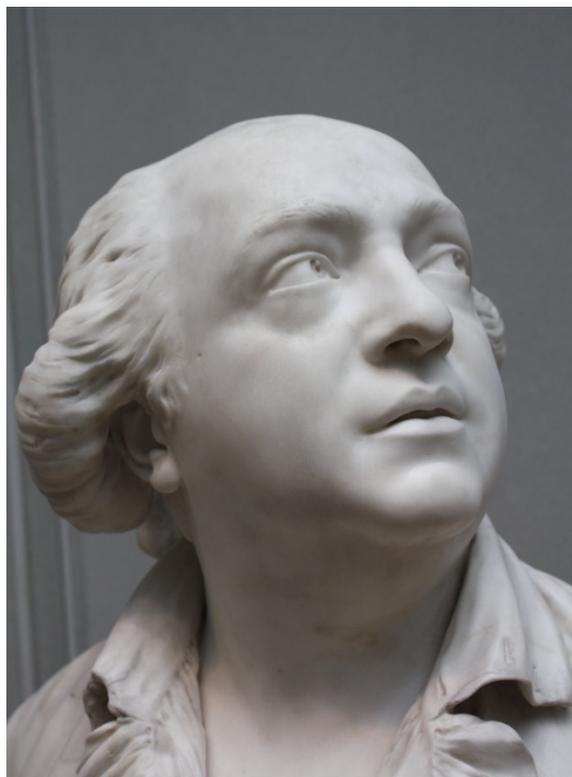
Fig. 10. Detail, after treatment: Houdon, *Giuseppe Balsamo* (Photograph by Abigail Mack)

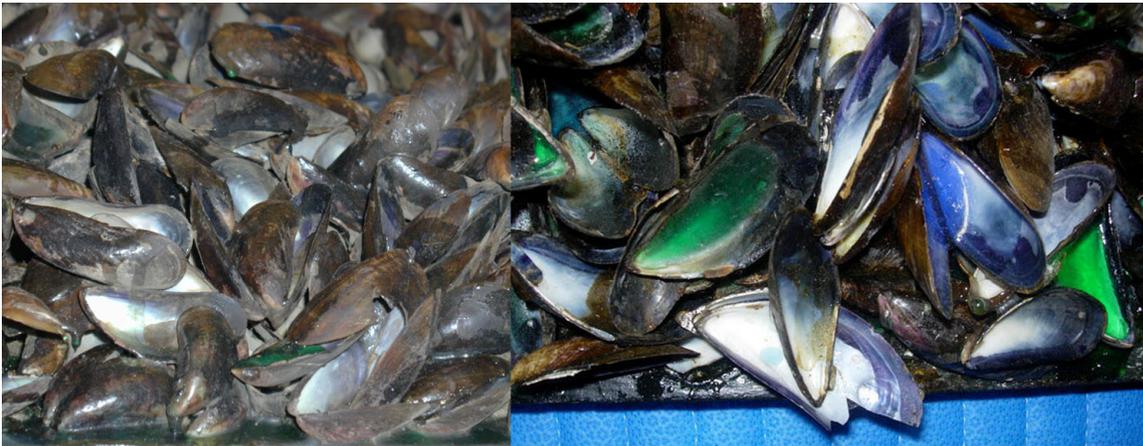
Fig. 11. (left) Detail, before cleaning; Marcel Broodthaers, *Panneau de Moules*, (right) Detail, after cleaning; Marcel Broodthaers, *Panneau de Moules*. (Photographs by Judy Ozone)

The initial, though not insignificant step, was to clean away years of accumulated dust and dirt. Historically the panel had been hung from all four sides, so every conceivable surface was covered with dust, giving the panel an overall grey appearance. In the course of cleaning, the full extent of the work's instability became apparent, as did the still brilliant colored resin that Broodthaers used to fill the shells (fig. 11). A reference system was devised to ensure accurate documentation and to track treatment progress. The mussel panel was laid on a temporary support board to which was attached a low wooden upright along each side. Lightweight string was woven around the uprights to create a 64-section grid suspended over the surface of the mussels (fig. 12).

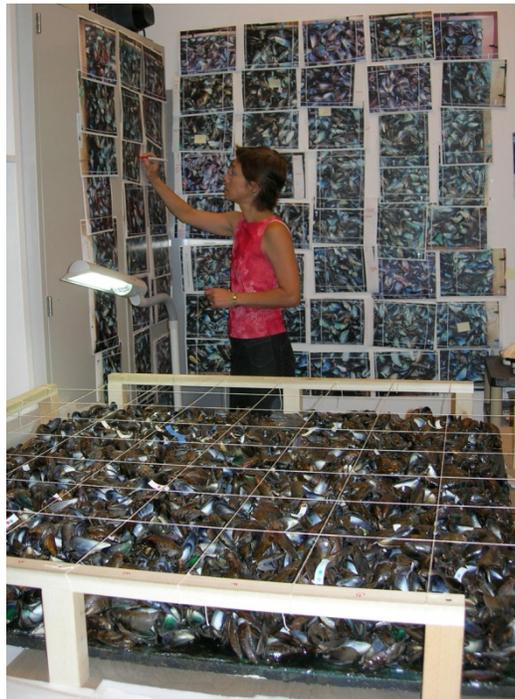
Fig. 12. During treatment, overall grid system; Marcel Broodthaers, *Panneau de Moules* (Photograph by Abigail Mack)

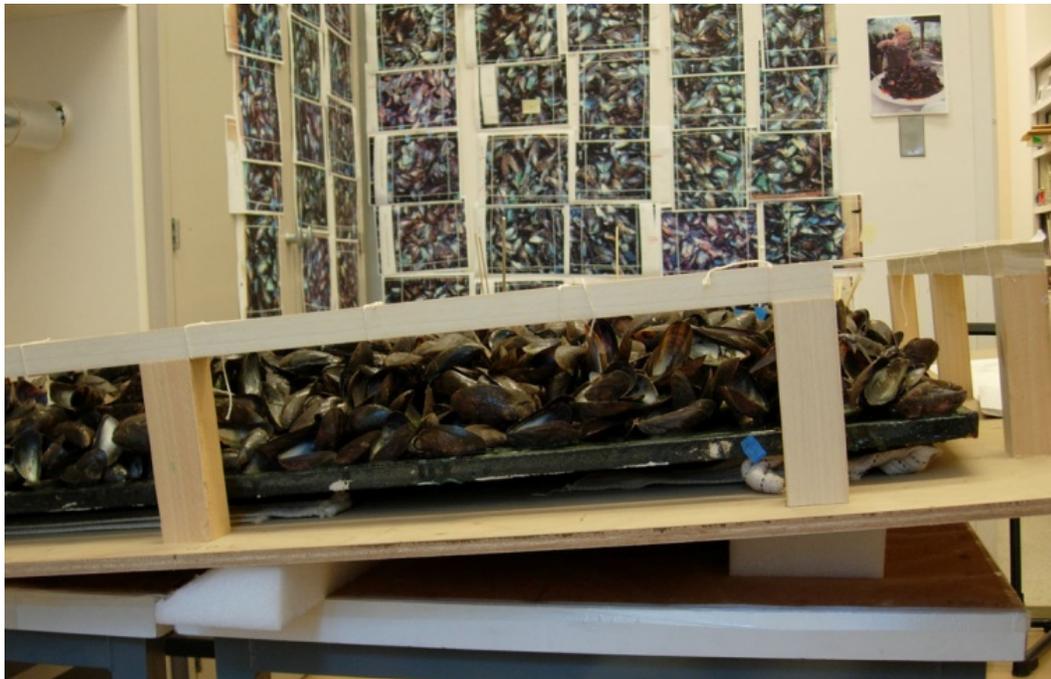
Fig. 14. Panel on slant during epoxy application (Photograph by Abigail Mack)

With the edges securely dammed, each of four sides of the object was propped up sequentially so that as the Hxtal epoxy was introduced, it would flow toward the center (fig. 14). The epoxy was applied until sufficient epoxy “fingers” met or overlapped, as determined by inserting a skewer to see how far the wet epoxy had reached. After each application, the epoxy was allowed to cure fully for two days before the object was turned. Written and photographic documentation was critical to monitor the location of each injection port, the succession in which epoxy was injected from each side, and the direction and extent of adhesive flow (fig. 15).

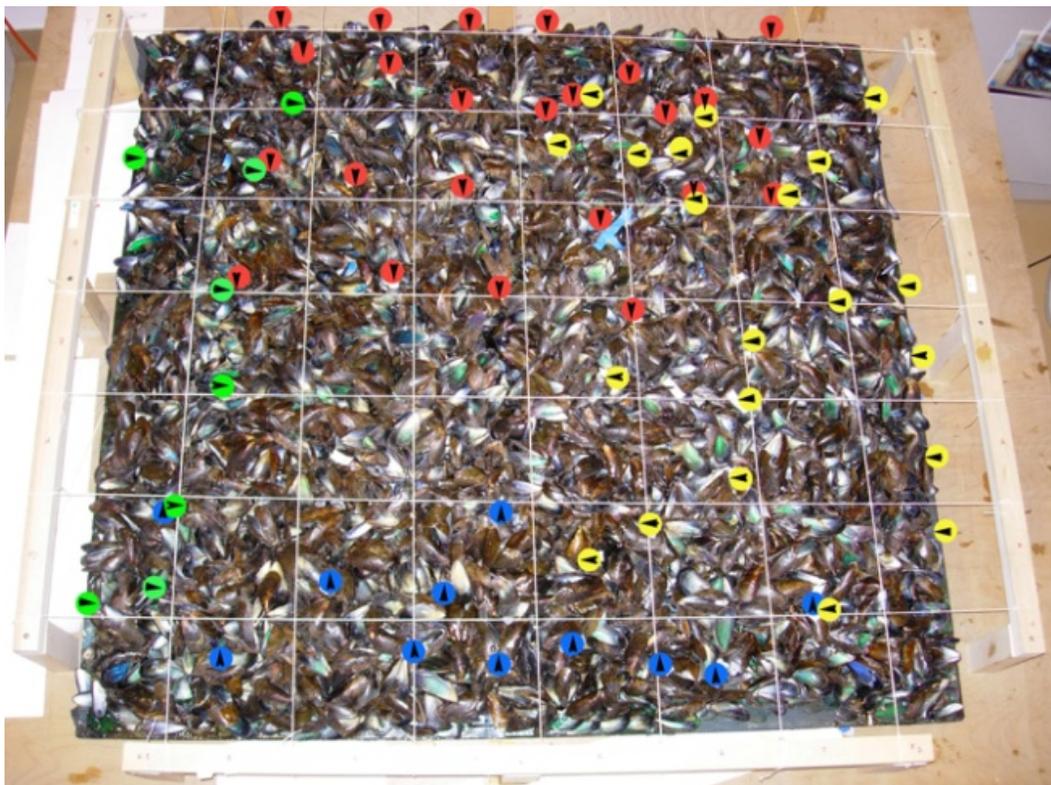
Fig. 15. Annotated photograph showing location of epoxy injection ports, order of application, direction and extent of flow (Graphic by Abigail Mack)

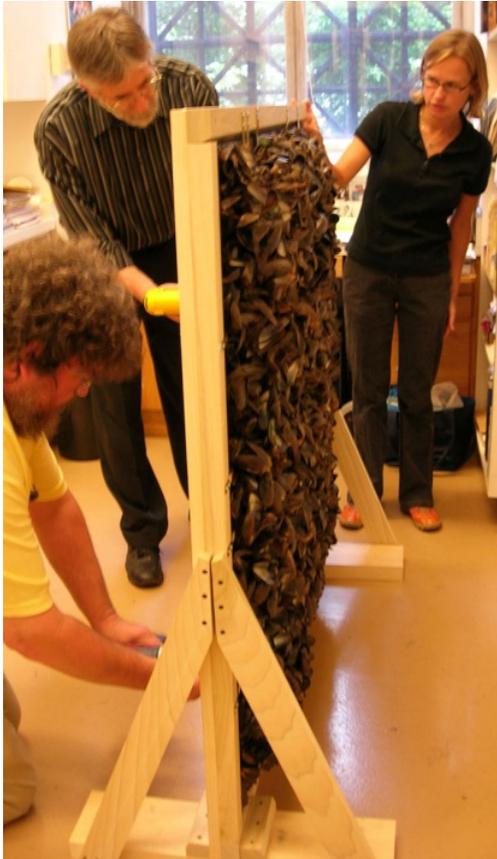
Fig. 16a. Securing art work into temporary wooden frame (Photograph by Judy Ozone)

With the front of the work successfully consolidated, the panel was turned upright and placed in a temporary vertical wooden frame to gain access to the reverse (fig. 16a). This was necessary to accomplish three steps: 1) remove the existing inadequate hanging device (small metal rings attached with short screws) and an aluminum X-shaped brace from the back of the particleboard (fig. 16b); 2) consolidate the entire back of the porous particleboard; 3) attach a rigid support that would inhibit flexing and incorporate a new hanging method.

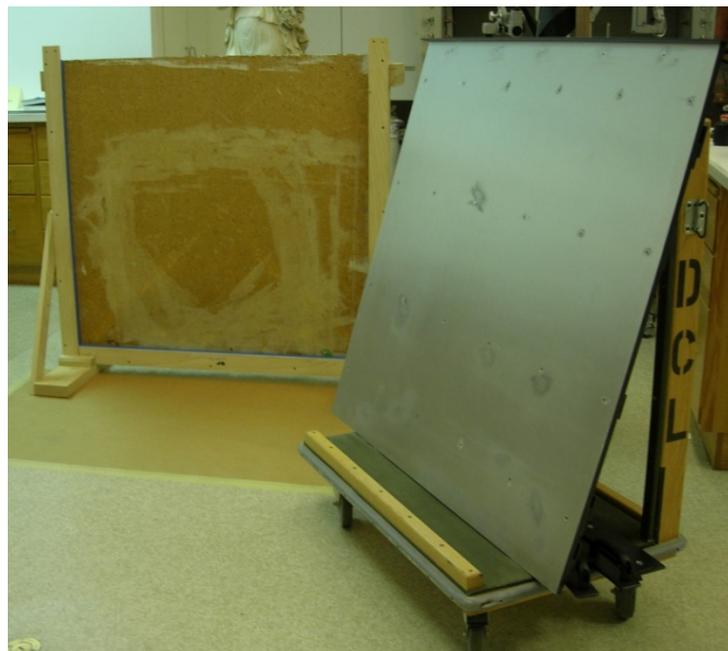
Fig. 17. Back of *Panneau de Moules* (left) and attachment face of aluminum honeycomb (right). (Photograph by Judy Ozone)

A new support made of aluminum honeycomb panel was designed to both stabilize the work of art and to facilitate handling and installation. The  $\frac{3}{4}$ -inch thick aluminum honeycomb panel was chosen because its lightweight construction could provide support and rigidity to the fragile particleboard without adding appreciable weight to an already heavy object. The panel was made slightly smaller in dimension than the work of art so that it is less apparent to the viewer (fig. 17).

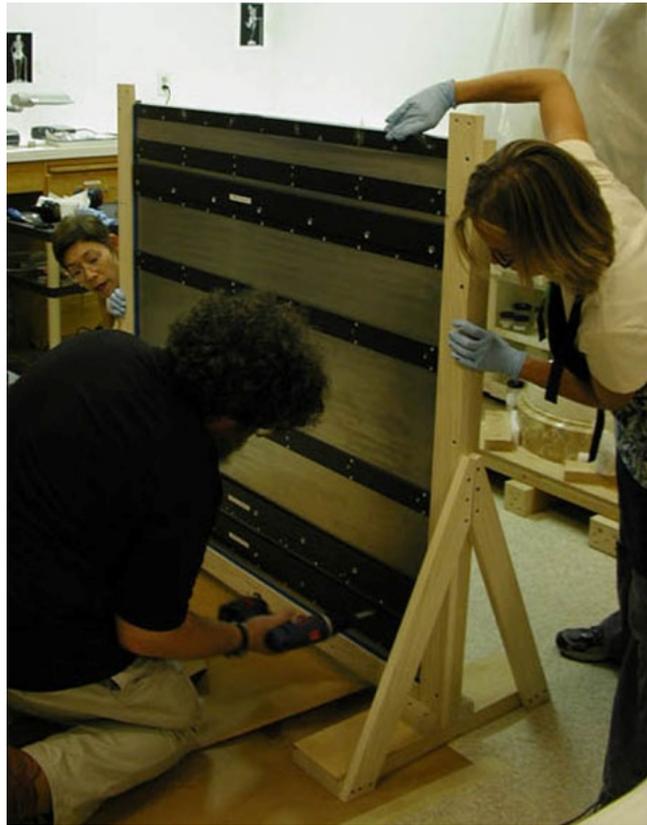
Fig. 18. Securing aluminum panel to back of Panneau de Moules, after adhesive application  
(Photograph by Judy Ozone)

Because the particleboard panel was too porous and friable to hold the new aluminum support by mechanical means alone, a structural epoxy was used to secure the honeycomb panel to the back of the object. After the epoxy cured, screws were attached through the back of the aluminum panel to provide additional security (fig. 18).

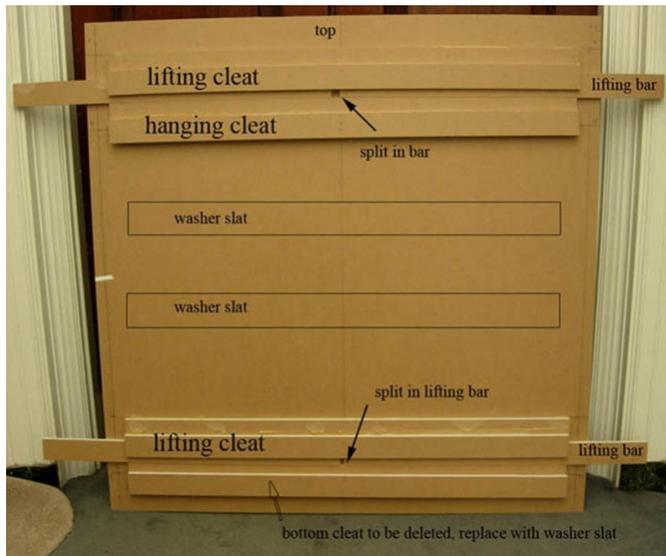
Fig. 19a. Mock-up of Z-cleat design for back of honeycomb panel  
(Constructed and photographed by Andrew Krieger)

Attached to the back of the new support panel are three sets of aluminum Z-cleats: one for hanging and two for lifting by means of removable handles (fig. 19a). The removable handles were designed so that art handlers would never have to touch the face or the sides of the object, and to distribute the weight of the object during installation (fig. 19b).

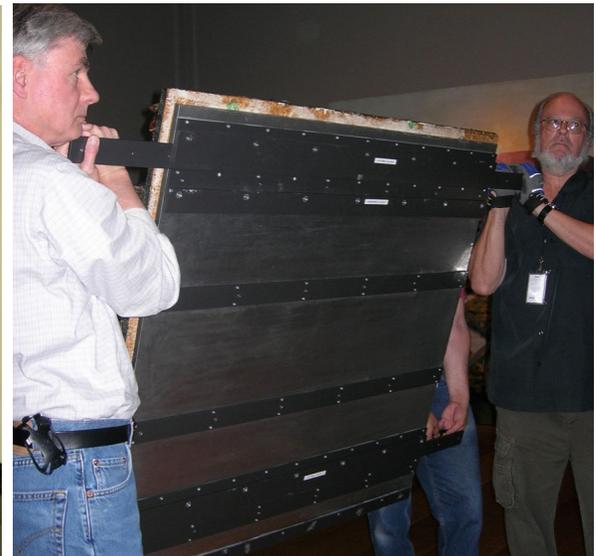
Fig. 19b. Art handlers lifting newly treated Panneau de Moules by means of lifting handles  
(Photograph by Judy Ozone)
