Beverly Pepper's Denver Monoliths and **Concrete Artificial Rock Construction**

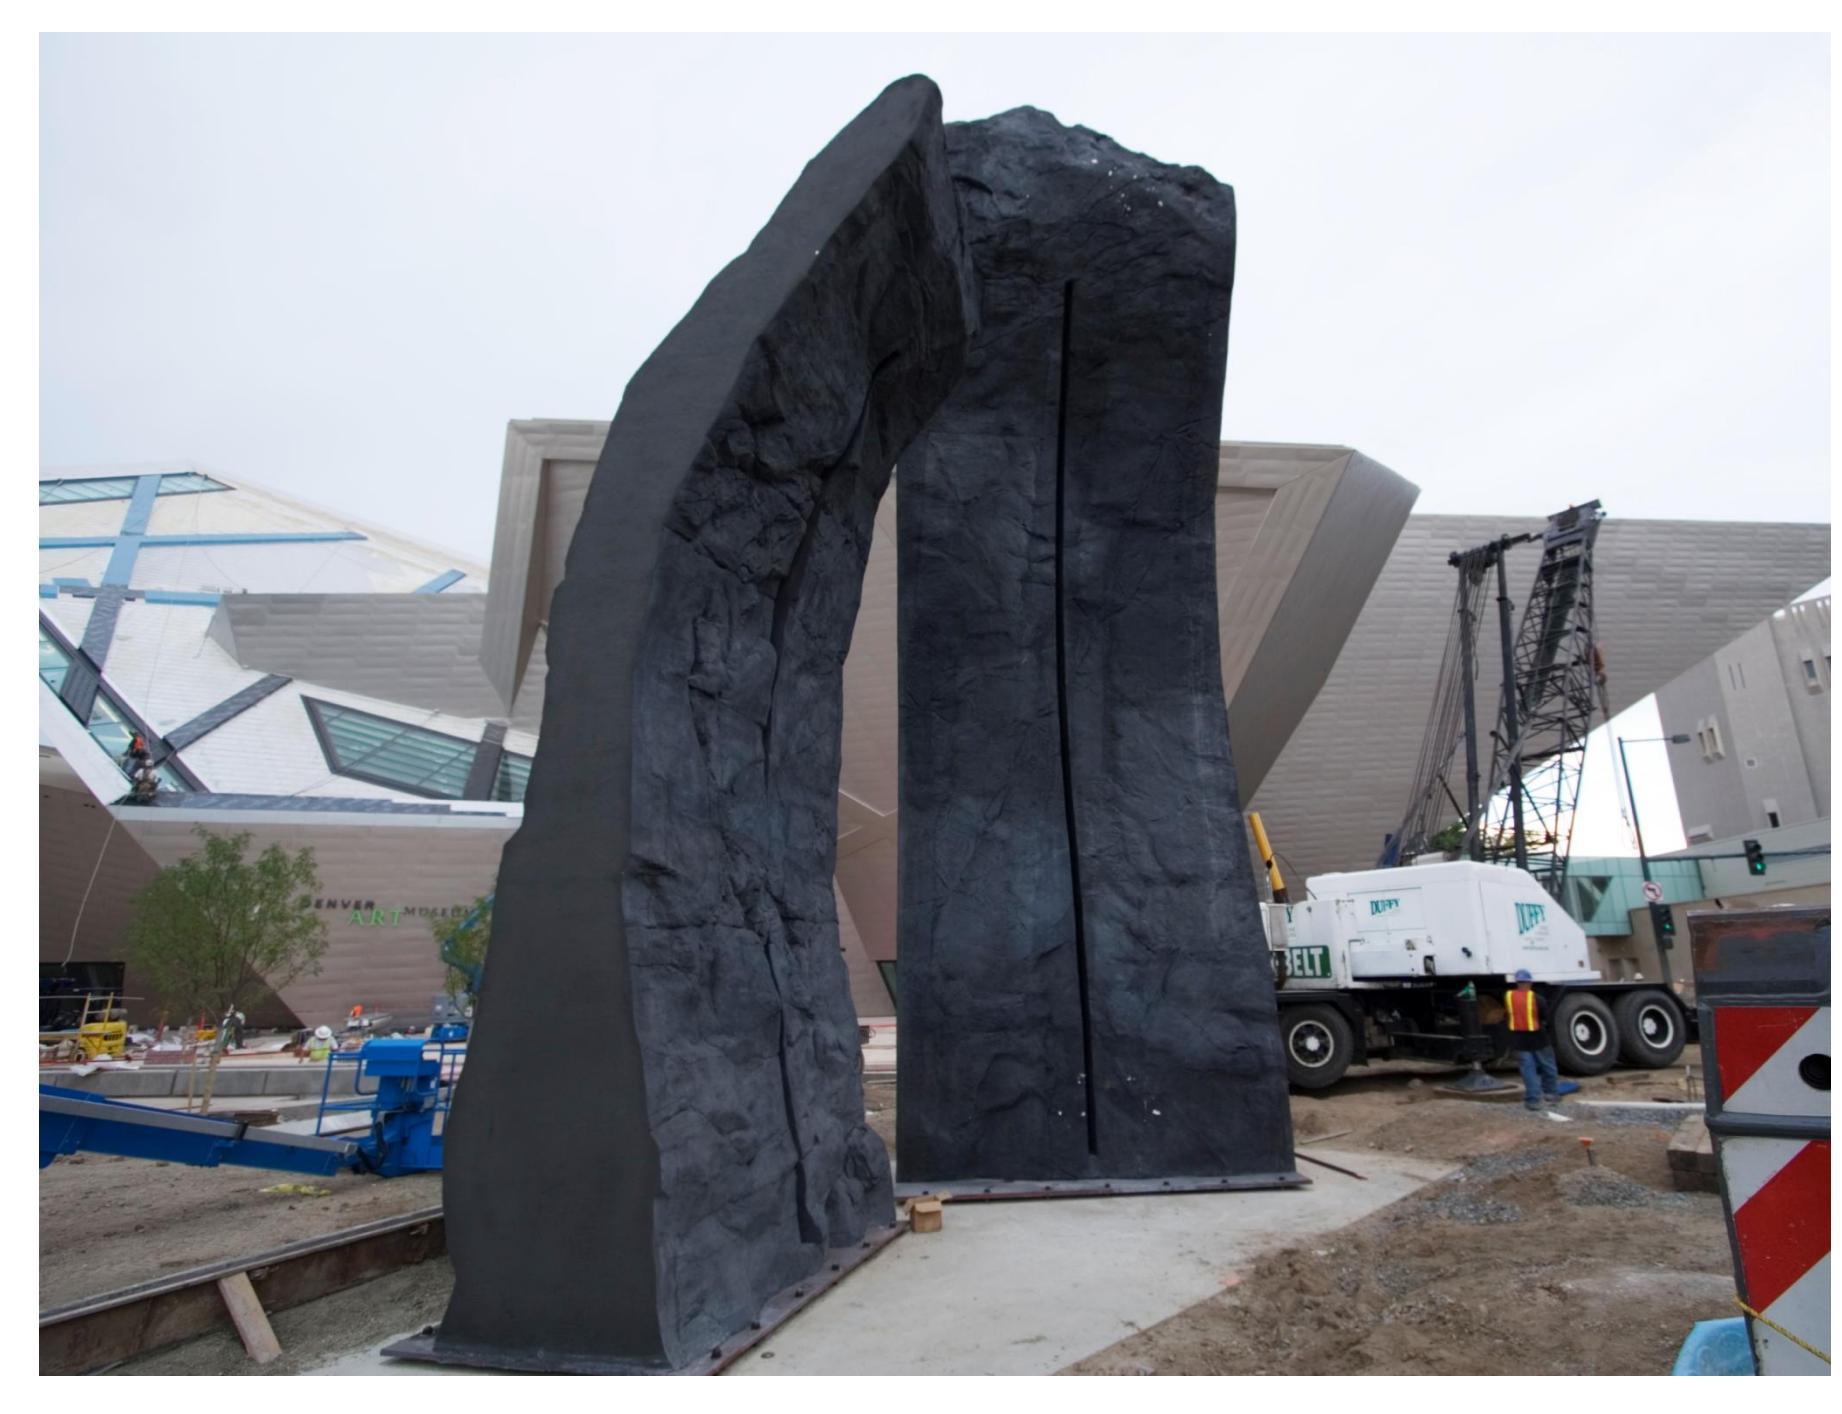
Beverly Pepper, Denver Monoliths, 2005-2006. During installation, 2006. Note dark coloration and subtle streaking on taller sculpture. (Denver Art Museum Collection: Funds from Jana and Fred Bartlit, 2006.64, © Beverly Pepper)

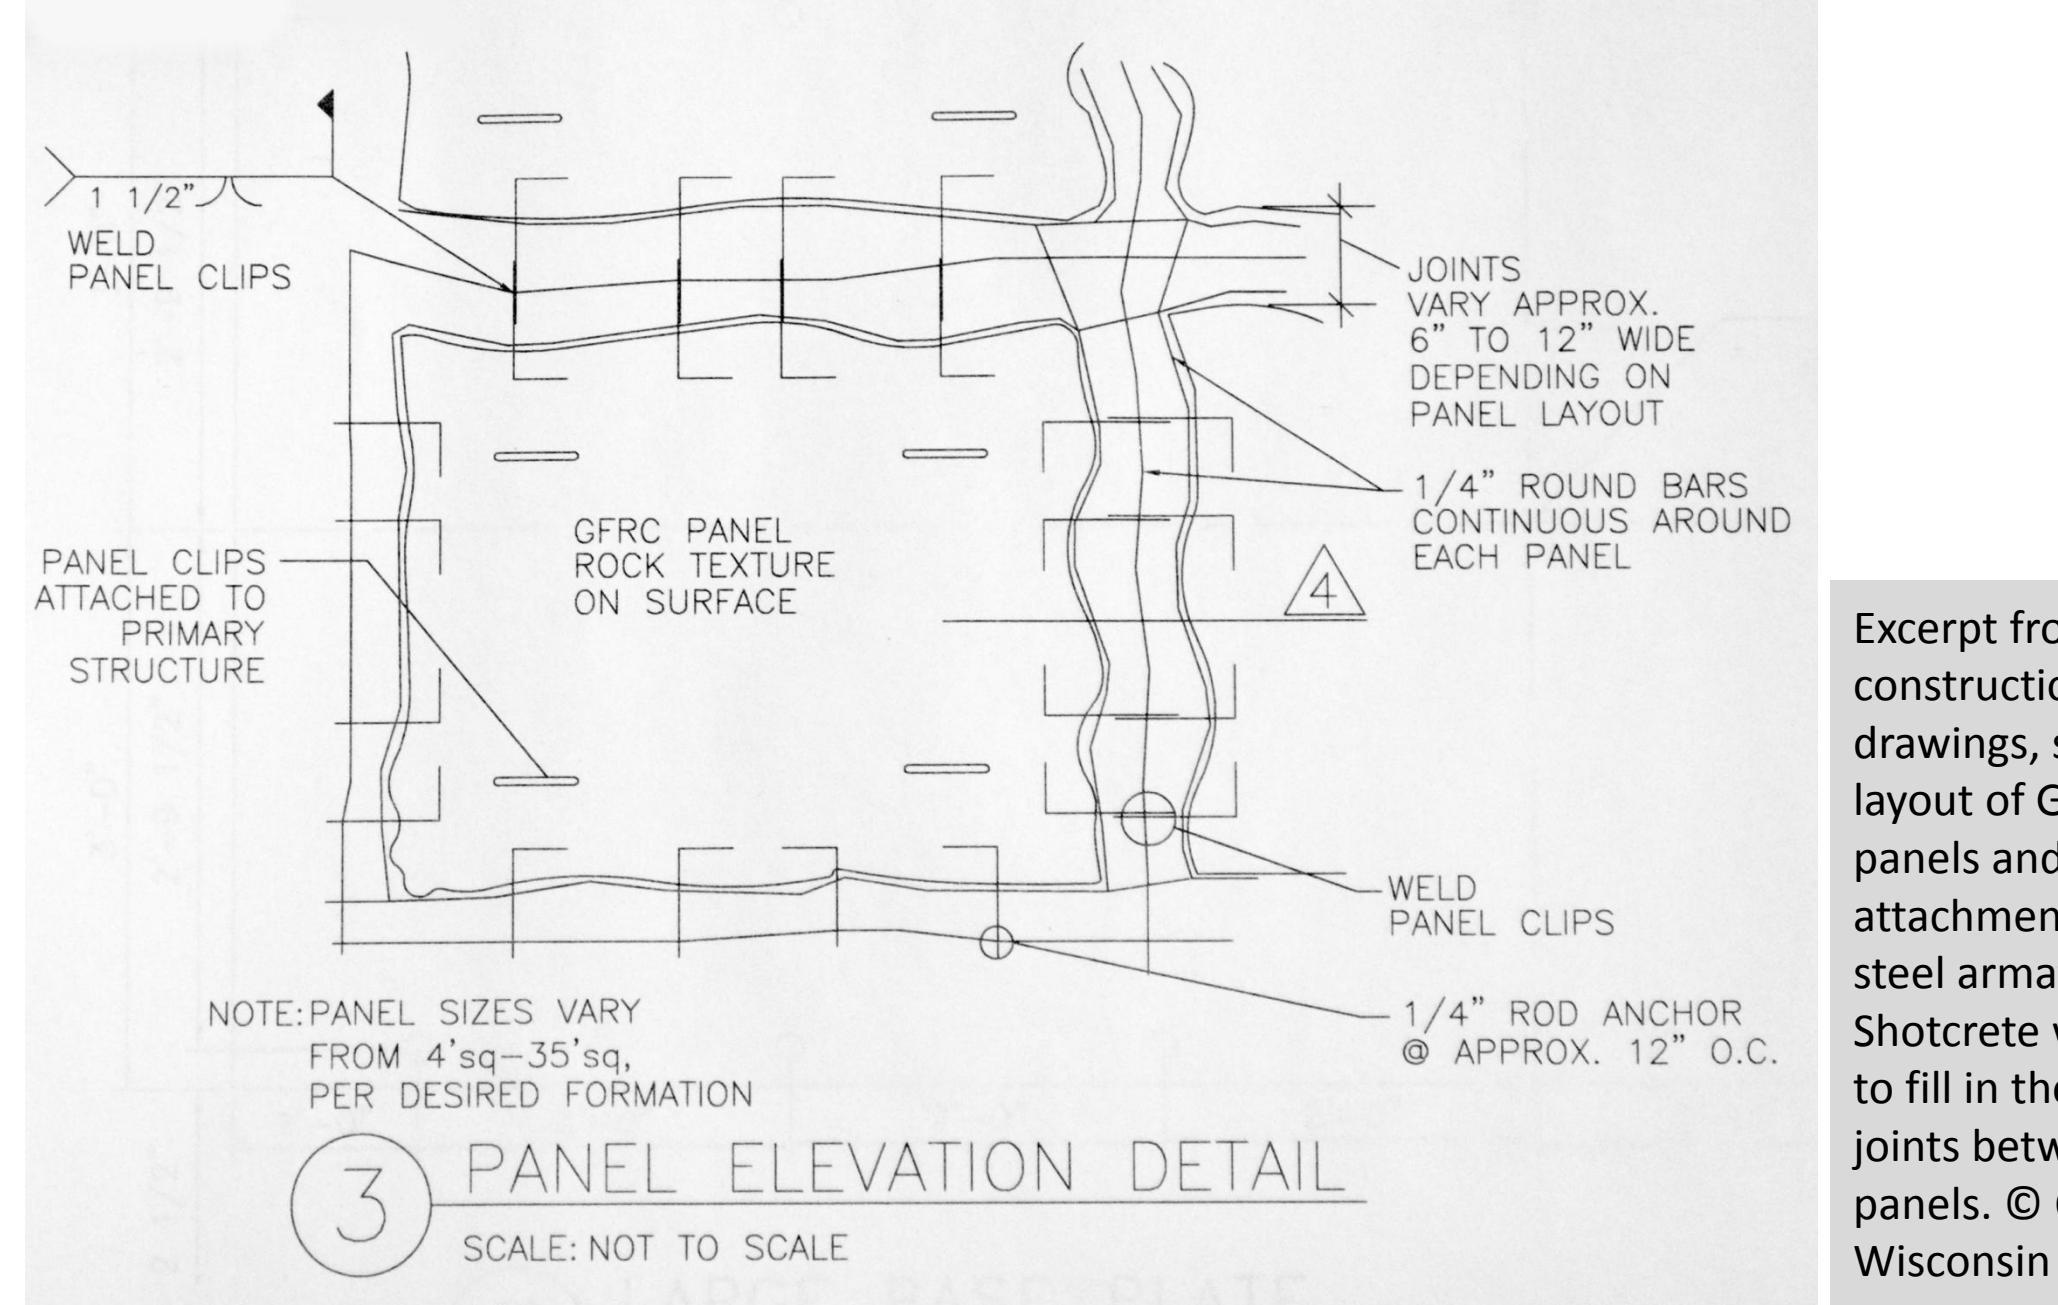
Excerpt from as-built construction drawings, showing layout of GFRC panels and attachment points to steel armature. Shotcrete was used to fill in the 6-12" joints between the panels. © Cost of

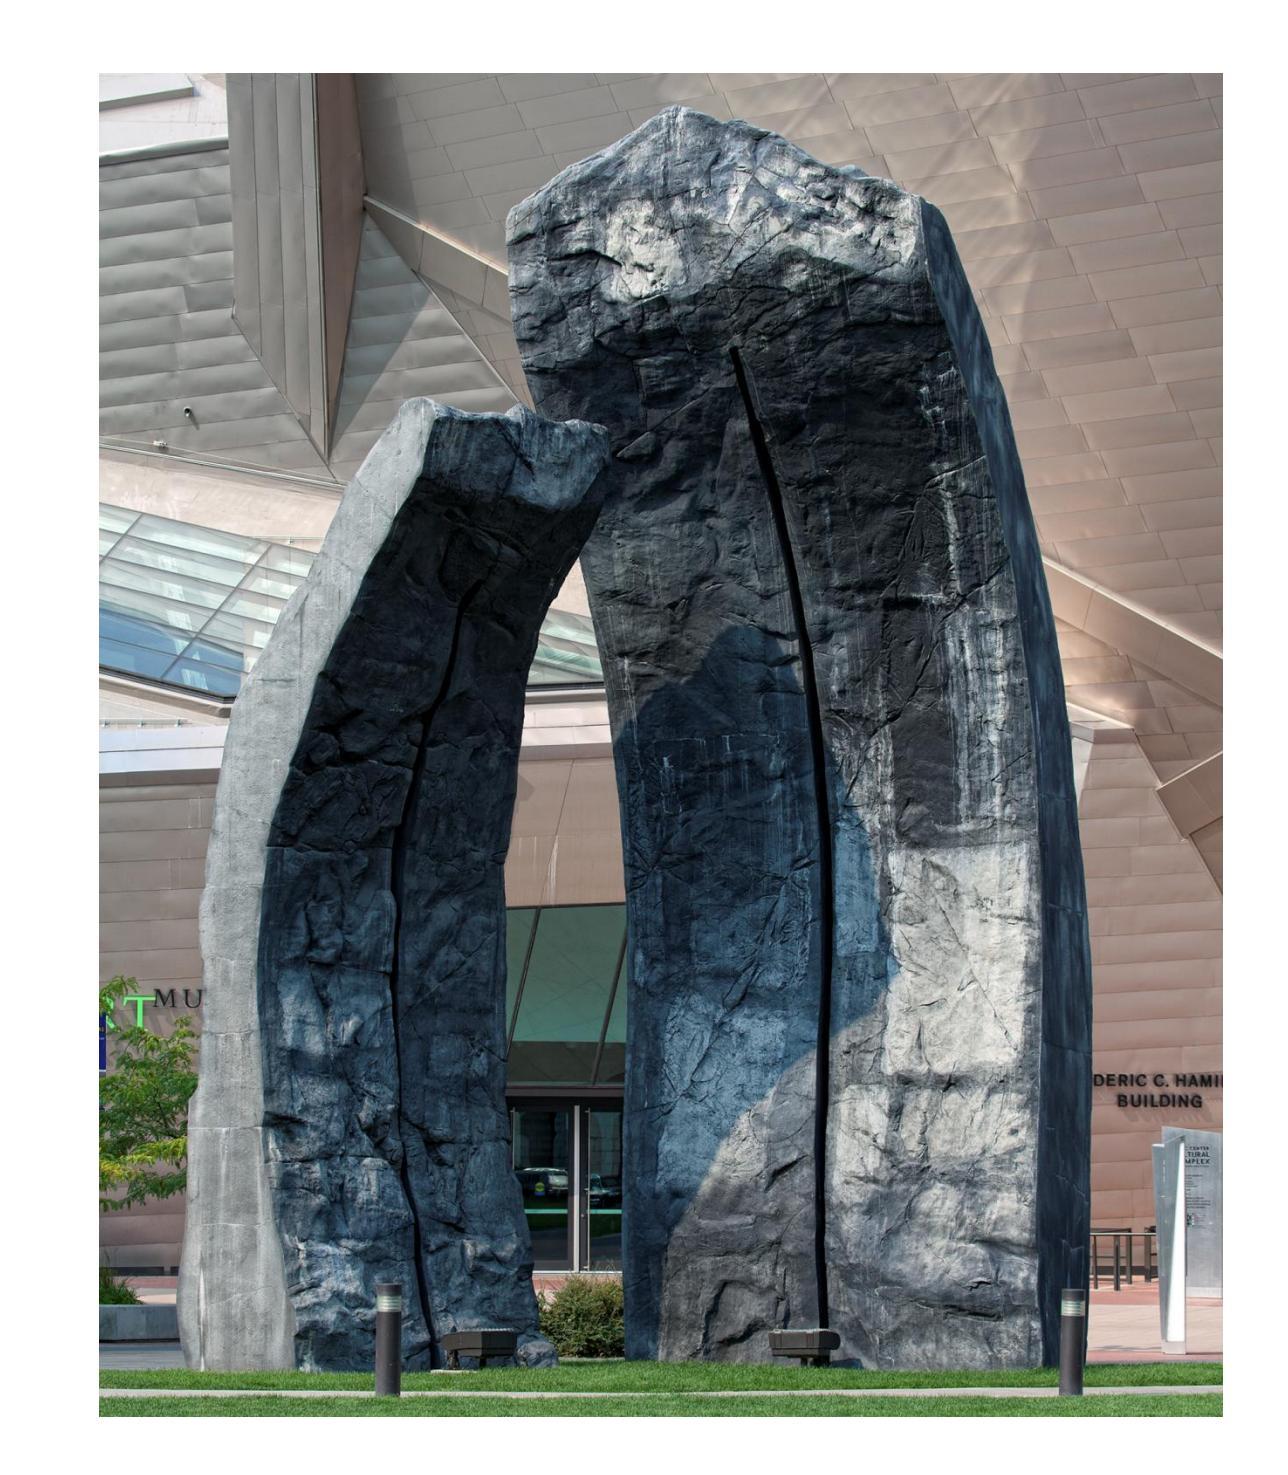
By about a year after installation, condition issues with the sculptures were appearing. Hairline cracks were noted, as well as efflorescence. (Some efflorescence-like streaks were noted at installation, though conversations with the sculpture's fabricator, Cost of Wisconsin, indicated that some streaking was intentional.)⁴ Overall lightening of the coloration and more extreme lightening of several of the GFRC panels is visible in photographs of the sculptures taken in 2007. In 2011-2012, a close assessment of the sculptures was undertaken. Cracks, hairline and wider, were present around each GFRC panel and some cracks crossed shotcrete seams. The entire surface appeared faded, and several panels stood out stark white. The illusion of a continuous rock face was completely disrupted.

Beverly Pepper, Denver Monoliths 2005-2006. Before treatment, 2012. Note uneven light discoloration and efflorescence. (Denver Art Museum Collection: Funds from Jana and Fred Bartlit, 2006.64, © Beverly Pepper)

Treatment of the sculptures was carried out by Cemrock in August 2012 and consisted of power washing, spray application of an exterior grade, flat finish acrylic paint matching the original coloration, and application of an alkoxysilane penetrating sealant. The intended purpose of the sealant was to repel water from the fine cracks and help to reduce efflorescence.

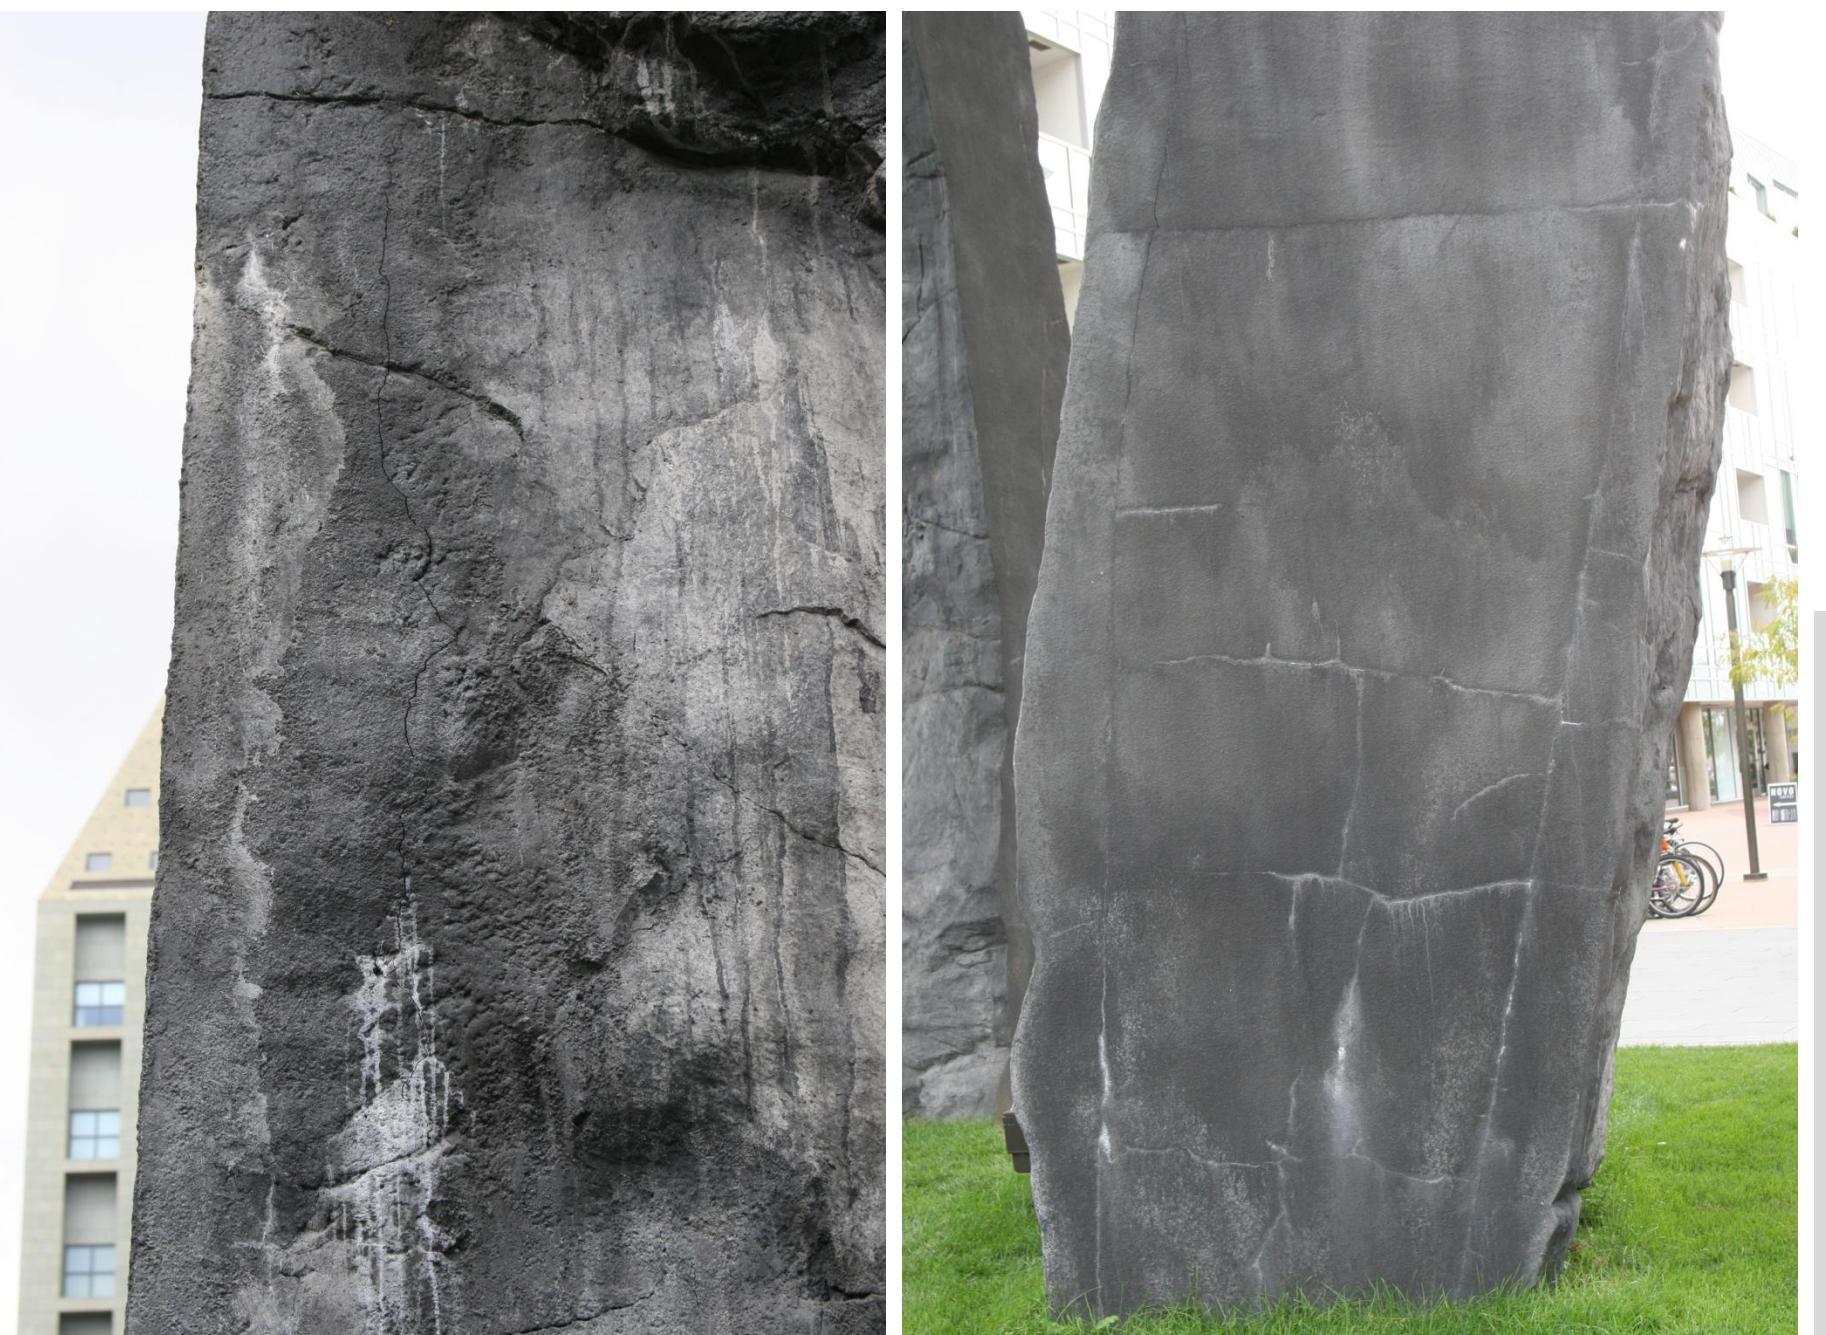
Details of the Denver Monoliths. Left: Example of vertical crack along left edge of GFRC panel, before treatment, 2012. Right: Cracks and efflorescence on side of larger sculpture, before treatment, 2012.

The engineers carried out a visual review of the sculptures, reviewed as-built construction drawings, and interviewed the fabricator of the sculptures. They found that the cracks were caused by one or a combination of three factors: differential shrinkage of the GFRC and shotcrete during curing, differential thermal expansion and contraction of the two materials, and/or wind pressure deflecting the sculptures. Wind movement at the top of the larger sculpture was calculated to be 1 ½". The cracks were not found to be undermining the structural integrity of the sculptures or posing a hazard to passersby, as the panels and shotcrete were securely tied into the steel

structure, and cracks were not affecting the panels. Although the cracks were admitting water, closed cell foam filling the interior voids of the sculptures and epoxy coating on the structural steel were protecting the integrity of the steel armature.

If treatment of the cracks were to be undertaken, the engineers recommended use of a flexible sealant that would move with the structure. Cracks would need to be widened to at least ¼" to accommodate the sealant. Repairs were likely to be or to become visible and would need periodic maintenance.⁶

Weighing of this information led to the decision to refrain from treatment of the cracks at that time and to limit treatment to cleaning, recoloring, and sealing of the surfaces.

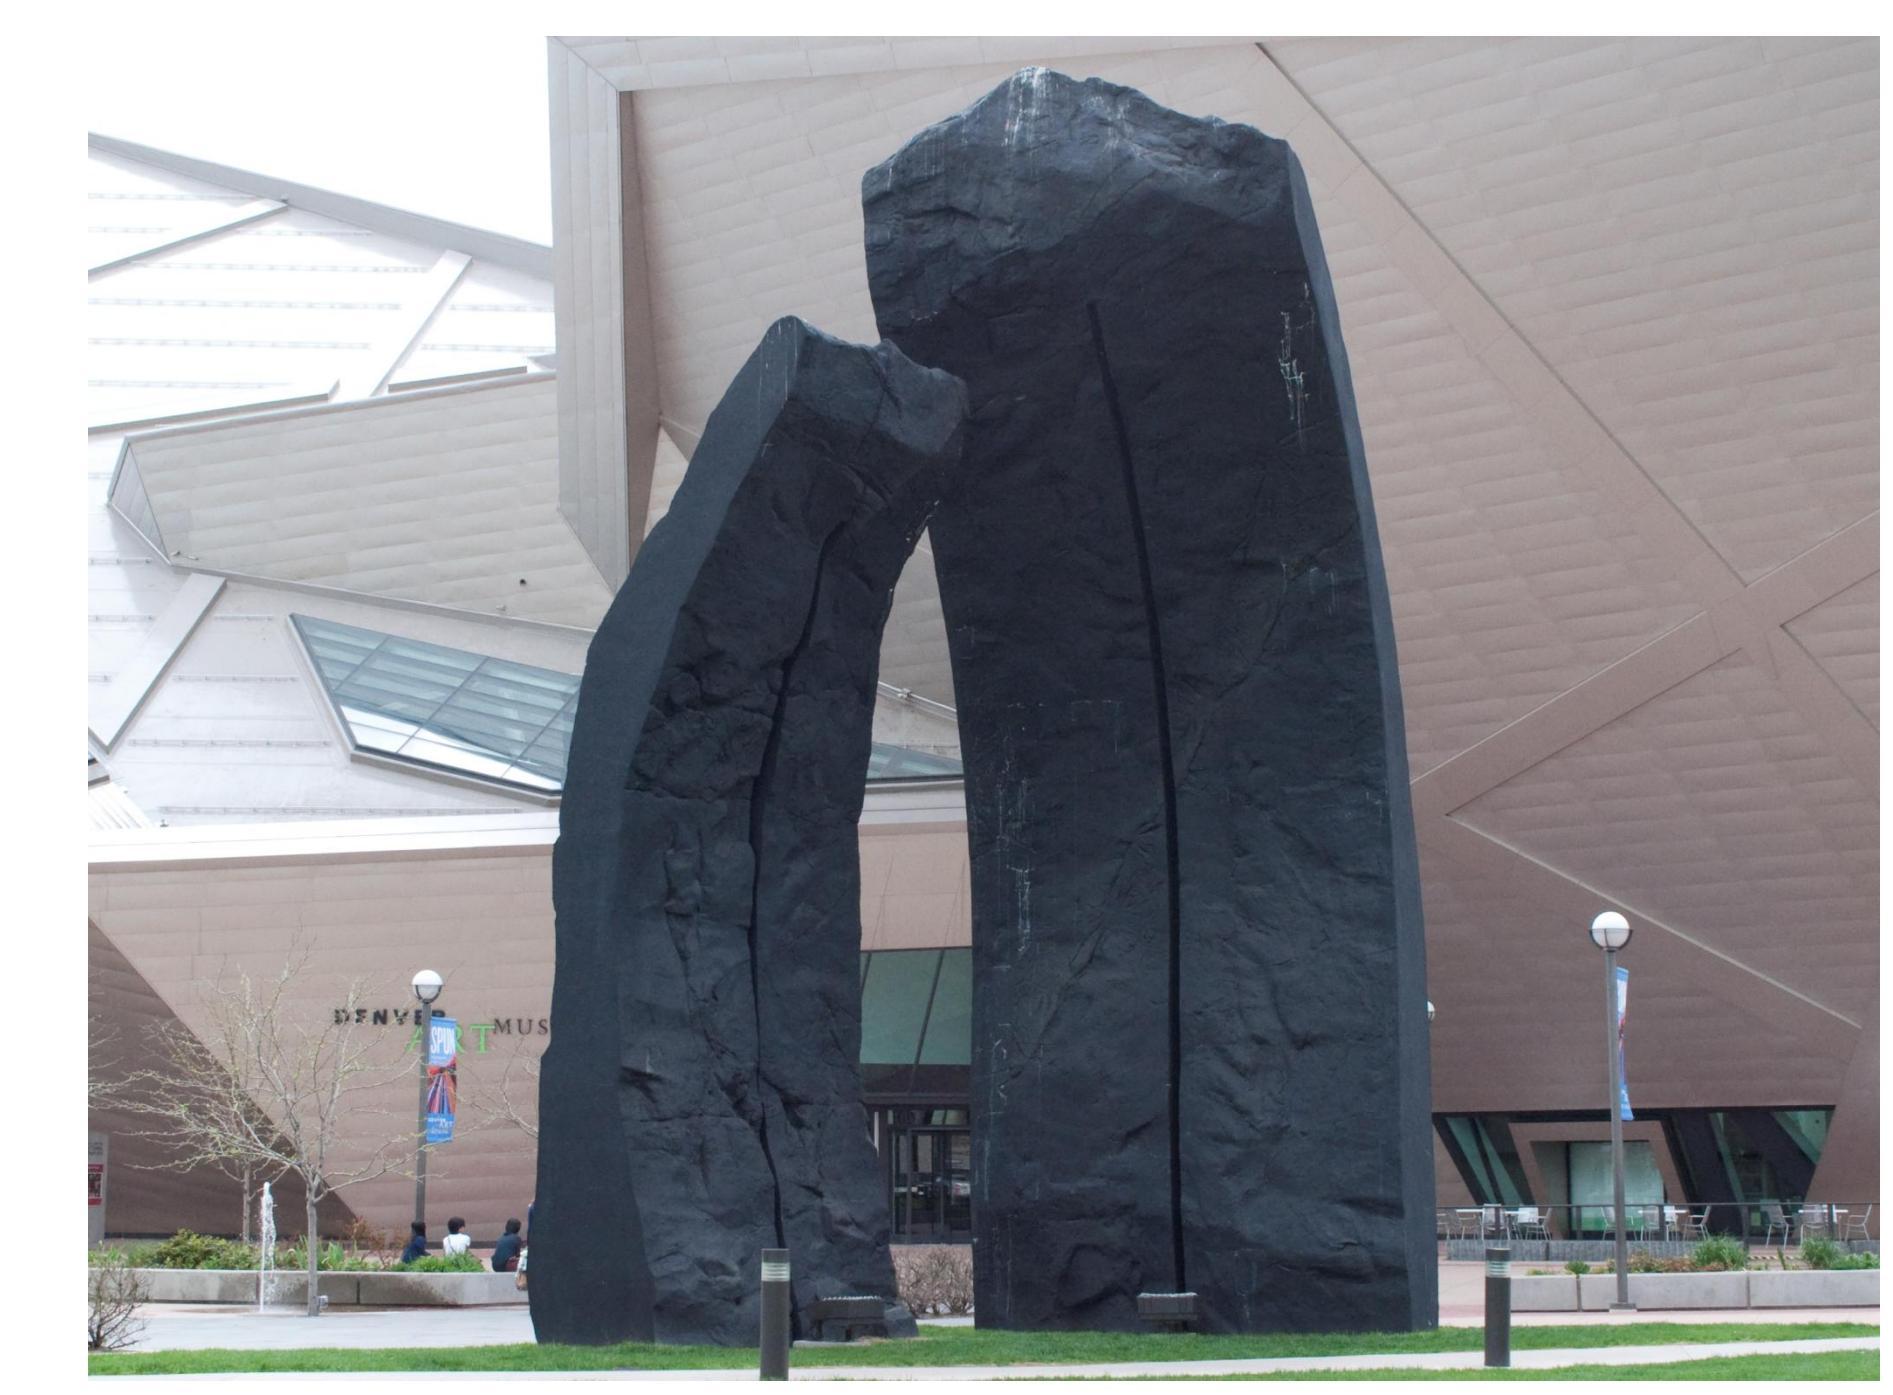
Beverly Pepper, Denver Monoliths, 2005-2006. After treatment, May 2013. Note streaks of white efflorescence. (Denver Art Museum Collection: Funds from Jana and Fred Bartlit, 2006.64, © Beverly Pepper)

Eight months later, precipitation has led to water entering and exiting the cracks and depositing streaks of efflorescence in various locations. The efflorescence is not totally inconsistent with the appearance of natural rock faces and some efflorescence-like streaking was visible at the time of installation. However, the current streaks stand out against the recolored surface. Further exploration with the artist on this issue is under consideration. Moving forward, the impact of the efflorescence versus the limitations of treating the cracks will need to be weighed.

Even setting aside treatment of the cracks, the *Denver Monoliths* require ongoing and intensive maintenance. In all likelihood, the recoloring and sealing process will need to be repeated every 5 years. An annual wash and inspection with a boom lift is also recommended. Work plans will need to include rental of a boom lift and site preparation. In addition to the discussion above, ongoing maintenance requirements are factors to consider for those planning for care of existing large-scale sculptures and artificial rock structures as well as for those considering acquiring works of similar size or features.

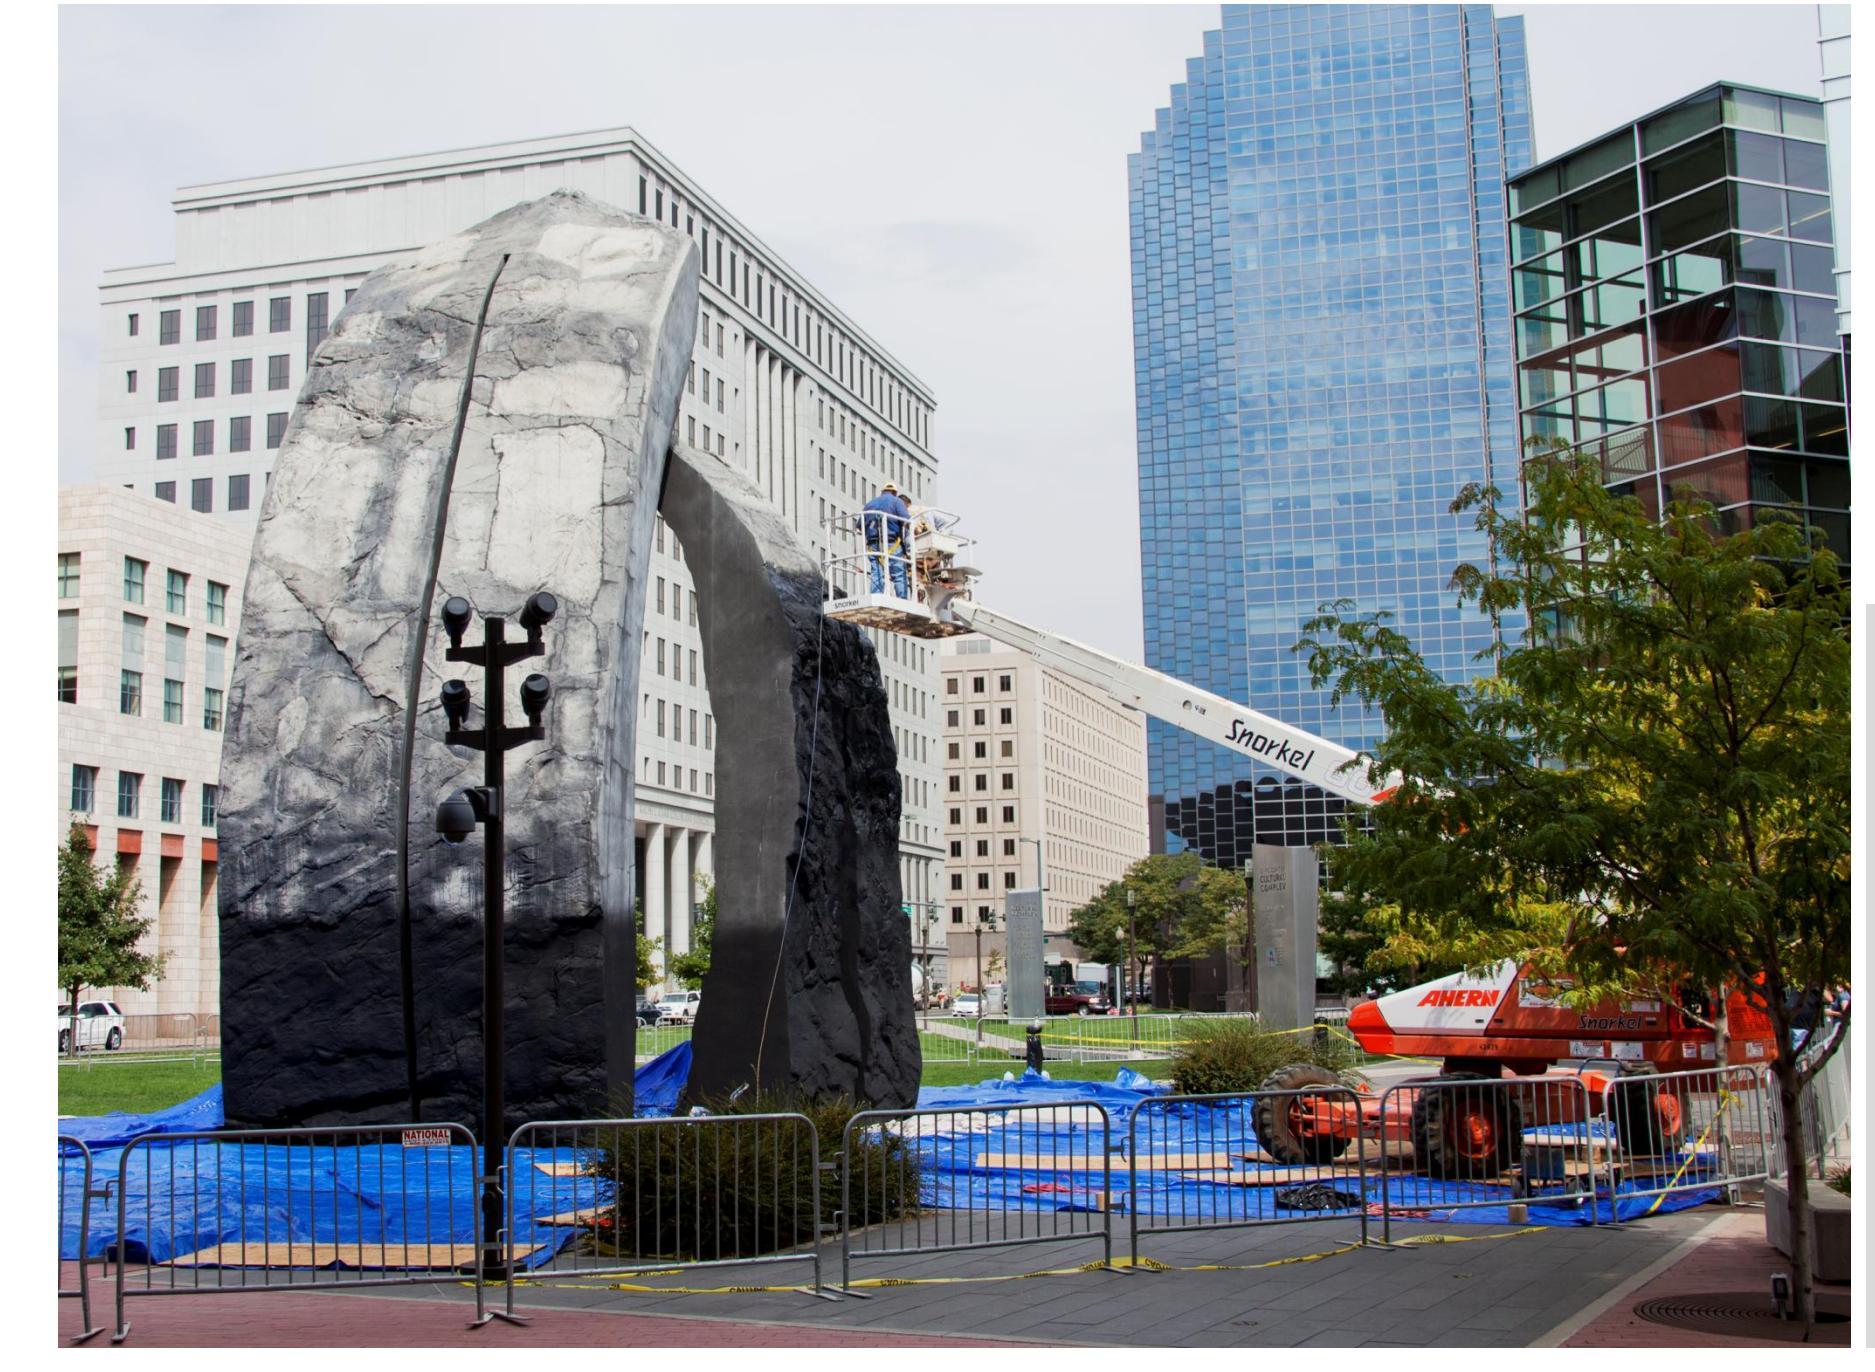
Beverly Pepper, Denver Monoliths, 2005-2006. During treatment, August 2012. Note use of boom lift, fencing, tarps and plywood. (Denver Art Museum Collection: Funds from Jana and Fred Bartlit, 2006.64, © Beverly Pepper)
