Sustainable Strategies for Mechanical System Operation in Collection Environments — Christopher Cameron, Image Permanence Institute

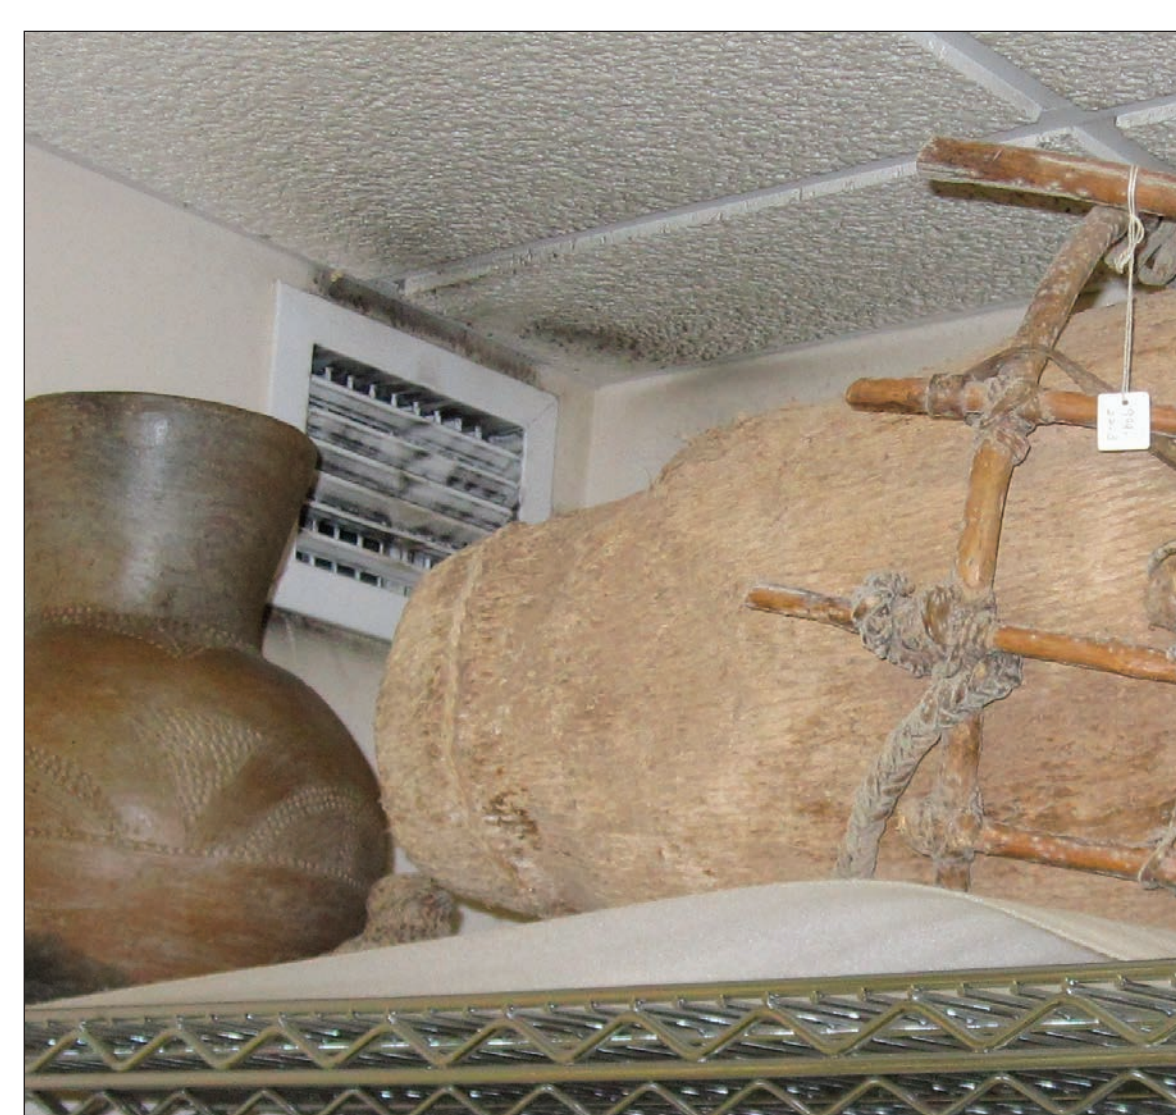
Identify Heat or Moisture Issues

Dampness and dryness are primary collection preservation concerns, leading to accelerated chemical decay, mechanical damage, corrosion, and the risk of mold growth. Analysis of mechanical system data can identify periods of humidification and dehumidification and expose inappropriate moisture conditions in a space that have an effect on collection preservation.

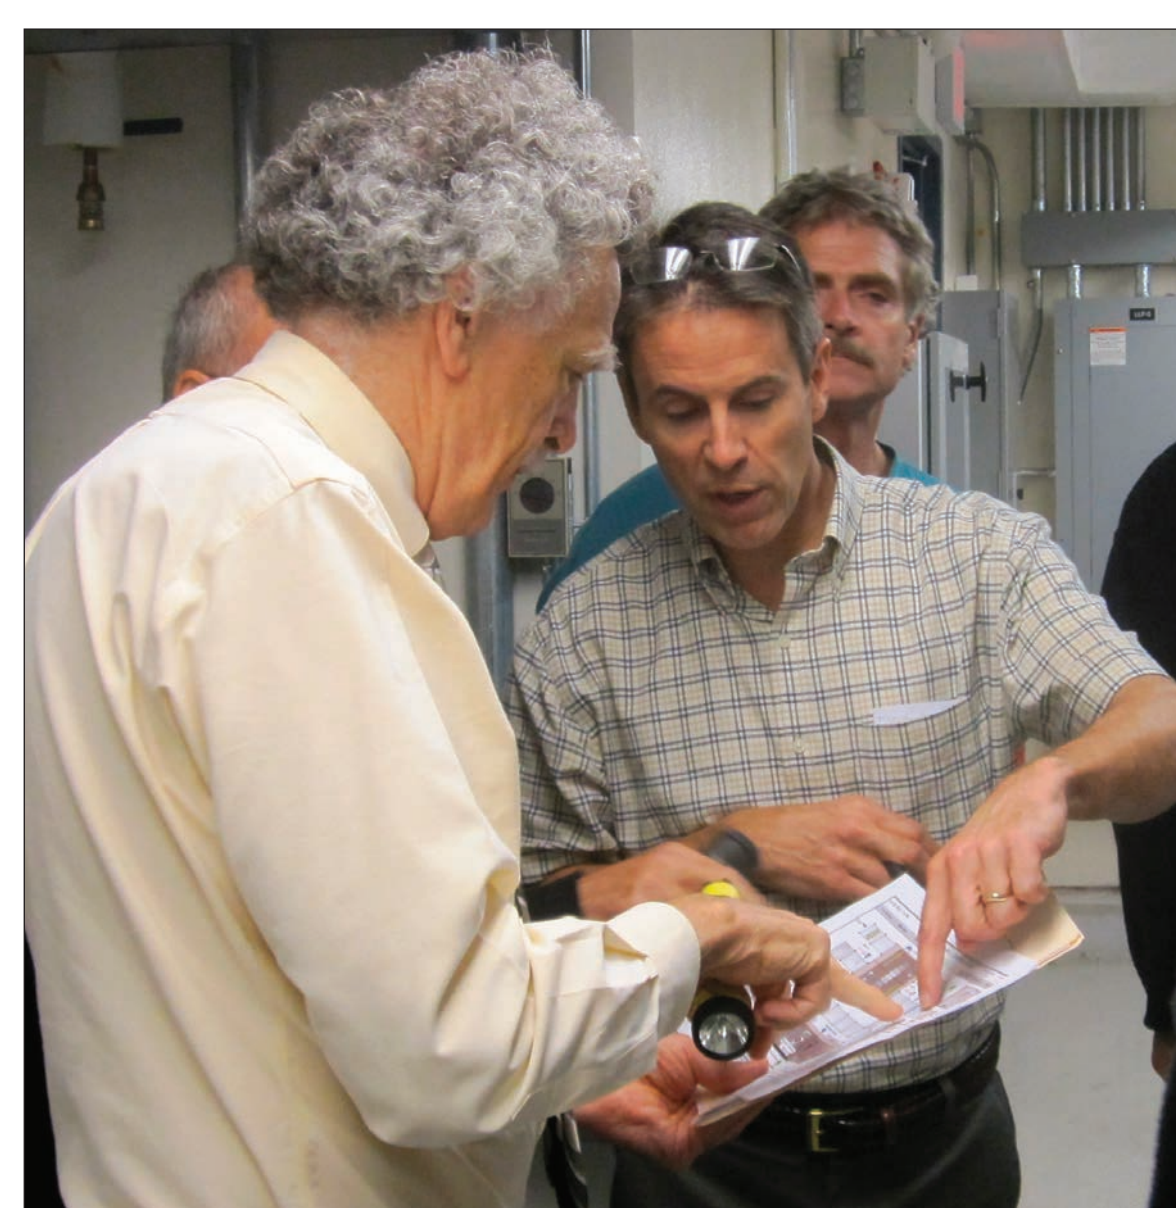
Review System Response to Extreme Weather Conditions

Extreme weather conditions are occurring more frequently. Understanding how your mechanical system responds to these events will help you evaluate disaster recovery, identify potential dangers to collections, and develop effective risk management plans. You may also find that the facility was safe and the environment stable during the event.

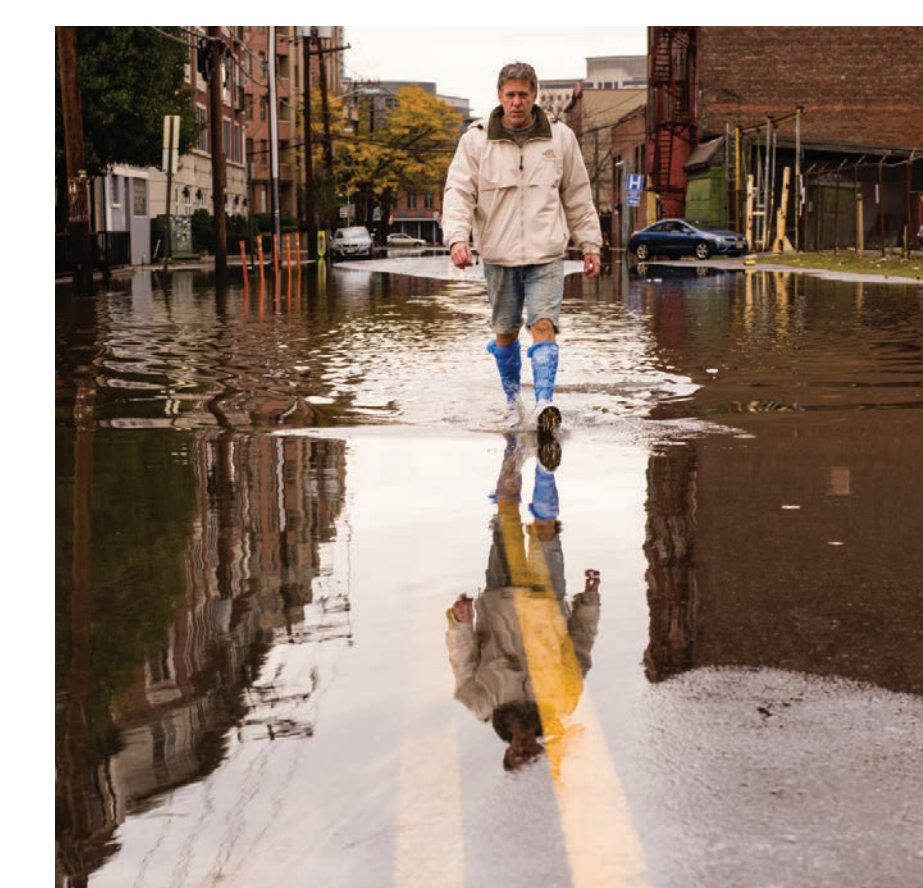
Data showed a noticeable upward swing in temperature and RH for many locations. Often these swings lasted only a day or two before dropping back to normal or, due to the loss of HVAC function, below normal. RH levels as low as 30% lasted for only a few days before returning to pre-storm conditions. At worst, temperatures rose 5-6°F for a week after the storm in facilities without power. When power was restored spaces quickly returned to normal temperature. Overall the impact on collections due to high temperature or RH conditions was small. Often collection items stored in boxes or cabinets were buffered from T and RH swings.
