FIRST PHASE: 2009-2010

SECOND PHASE: 2014-2015

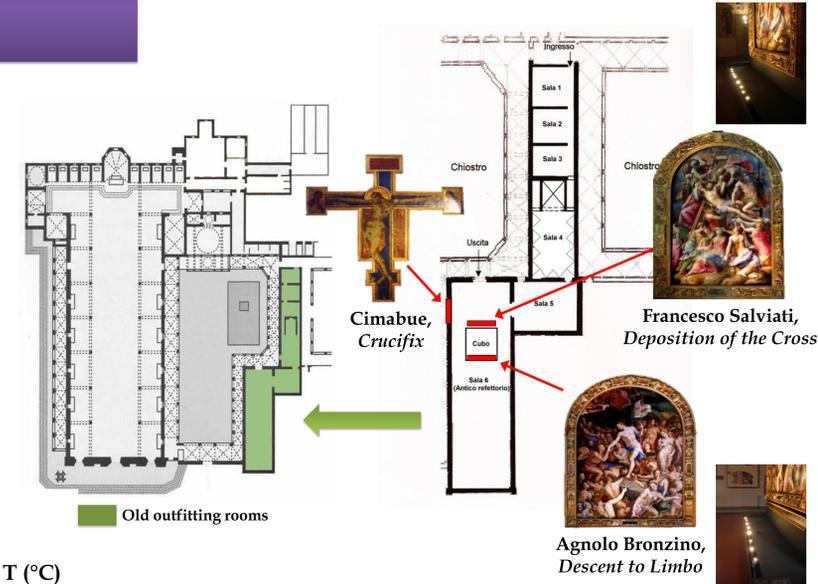
- Continuous measurements with wired sensors:
- air temperature
 - relative humidity
 - surface temperature of wooden paintings
- Seasonal manual campaigns:
- psychrometric measurements before, during and after the opening to the public
 - radiometric measurements on wooden paintings

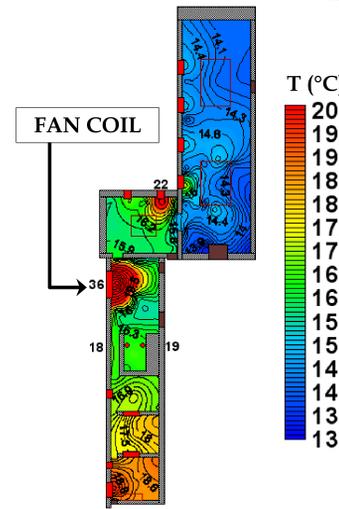
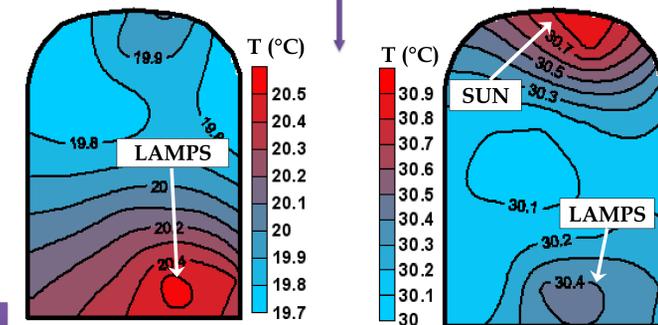
ANTHROPIC FACTORS	INFLUENCE ON MICROCLIMATIC CONDITIONS	POSSIBLE RISKS FOR THE CONSERVATION OF WORKS OF ART
Heating system with fan coils	Variations of T (up to 20°C) and RH (up to 40%), formation of convective cells, increase of particles deposition risk	T-RH values out of the ranges recommended for conservation, variation of equilibrium moisture content (EMC), physical-mechanical stresses
Opening of external doors	Entrance of air at different thermo-hygrometric levels	
Cleaning system with use of water	Increase of specific humidity	
Artificial (direct spotlight) and natural (solar radiation from the windows) lighting on painted wood	Surface heating	Physical stresses (top/bottom and surface/internal layers), EMC variations, degradation of the paint layer (e.g. discoloration due to UV rays)

Influence of the management:
increase of T near the heating source
increase of surface T due to artificial and natural lighting

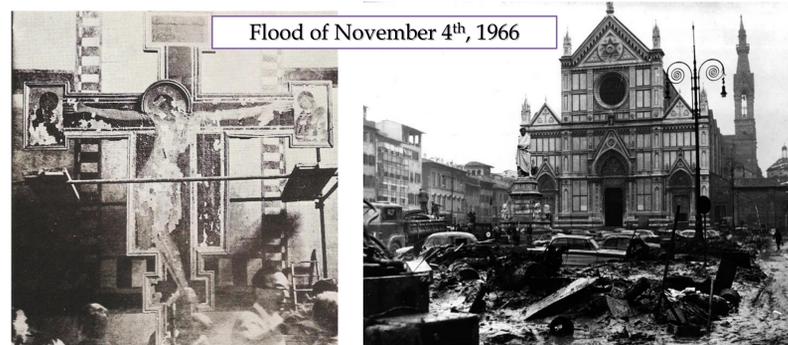
- Preventive actions and mitigation risk strategy against floods:
- Emergency management plan
 - Moving of threatened works of art in safer locations.
-
- ✓ Microclimatic monitoring of the new outfitting

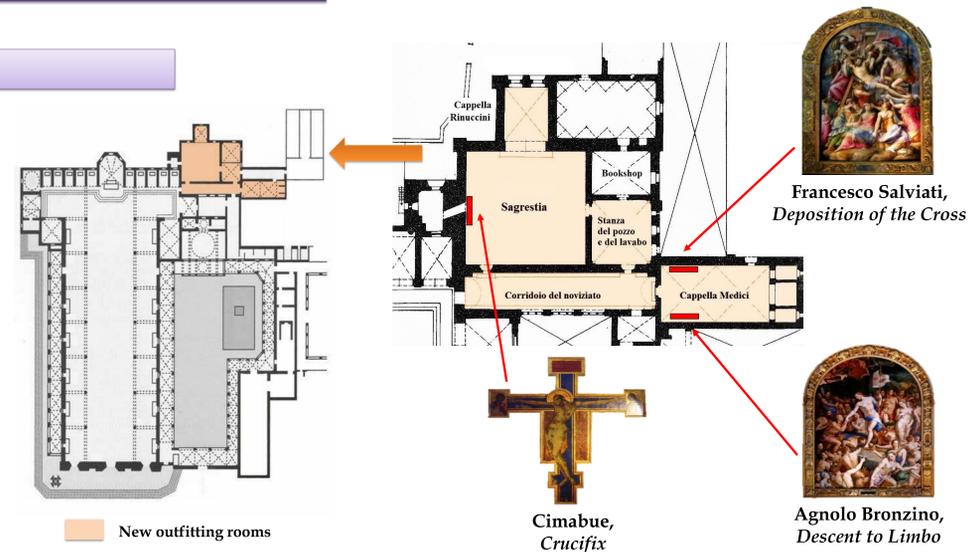
- Continuous measurements with wireless sensors:
- air temperature
 - relative humidity
- Evaluation of results:
- compliance with the T-RH ranges recommended for wood by UNI 10829 & Ministerial Decree n. 112/98 of 5th May 2001
 - daily thermo-hygrometric variations
 - respect of "historic climate" established by EN 15757-2010: comparison with previous environmental conditions

Wooden paintings	Year	T=19±24°C	ΔT daily_max ≤1,5°C	RH=45±65% (M.D. 112/98)	RH=50±60% (UNI10829)	ΔRH daily_max ≤2% (M.D. 112/98)	ΔRH daily_max ≤4% (UNI10829)
Crucifix	2010	40%	9%	94%	77%	0%	12%
	2014	30%	97%	98%	78%	20%	66%
Deposition of the Cross	2010	40%	8%	94%	77%	0%	12%
	2014	27%	97%	90%	57%	9%	62%

Percentage of time with respect to the total time of monitoring when the measured T-RH values and daily variations were included within the recommended ranges
