The Recovery of St. Trinity Episcopal Cathedral Wall Paintings, Port-au-Prince, Haiti: An Assistant's Perspective

By Junior Norelus, Artist
Graduate of the Ecole Nationale des Artes

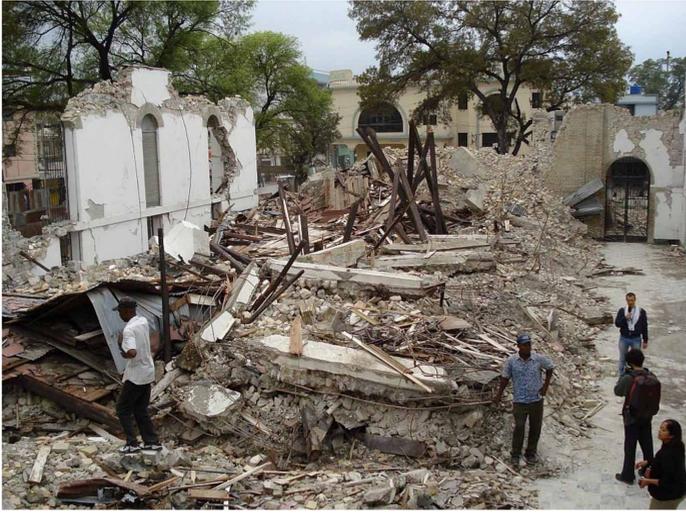
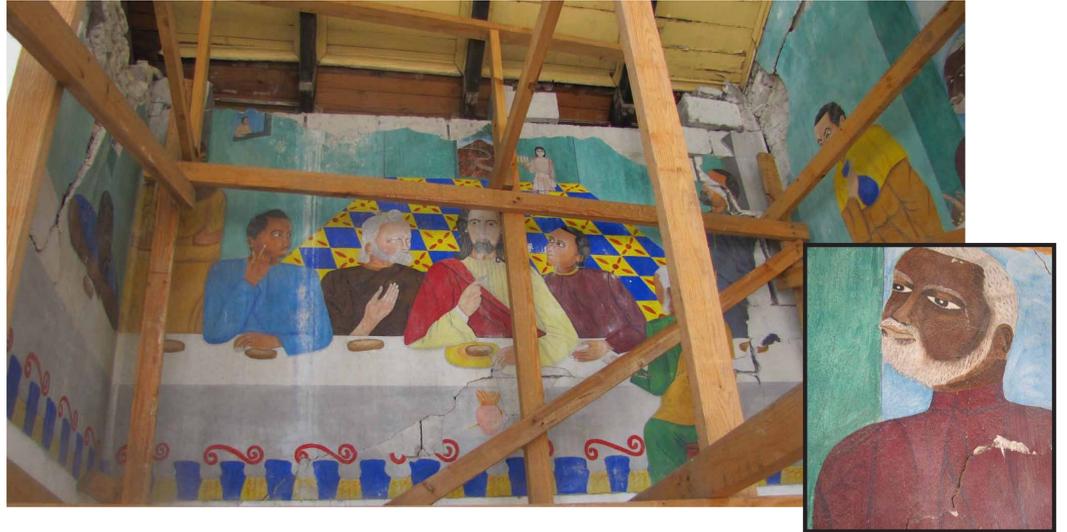
Most of the 14 wall paintings at the St Trinity Episcopal Cathedral were destroyed during the terrible earthquake of January 12, 2010. A year later among broken walls and piles of rubble, there were only three standing murals, "The Last Supper" by Philomène Obin, "Native Procession" by Préfète Duffaut and "Baptism of Christ" by Castera Bazile. The murals, painted on mortar, were severely cracked in many pieces and some fragments were lost. It was almost impossible for me to imagine that anything could be rescued from the devastated site, but our goal was to remove and salvage the remaining fragmented murals under the direction of mural paintings conservator Viviana Dominguez and architectural conservator Rosa Lowinger.

1. We cleaned and consolidated the painted surfaces, which were powdery to the touch.
2. We selected and subdivided areas of the murals to remove, using the deep cracks in the mortar (produced by the earthquake) and the design of the works as guides. Each section was then dimensioned and documented.
3. We photographed each piece before removing it, tagging each fragment with a number that identified its location within the mural on the wall.
4. We protected the surfaces of the painted walls with cotton gauze (tarlatan) which was adhered with acrylic resin, Paraloid B-72, dissolved in acetone.

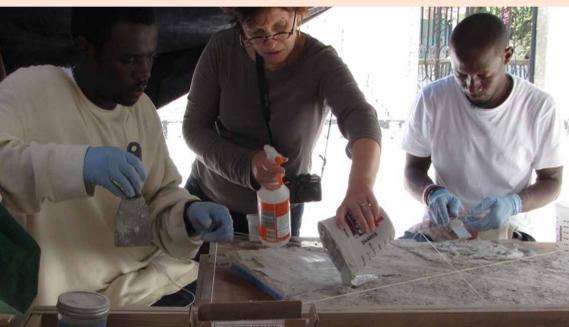
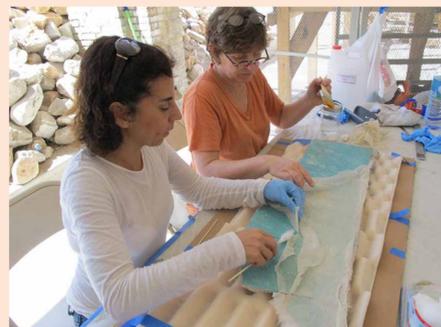
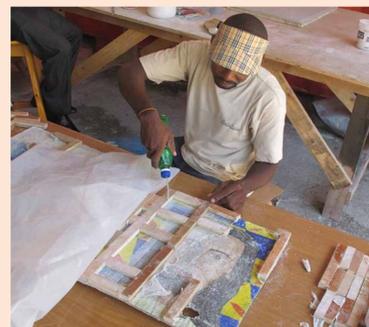
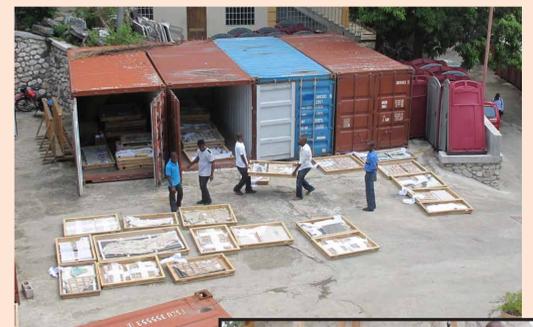
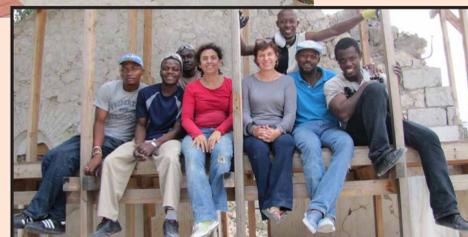
5. Fragments were separated from each other either by chiseling around the cracks or by cutting using a grinder with a diamond blade.

6. Each piece was secured with wood slats that formed a grid over the surface, conforming to the size and shape of each fragment.

7. In order to separate the fragments from the walls, work began by chiseling the sides to get behind the piece, working with thin and flexible spatulas as well as chisels.

8. The fragments were removed, placed upside down on reinforced cardboard trays and stored on tables to remove the mortar or the stones from the reverse sides, as well as to reinforce the extremely fine fragments by adding mortar.

9. Finally the fragments were transported on wooden trays protected with foam to the Haitian Cultural Rescue Center where they were stored in containers.
