Article: Two conservators, a whole lot of wallpaper and a room with a view – scenic respite or recipe for disaster?

Author(s): Michaela Z. Neiro

Source: *Objects Specialty Group Postprints, Volume Fifteen, 2008*

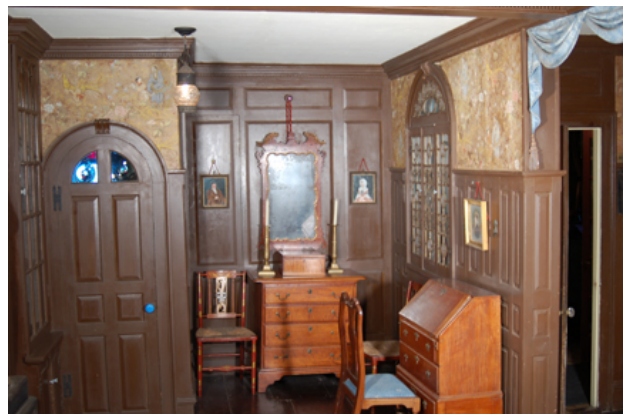
Fig. 2. The Central Hall before treatment
(Photograph by Michaela Neiro)

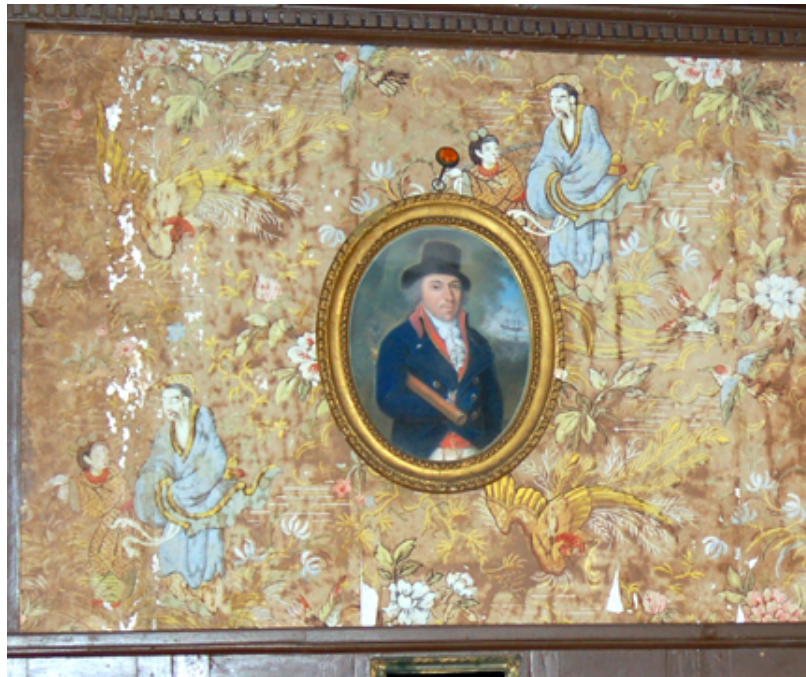
There are several factors that contributed to the poor condition and, therefore, appearance of the paper. The paper was darkened and embrittled over time, caused by the oxidation of the acidic wood pulp paper. As the paste dried and shrank over the years, delamination from the walls became widespread, as did tears and losses. The losses were especially unsightly since the paper was applied without a lining, and the rough, white plaster wall showed through. Additional losses were created by silverfish living in the dark, damp hall (fig. 3).

Fig. 3. The Chinoiserie wallpaper showing losses and dark stains (Photograph by Michaela Neiro)

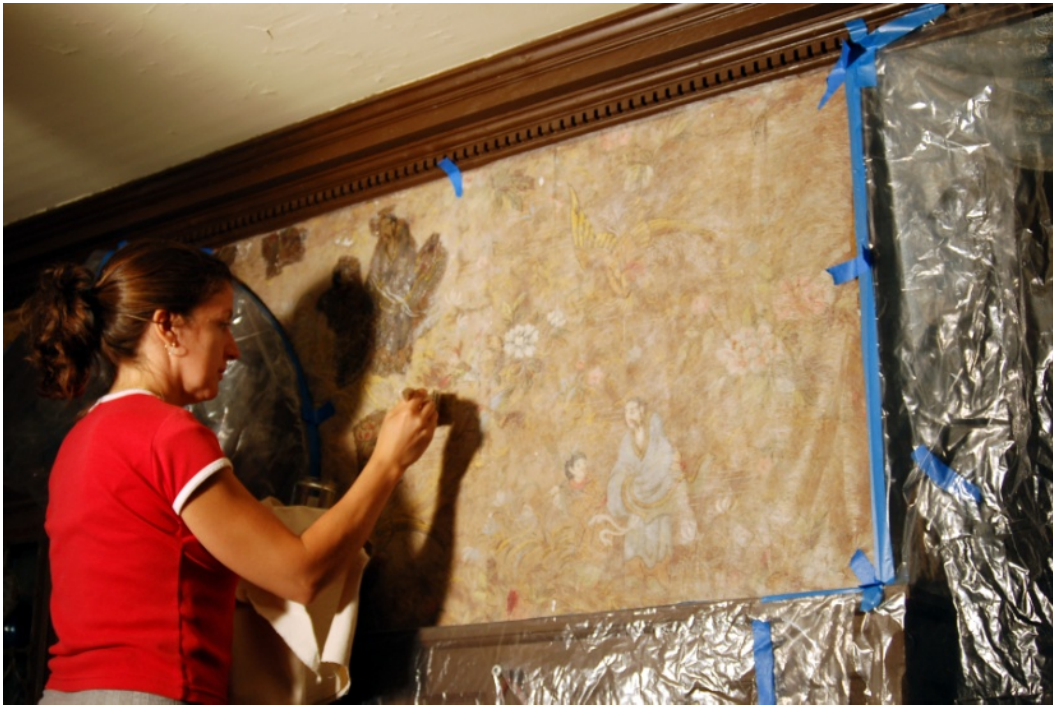
Fig. 4. Applying melted cyclododecane by brush (Photograph by Judith Bohan)

Japanese paper, rayon paper, Hollytex and Mylar. Cyclododecane and Hollytex proved to be the best combination of workability, reversibility, and functionality. The material cyclododecane is a cyclic alkane, and looks like a waxy crystal (Brückle et al. 1999). It melts clear and can be brushed on through the Hollytex. The most useful feature of this material is that it sublimates after a few days, so no solvents would have to be used in the historic house to remove it.

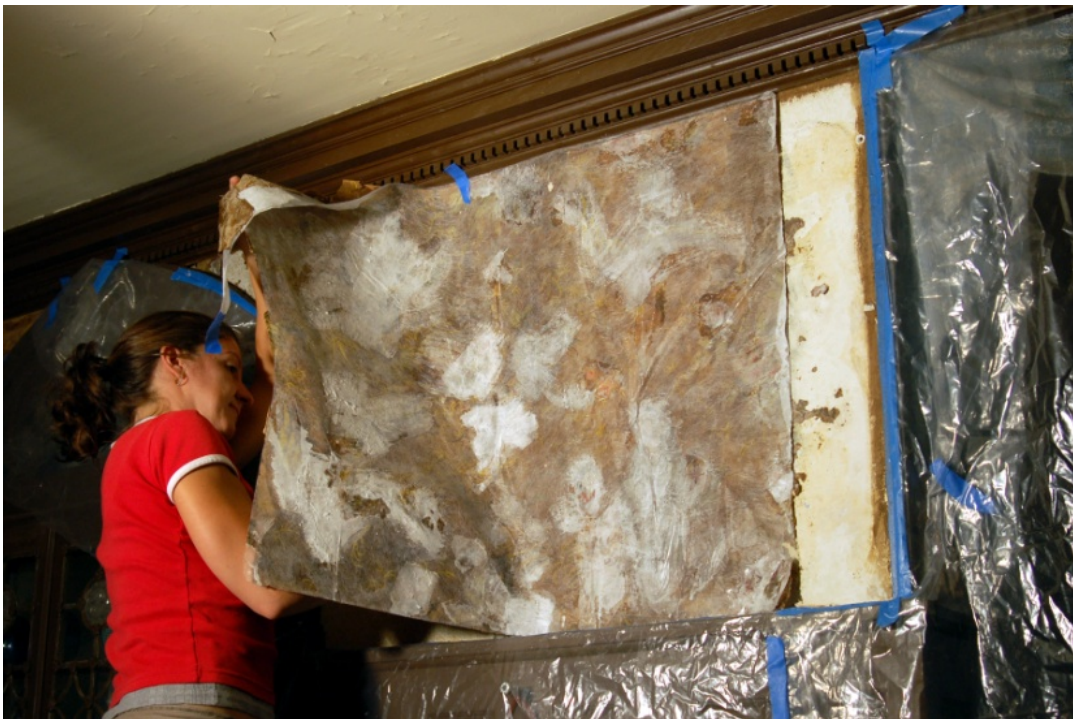
Fig. 5. Removal of the wallpaper with facing using a Teflon spatula (Photograph by Judith Bohan)

Starting work on Monday when the house was closed for tours, the goal for the day was to remove the wallpaper, repair cracks in the wall with lightweight spackle, and apply a pre-cut piece of cotton canvas on the wall. The purpose of the canvas was to provide a buffer between the plaster wall and the cleaned wallpaper, create a flat smooth surface for reapplication, and provide a substrate to enable the removal of the conserved wallpaper if needed. Removing the wallpaper was by far the most difficult, stressful part of the treatment. The first step in preparing to remove the wallpaper was to make a tracing on Mylar of the panel, indicating major shapes, tears, and edges of the wallpaper. This was essential for accurately repairing and reattaching the wallpaper. Hollytex was taped to the painted molding directly above the panel using low-tack blue painter's tape. The cyclododecane was applied over large areas using two-inch chip brushes. Using a heat gun, the crystals were melted in glass jars and quickly brushed through the Hollytex, allowing it to penetrate the wallpaper (fig. 4). The cyclododecane solidified quickly, therefore it had to be frequently re-melted. Heating the cyclododecane in this manner did create potent fumes but they were very localized and dissipated quickly. Information on the health risks of cyclododecane is not available, but the room was well ventilated and exposure was limited. After the facing was applied on an entire section, the wallpaper was removed by sliding 16-inch-long Teflon spatulas specially made for this treatment between the wall and the faced wallpaper (fig. 5). Where PVAC was encountered, the wallpaper easily tore into small bits (0.5 x 0.5 inch to 6.0 x 6.0 inch sections), so in these areas, smaller, finer metal palette knives were used to remove the wallpaper. In many areas it was necessary to remove a thin portion of the plaster wall along with the PVAC and the wallpaper in order to remove the wallpaper section as intact as possible. Unfortunately the facing did not always hold these small pieces together, the result being a puzzle of small pieces.

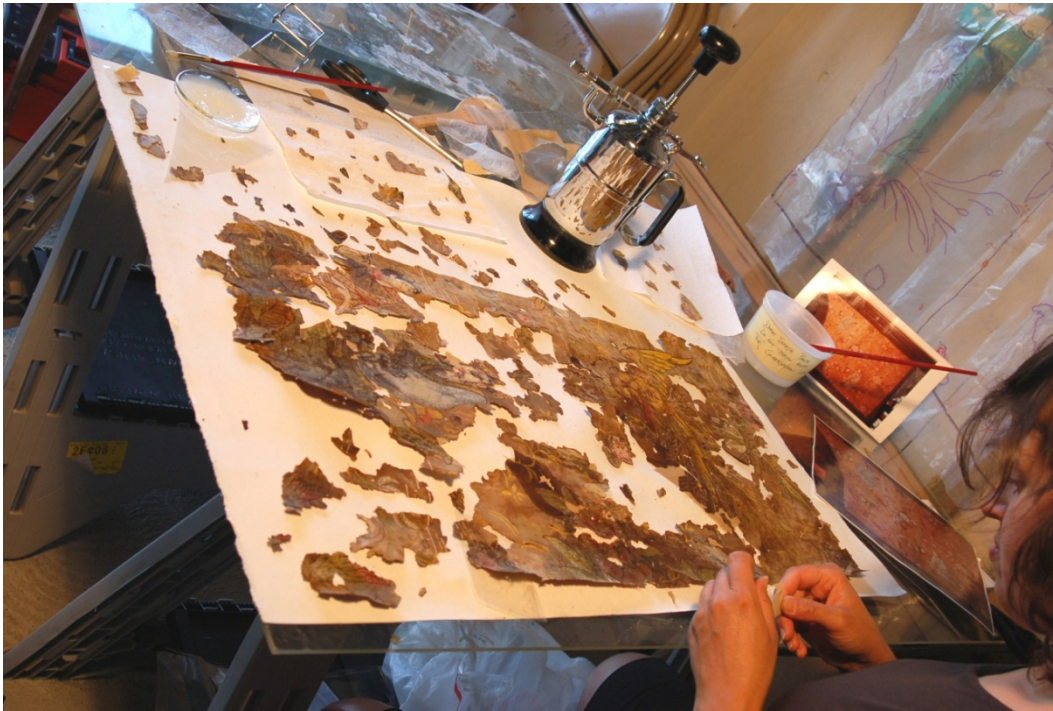
Fig. 6. Assembling small sections of wallpaper using wheat starch paste and Japanese tissue strips
(Photograph by Michaela Neiro)

After cleaning the back, the wallpaper was flipped over to begin the tear repair portion of the treatment. Before-treatment photos were crucial at this stage to guide the correct placement of the small pieces. Using Zen Shofu wheat starch paste and thin strips of Japanese tissue on the verso, pieces were pasted together. A tacking iron and blotter paper were used to speed the drying of the wheat starch paste and inhibit tide lines (figs. 6-7). Due to the quantity of wheat starch paste used in this treatment, tests were conducted to determine the feasibility of using the significantly less expensive paste, Aytex-P. These were quite successful, but it was felt that the more refined Zen Shofu paste performed slightly better during the tear repair portion of the treatment. It was decided to only use the Zen Shofu paste exclusively during tear repairs.

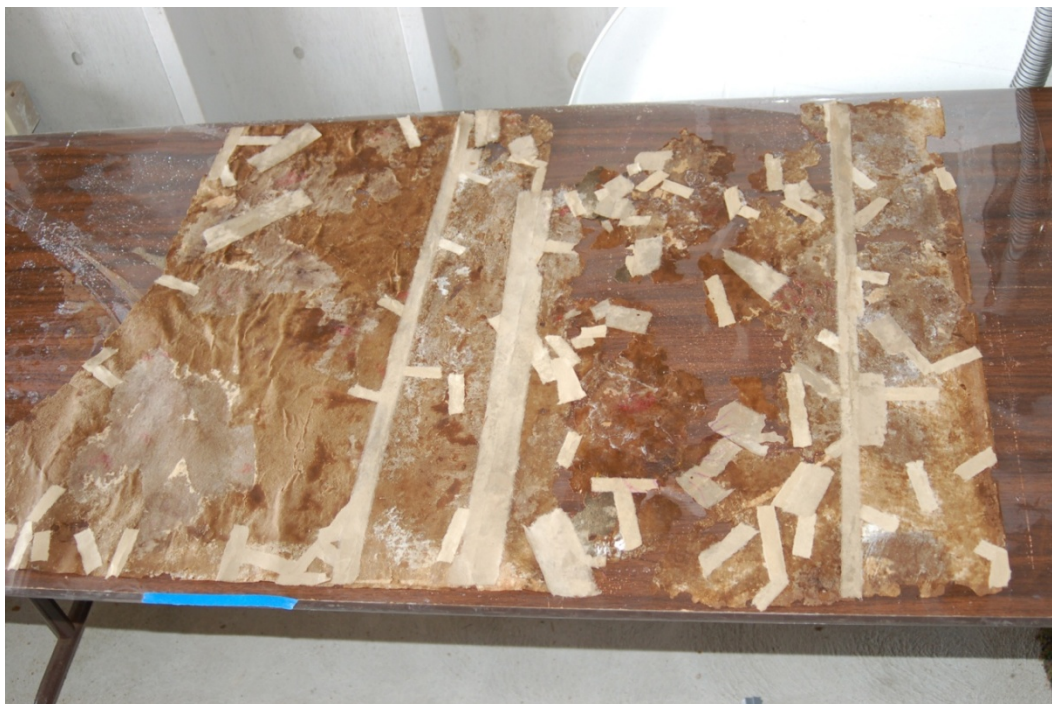
Fig. 7. Japanese tissue “band-aids” on the verso (Photograph by Michaela Neiro)

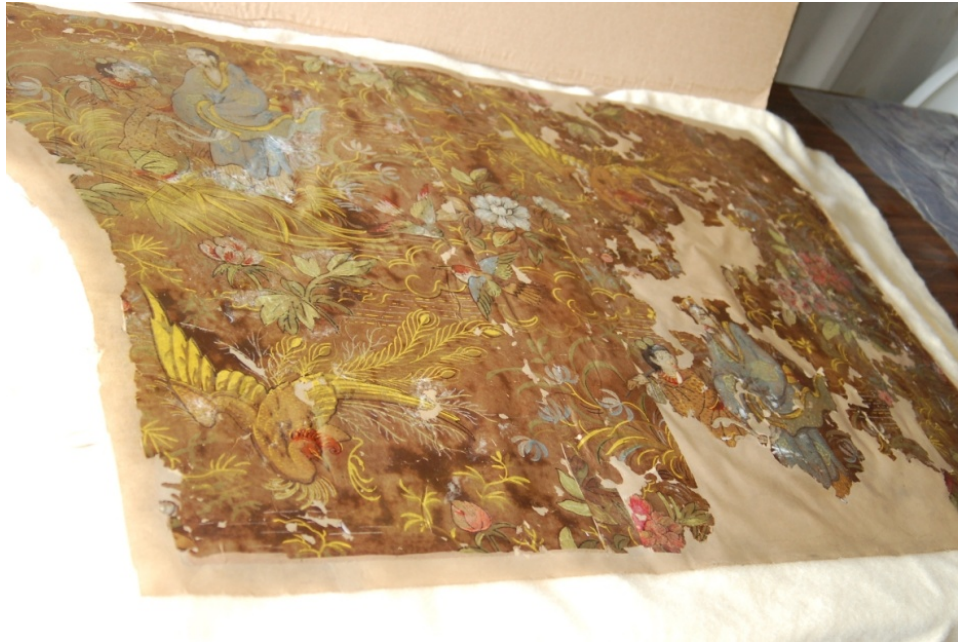
Fig. 8. Original wallpaper after lining lying on wool felt. Residual cyclododecane is visible as white spots.
(Photograph by Michaela Neiro)

Once all the original wallpaper pieces from a discrete section of wall had been tacked together, the wallpaper was lined with a large sheet of Japanese paper. The Japanese paper was cut in advance from a roll to fit the section of wallpaper being treated, and toned with thinned acrylic paints to match the background color of the wallpaper. The toned Japanese paper was brushed with Aytex-P that had previously been cooked, cooled, sieved and thinned, and then was adhered to the verso of the repaired wallpaper. The lining paper was pounded using a Japanese *Nazebabe* brush to improve adhesion. After applying the lining, the wallpaper was dried between wool felts (fig.8).

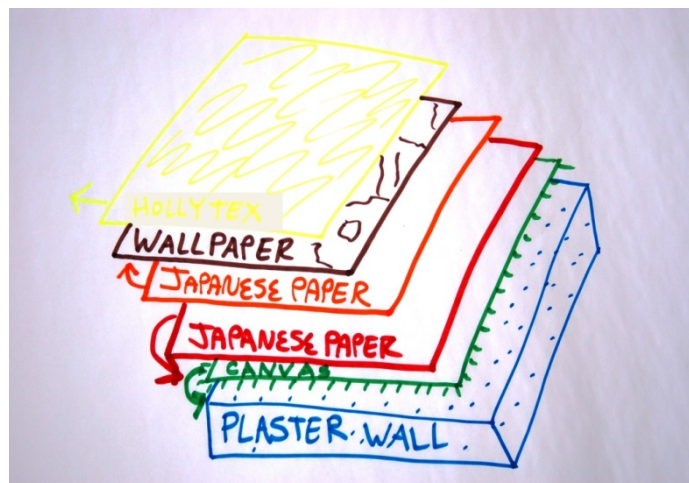
Fig. 9. Diagram of the layers applied to the original plaster wall (Photograph by Michaela Neiro)

The following day, the paper was ready to be re-hung. A section of toned Japanese tissue was applied on top of the previously-attached canvas with wheat starch paste to encourage better bonding with the wallpaper (fig. 9). The cleaned, repaired, and lined wallpaper was pasted with a 50/50 mixture of wheat starch paste and methyl cellulose for easier positioning. The Mylar tracing was used to support the lined, pasted wallpaper section and lift it into place. Once positioned, paint rollers and the Japanese pounding brush were used to firmly adhere the wallpaper in its original place. The Mylar was removed and the wallpaper was blotted with paper towels to wipe off excess paste. After the wheat starch paper was dry and the wallpaper flat, areas of loss were compensated using pastel pencils to continue the lines of the pattern.
