One Wall, Many Challenges: The Conservation of Late Roman Painted Wall Plaster at Sardis

Three Approaches to One Wall

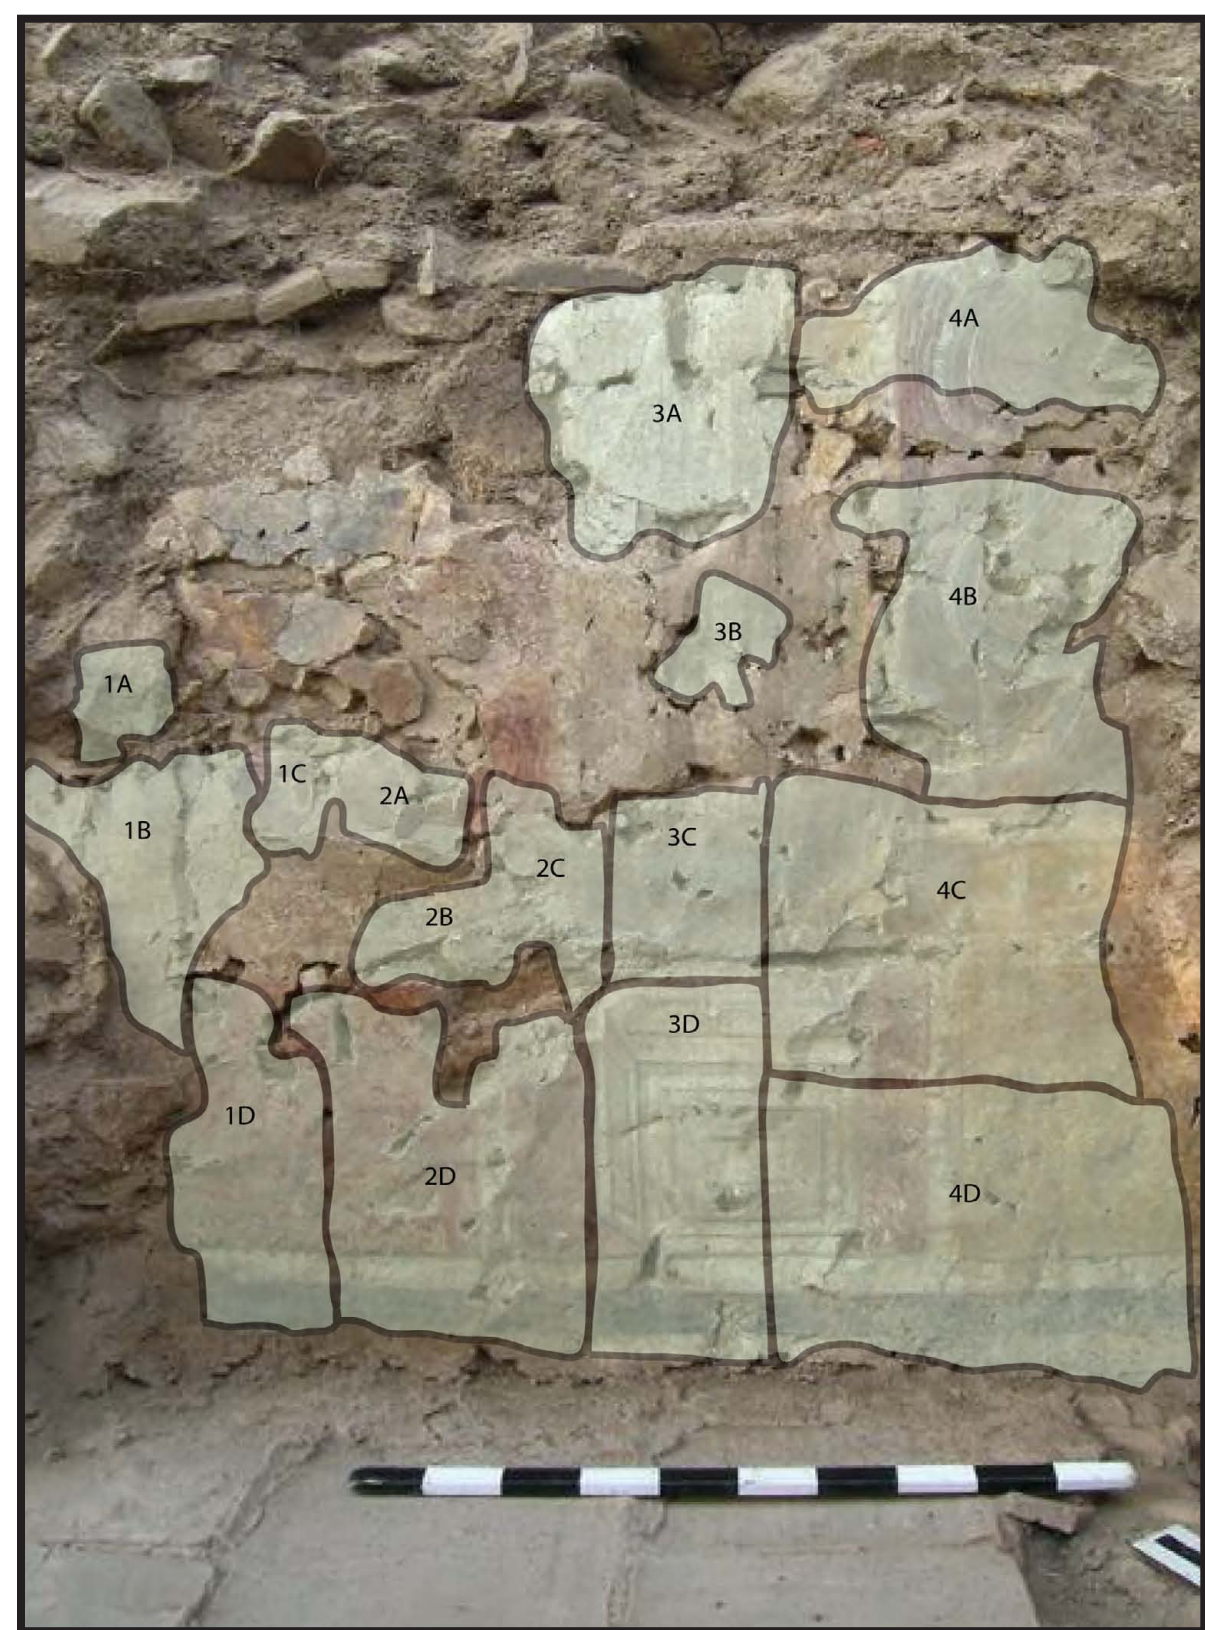
Above: After treatment photo from 2005; Digital overlay of the areas that remained in 2014

Background – Consolidation with Primal AC-33 and edging with plaster of Paris were undertaken in 2005. The wall was covered with geotextile and reburied at the end of the season.

Condition – In 2014, approximately 30% of previously treated plaster was lost and the rest was in very fragile condition. Damage occurred as a result of root growth and the plaster of Paris edging, which contributed to erosion of the ancient mortar and breakage of original plaster.

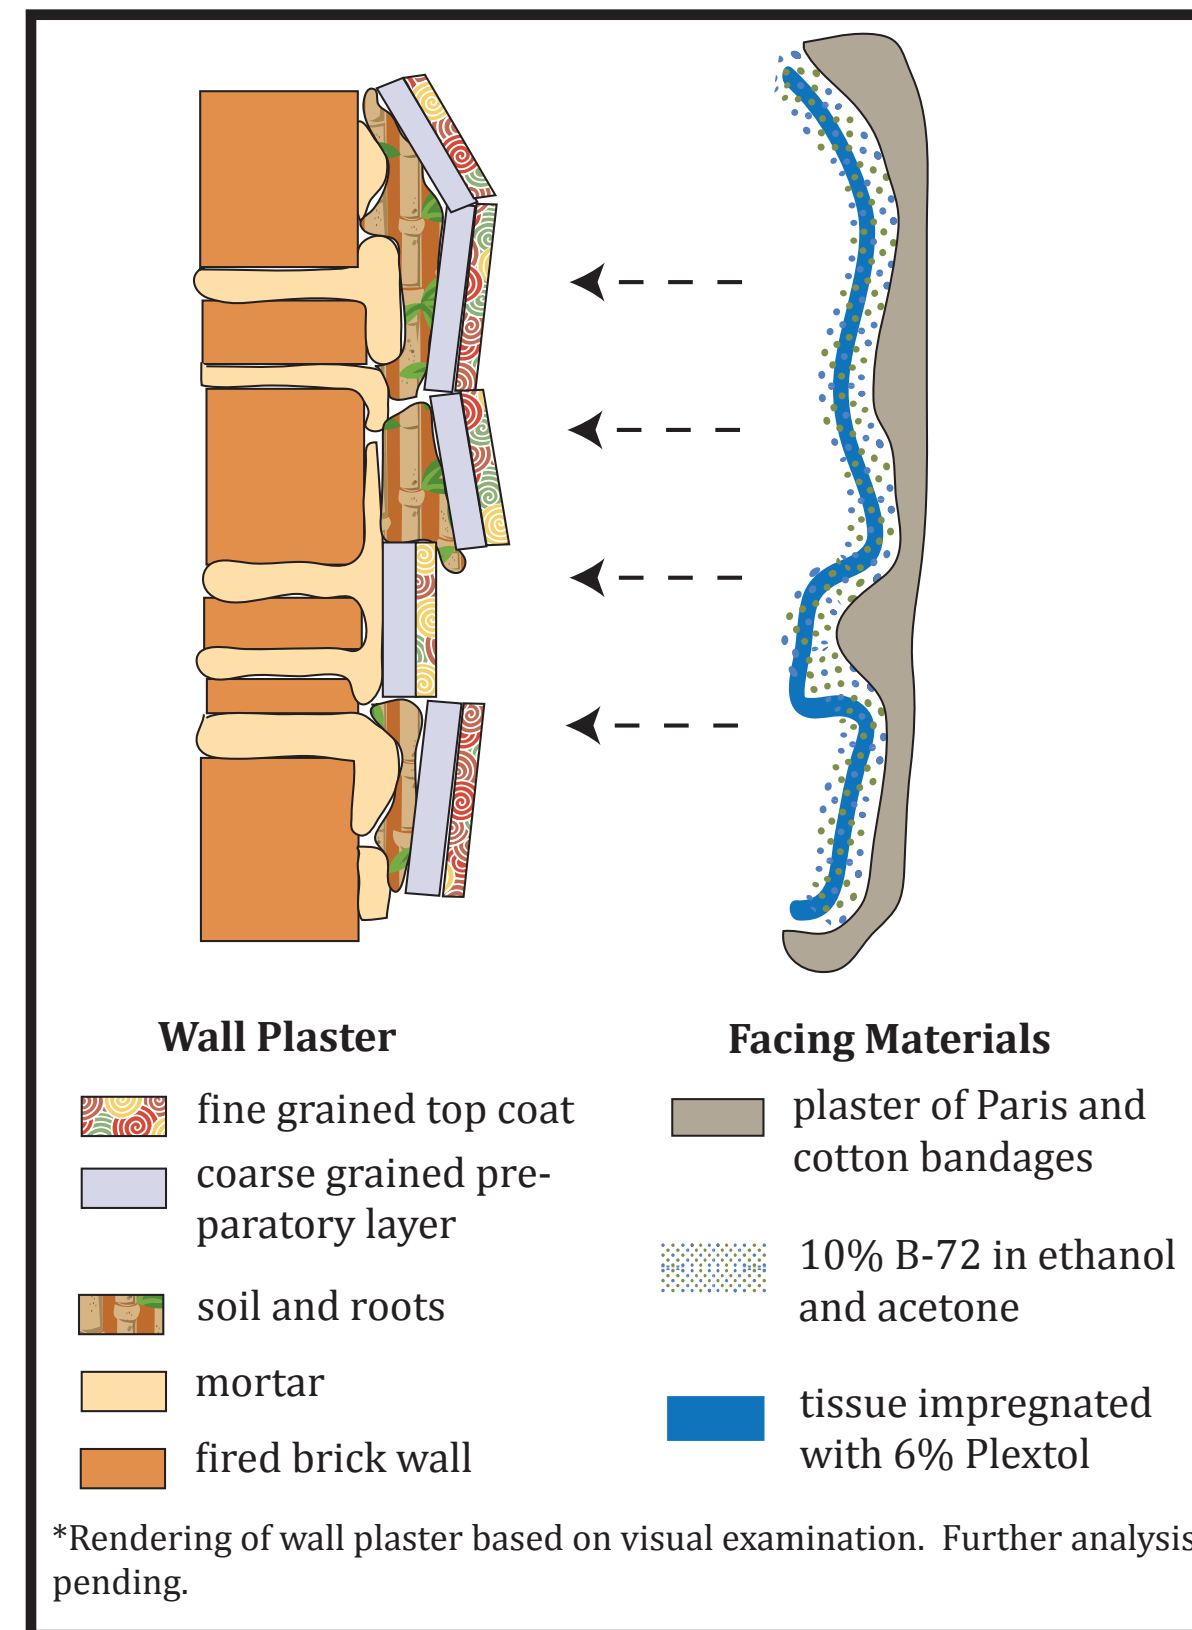
Above: Drawing of the wall plaster stratigraphy based on examination and facing materials

Treatment – A grid and numbering scheme was assigned. Wall plaster was faced with tissue paper, 6% Primal AC-33, and 10% B-72 in 1:1 acetone and ethanol, then covered with cotton bandages impregnated with plaster of Paris. Sections were loosened with bamboo skewers, lifted from the fired brick substrate, and placed in storage.

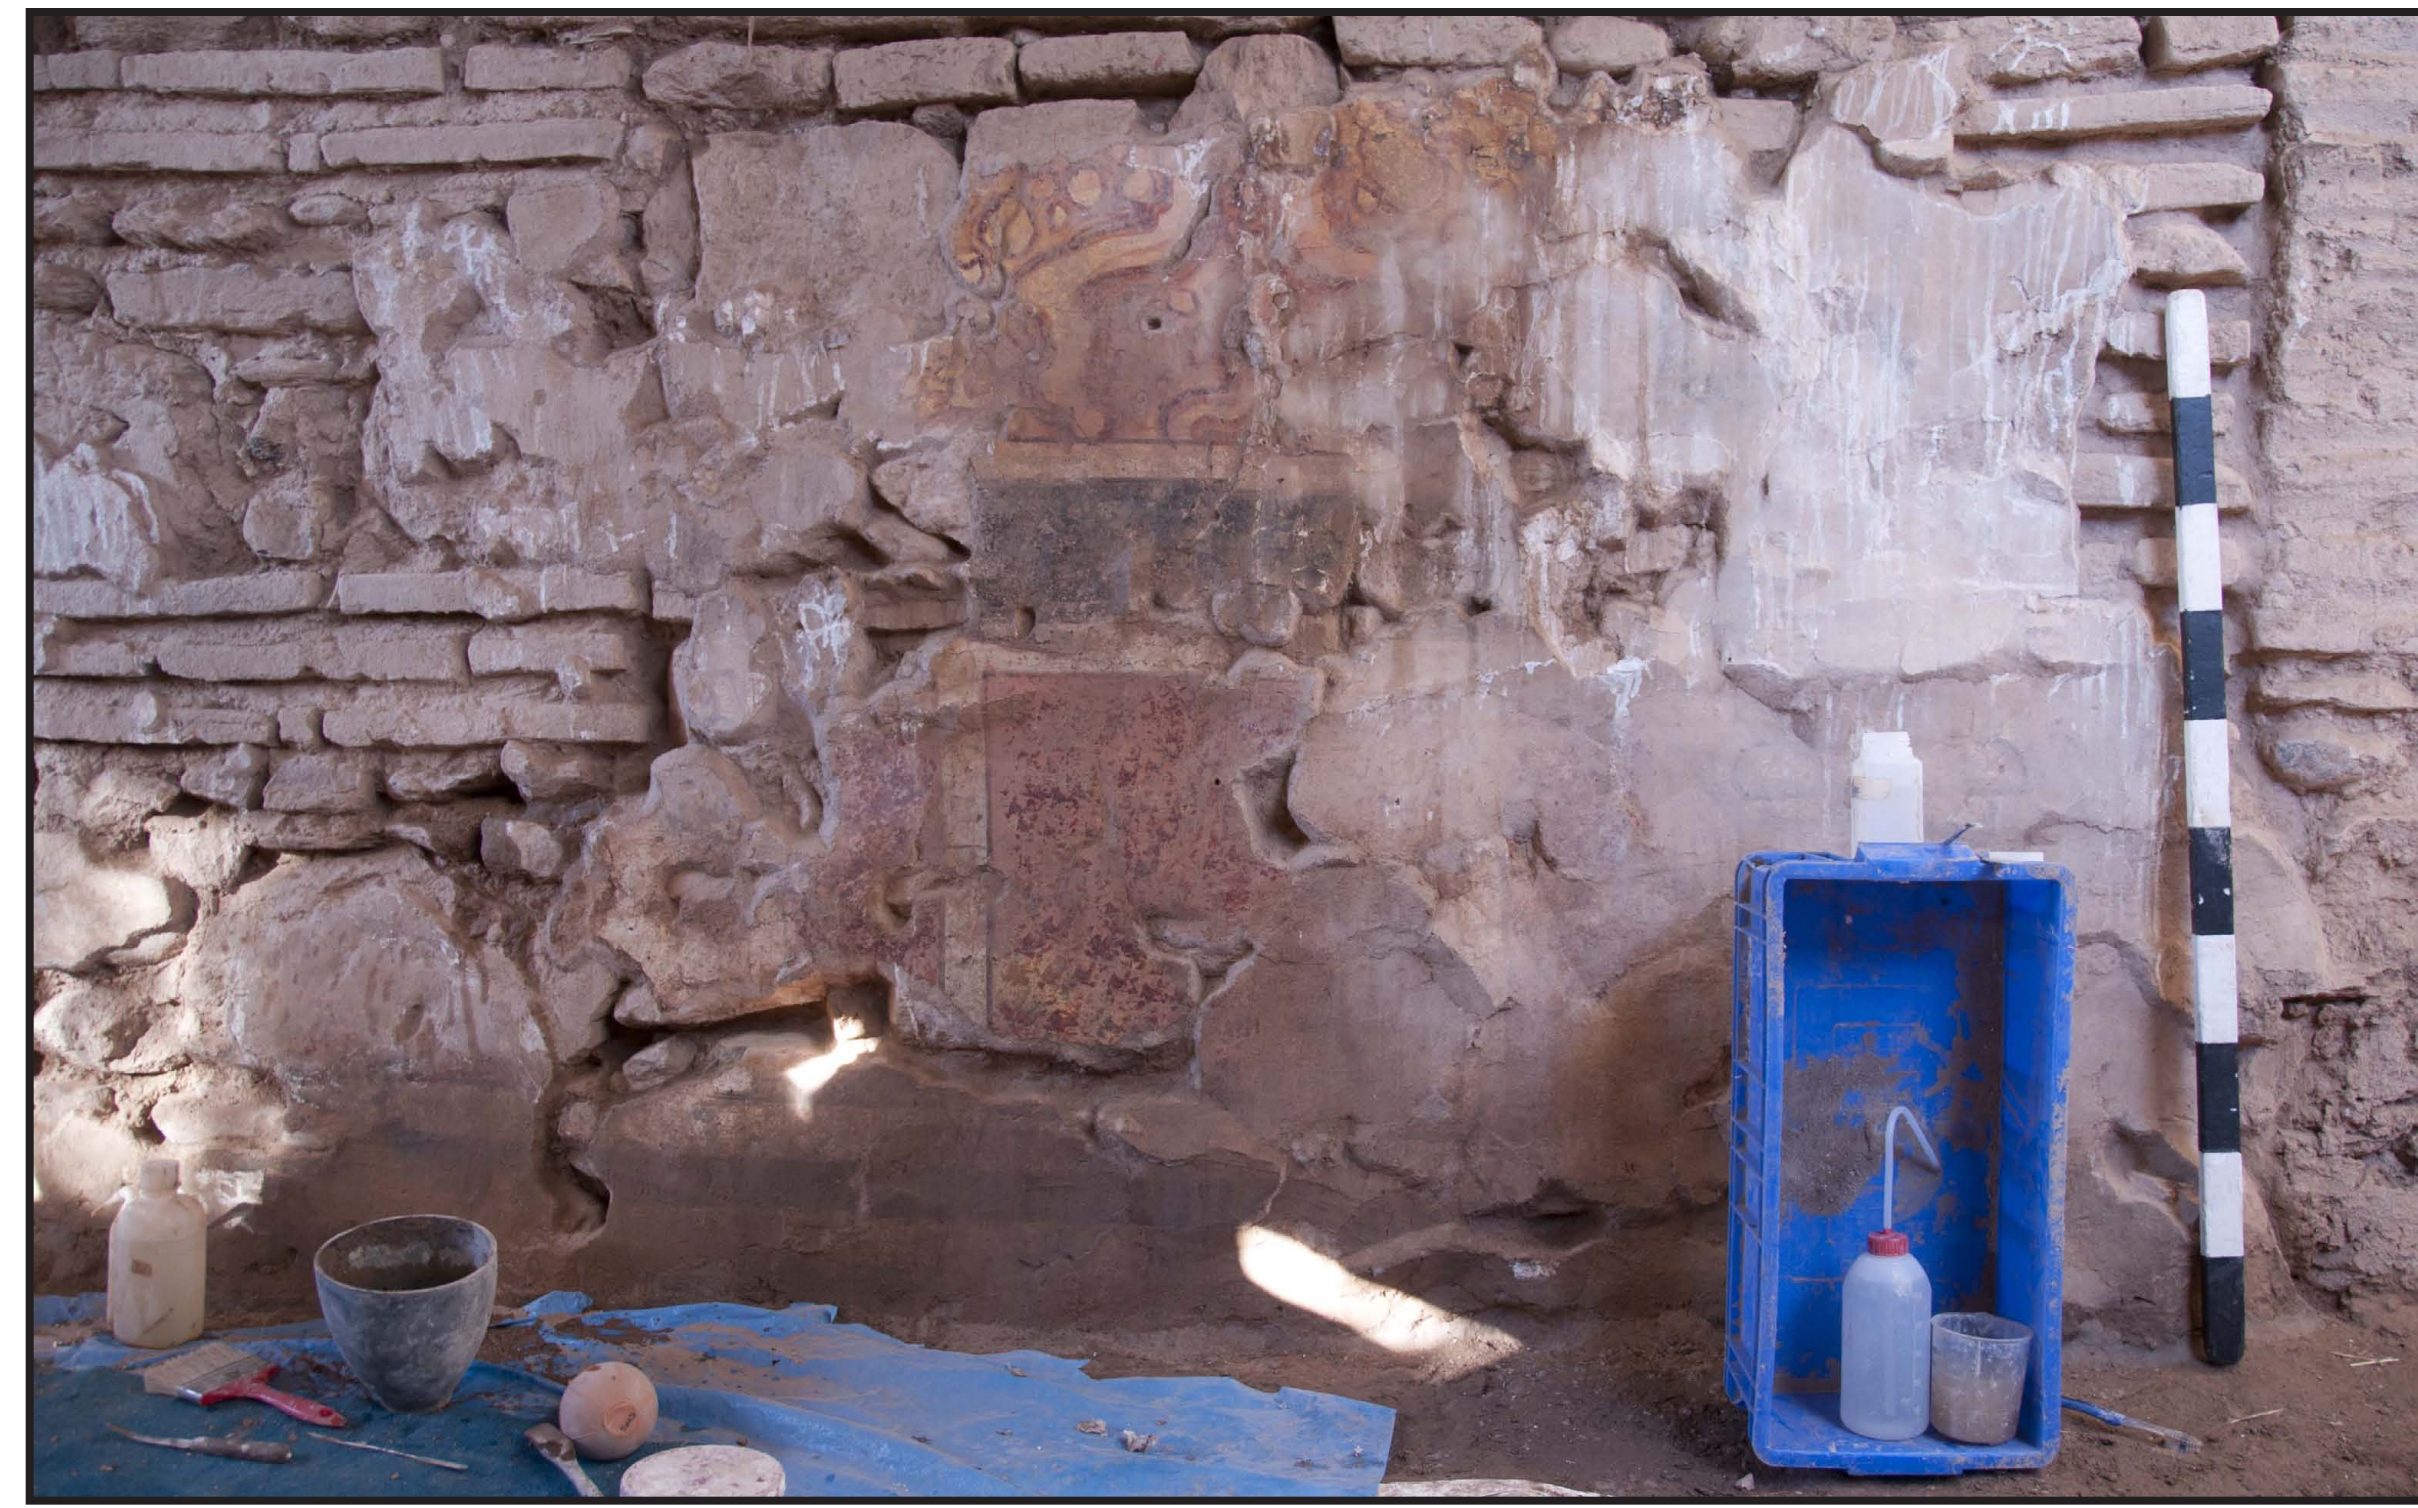
Above: Newly excavated wall plaster being treated in-situ

Condition – Newly excavated wall plaster was in more robust condition.

Treatment – The surface was consolidated with 6% Primal AC-33. Edges and voids were filled with a mortar mixture of 4:2:3 sifted sand, silty soil, and lime putty. Malta grout slurry was injected into fine surface cracks. The area was kept damp for five days to allow the mortar to set. The surface was cleaned to reveal the painted design.

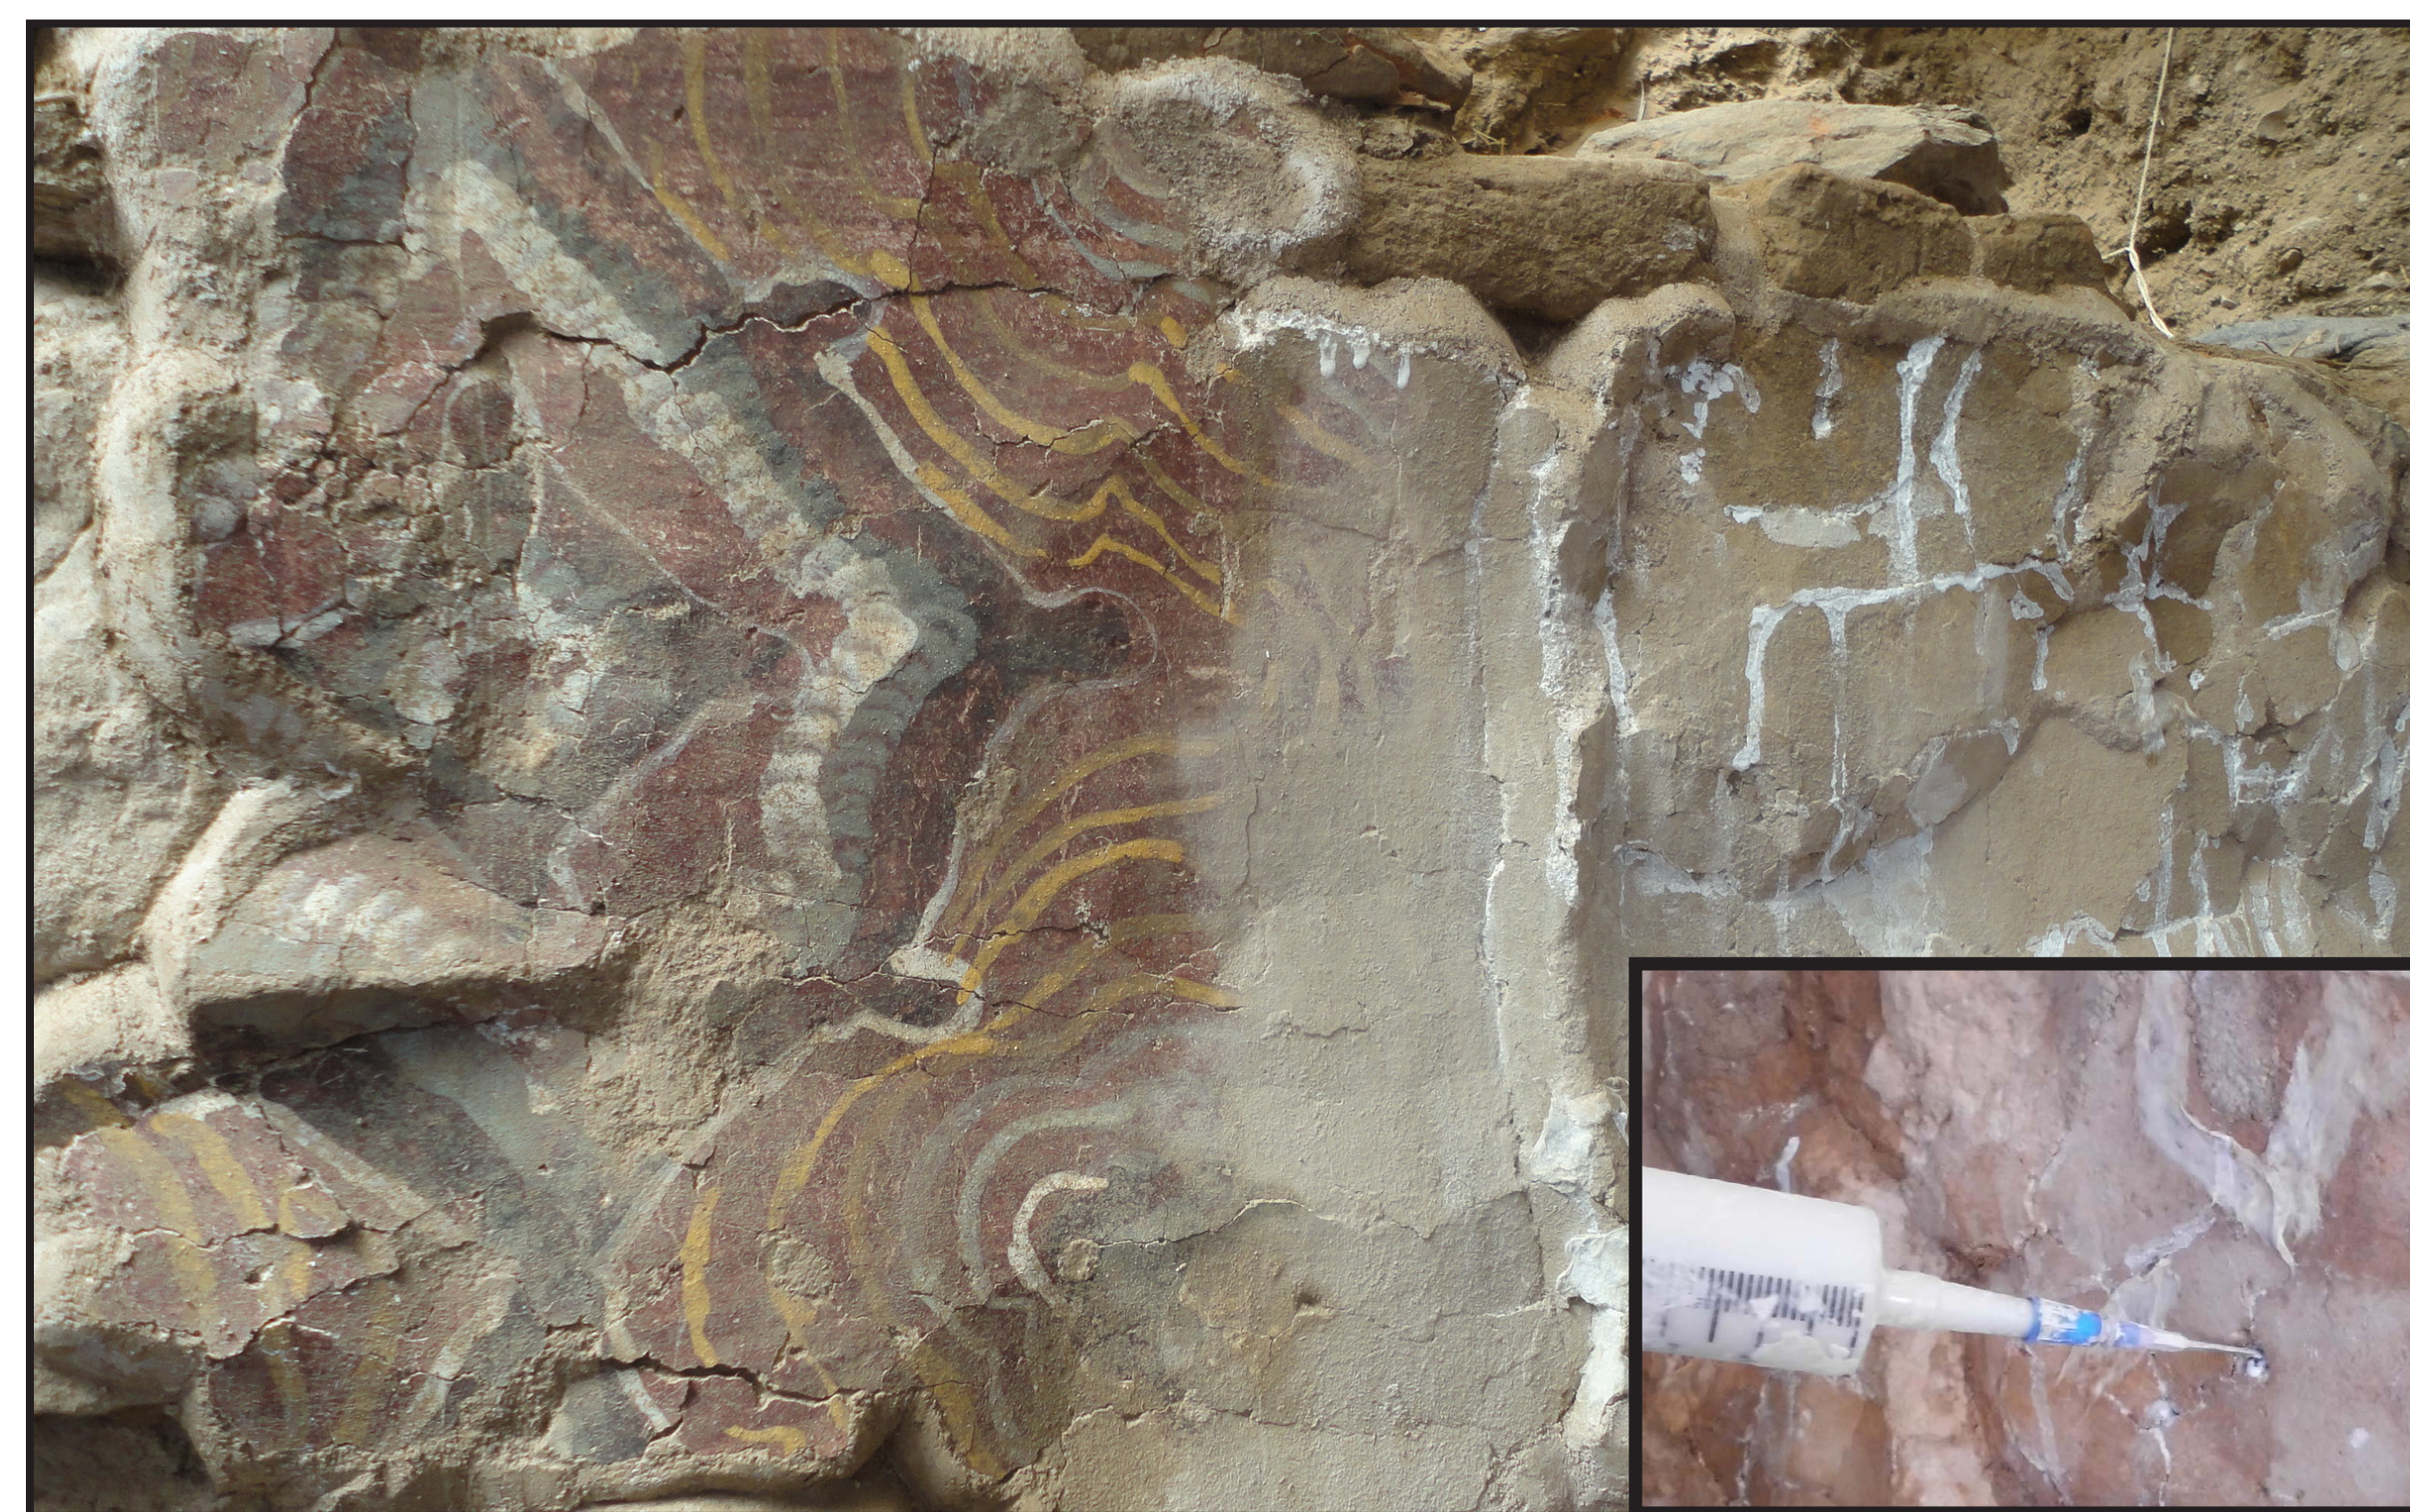
Above: Mortar edging, injection grouting with a syringe, and surface cleaning

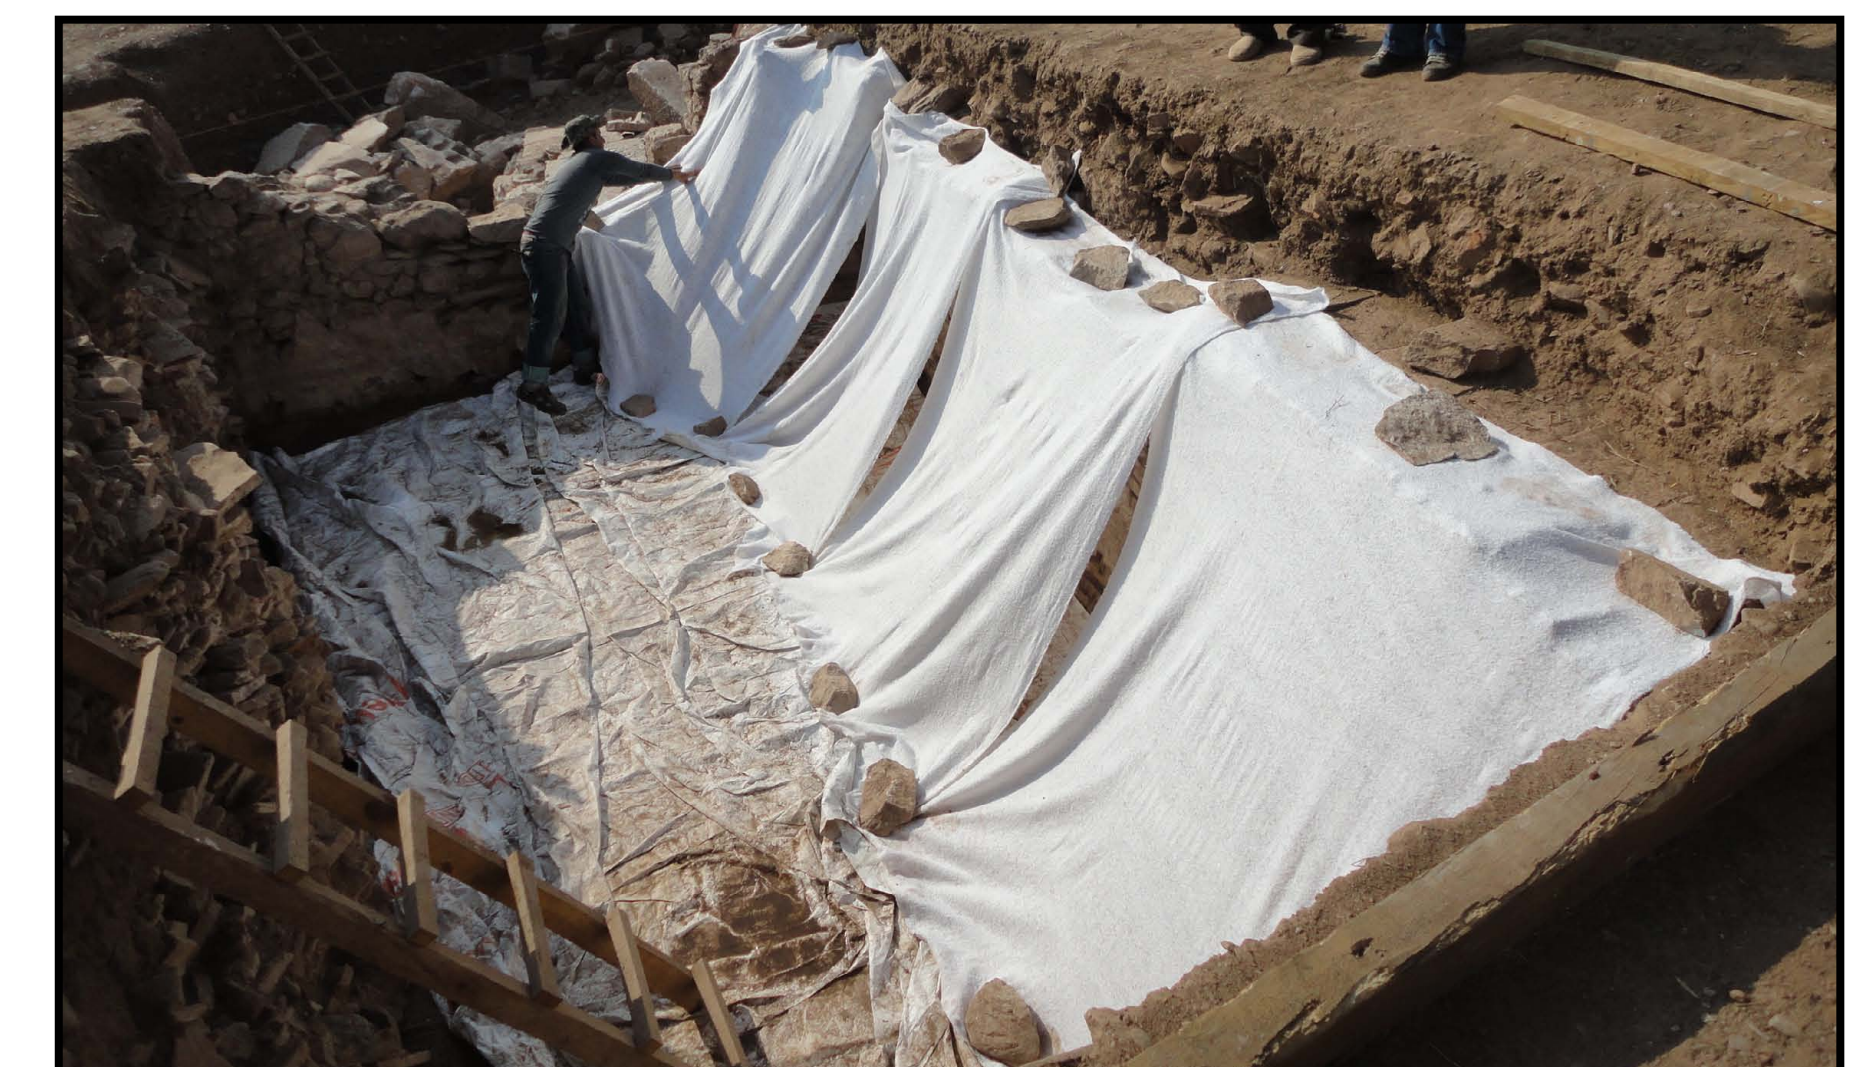
Left: Architectural drawing of the two rooms, Field 55 by Brianna Bricker; Green (stabilized in-situ), Yellow (stabilized & surface cleaned in-situ), Blue (lifted), Orange (unexcavated), and Purple ("reburied")

Due to time constraints, wall plaster excavated toward the end of the season was "reburied". Brick retaining walls were constructed in front of the wall plaster and sifted sand filled the space in between.

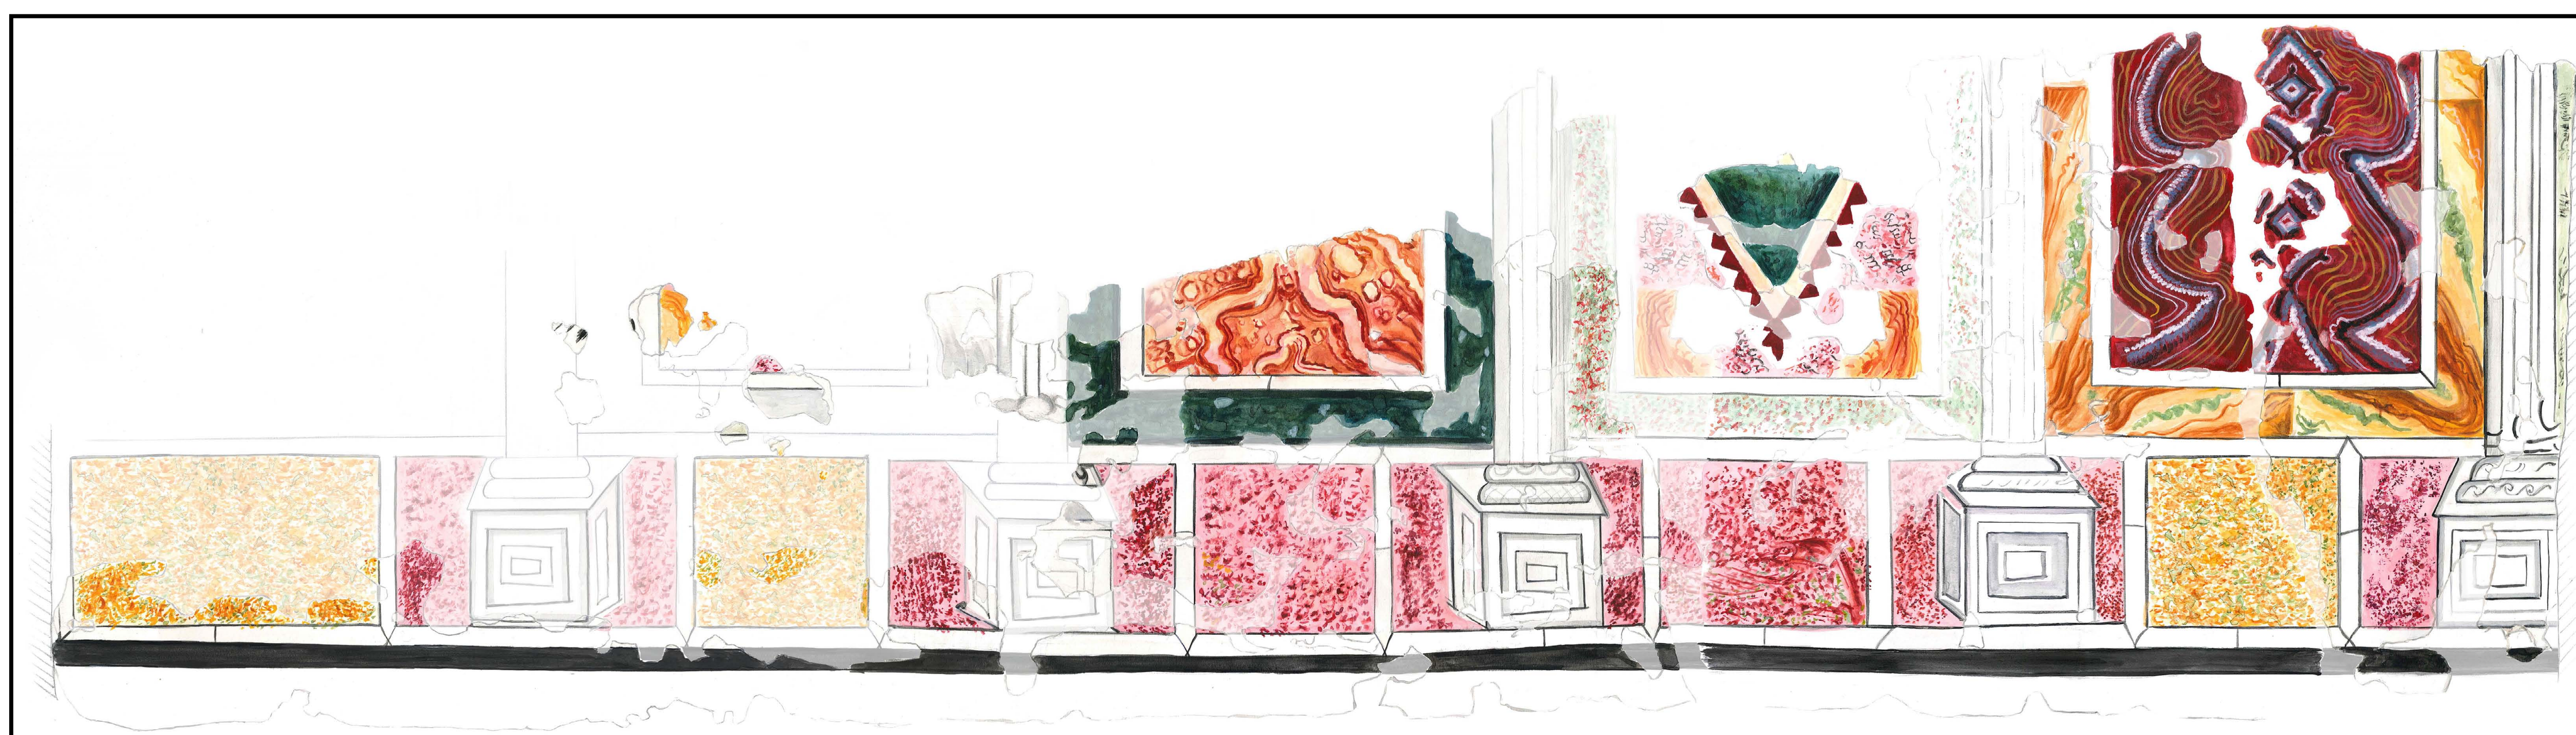
Above: Illustration of the South Wall by Cathy Alexander, showing existing plaster and reconstruction. Dimensions: 6.19 x 1.70 meters
