Weathering the Unexpected: Lessons Learned in Keeping Seminole Cultural Property Safe

Marlene Gray, Ah-Tah-Thi-Ki Conservator

AIC 44th Annual Meeting & CAC 42nd Annual Conference in Montreal, Canada, May 2016

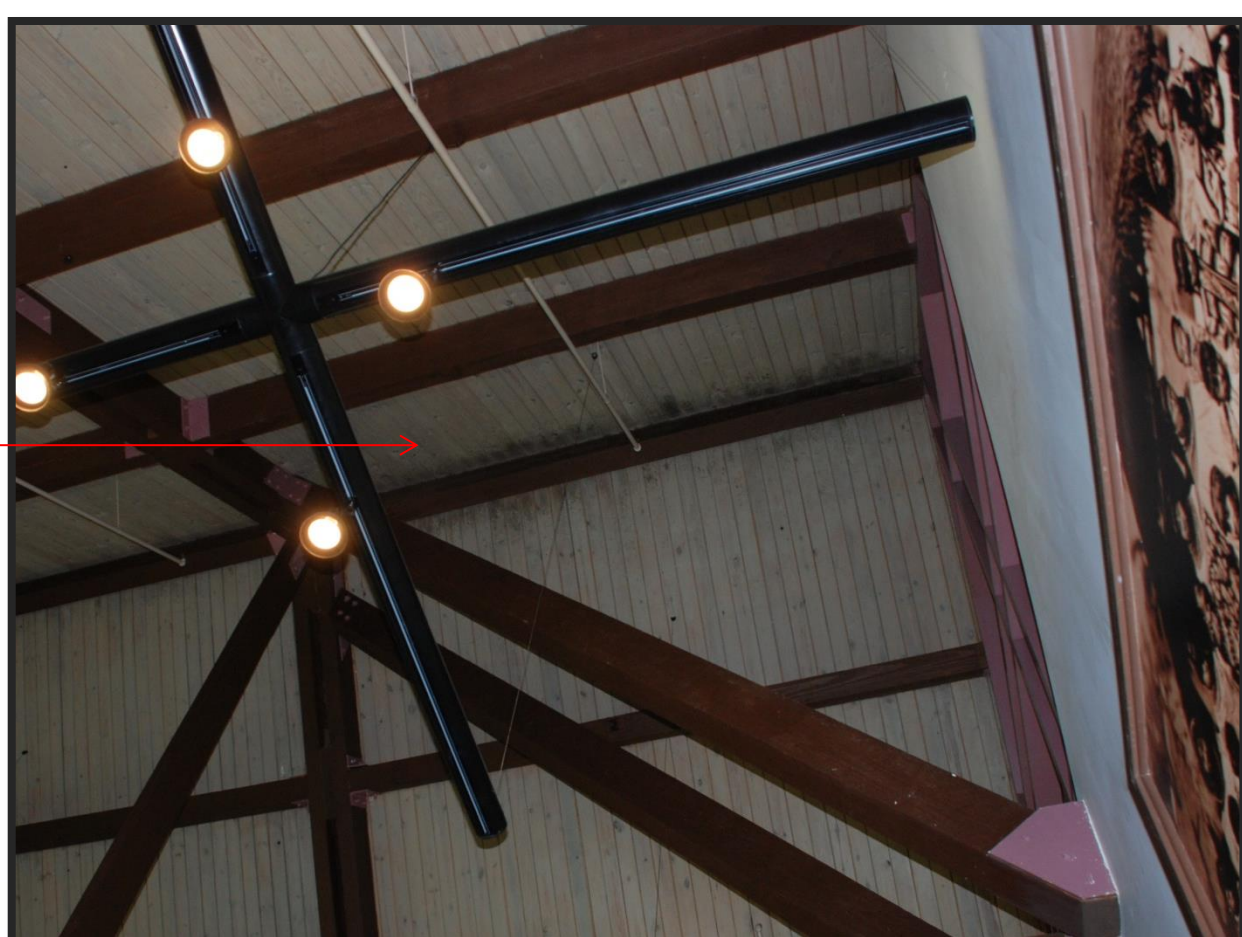
Dirt accumulation and possibly mold in crevices of Museum roof beams.

In summer 2015, the Museum closed for a month to clean and apply a sealant to the ceiling in order to prevent the buildup of dirt in crevices, which had previously led to mold growth. Even though this was not an emergency situation, the same basic procedures as mentioned above were employed to keep collection objects safe during cleaning and accessible to Tribal Members. Many of the staff were not with the Tribe during these previous situations, so this was also a sort of test run in deinstalling the Museum in the event of an emergency. This project was a good time to arrange for a textile rotation of the permanent collection since the objects had to be removed from display anyway. Most important lesson – preparedness and documentation is the key to a successful recovery from disaster!

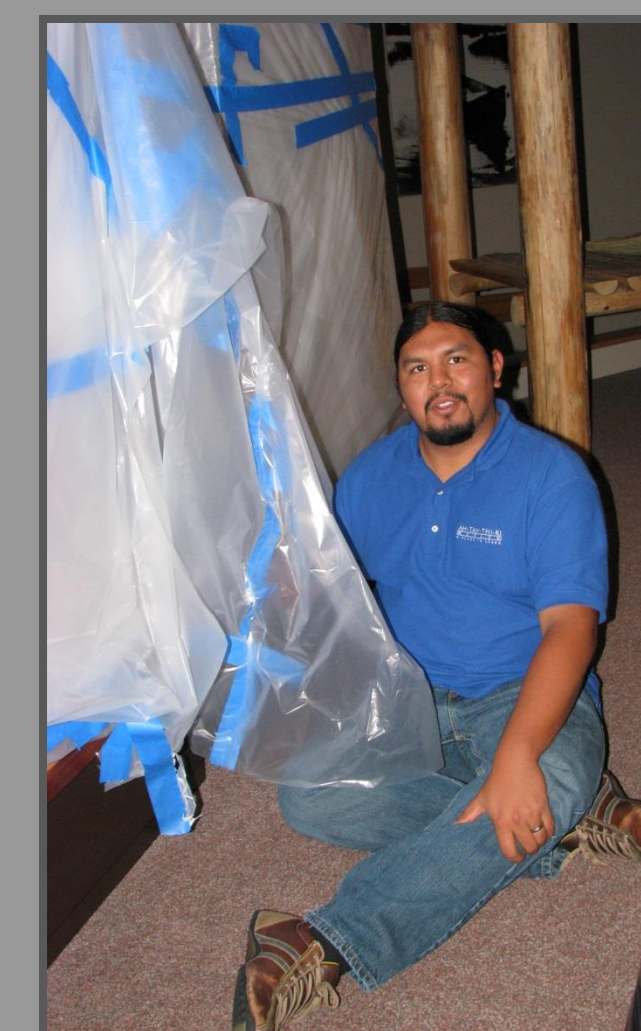
Museum staff member Pedro Zepeda covering exhibit cases with Visqueen

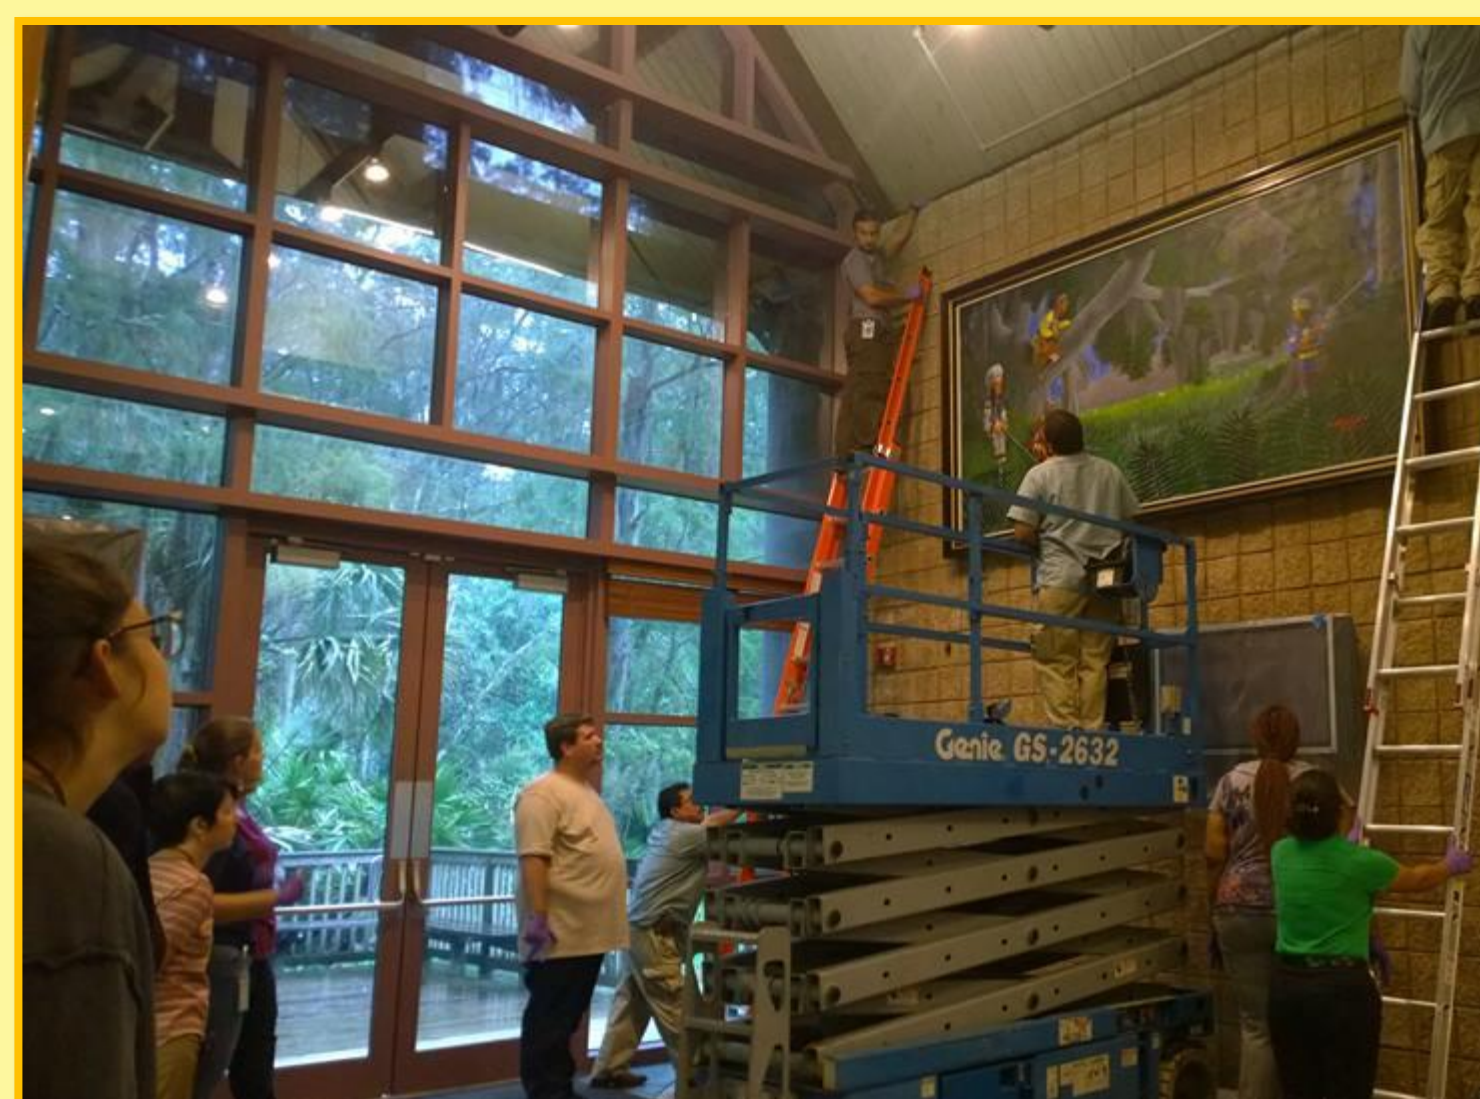
Deinstallation - from left: 40 mannequins line the aisles of the archival vault and Museum/THPO staff taking down the large Noah Billie painting for safekeeping in the Library.
