Abigail Elizabeth Rodriguez, Conservation Intern and Daniel Ravizza, Staff Conservator Emil Buehler Conservation Laboratory, Smithsonian National Air and Space Museum (NASM)

INTRODUCTION

Tough Love for Magnesium

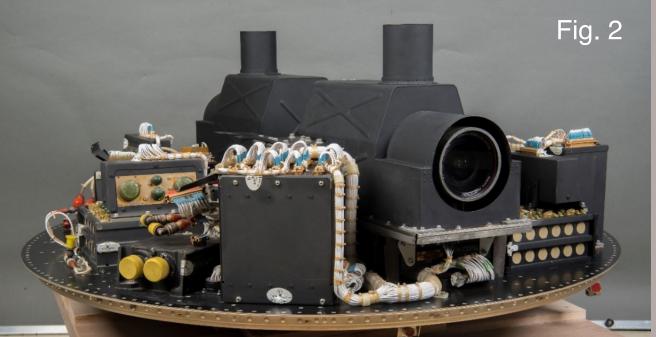
TIROS H (1964-65), a weather satellite, came into the lab for treatment (Fig. 1) and after an initial disassembly (Fig. 2), the satellite was found to have extensive magnesium corrosion on the majority of the internal components, including the two television cameras (Fig. 3-4).

Figure 1. TIROS H before disassembly **Figure 2.** TIROS H during disassembly Figure 3. Photomicrograph of magnesium corrosion on the camera at x100 magnification Figure 4. Detached camera with magnesium corrosion around the lens and base components

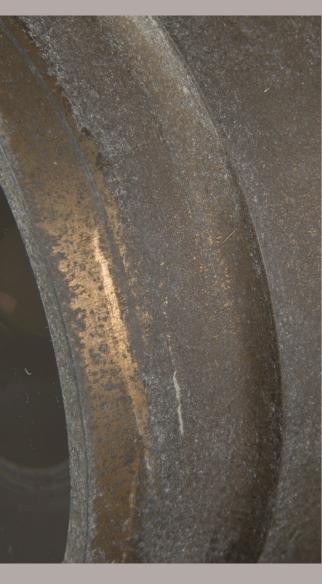
Coupon 1	Coupon 2
Preparation	Media blasting with crushed walnut shells	Media blasting Sanchem's 56 rinse and an a SafeGard CC
Photomicrograph before test, x35		
Test parameters	Both coupons were placed in a humidity	chamber for 48
Photomicrograph after test, x35		
Observations	The corrosion returned in pitted areas	The corrosion

did not return in pitted

Based on the photomicrographs, the combined treatment, utilizing an initial mechanical cleaning followed by an acid immersion and a final conversion coating treatment was highly effective at mitigating corrosion while preserving the original surface treatments. Why?

The Sanchem 560RTU cleaning acid clears active corrosion from pitted areas of magnesium where mechanical means cannot reach. This reduces the chance that corrosion will become active again, which is of great concern with magnesium.
