Iron-Stain Reduction from Alkyd Paint Films

Kate Brugioni Gabrielli | Lauren Anne Horelick

National Air and Space Museum

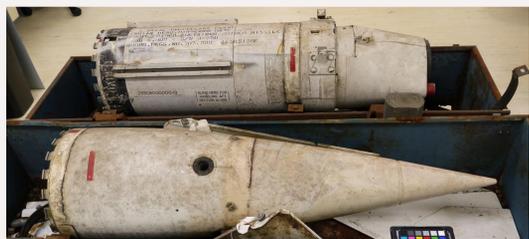
The original storage container was severely rusted, causing orange-brown staining to the painted surface.

Bullpup segments in original crate, before treatment (BT).

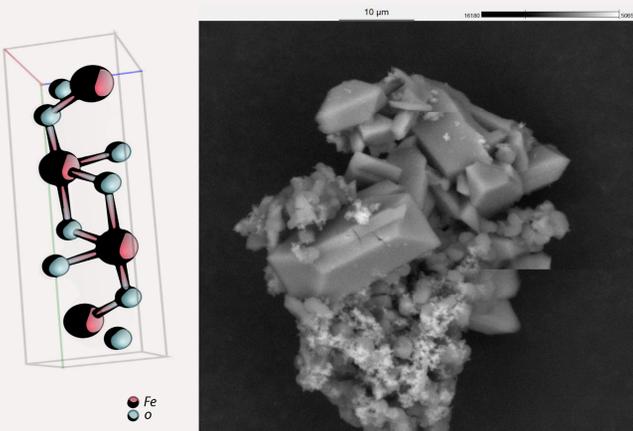
Analyses before and after staining—including pXRF, Raman, XRD, and SEM-EDS—reflected introduction of iron salts containing Fe²⁺ and Fe³⁺ into the paint film.

Unit cell of goethite (left). Iron oxide mixture with SEM (right).

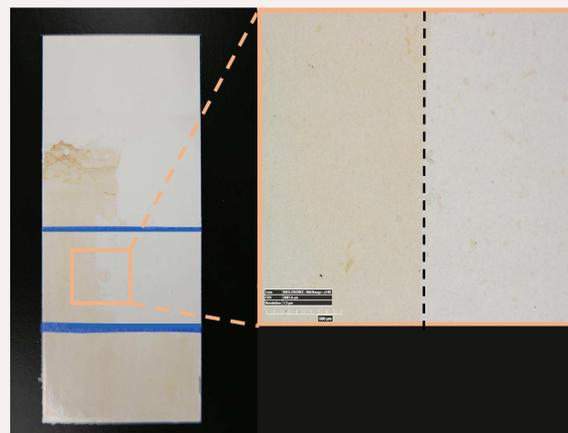
Oxalic acid in DI water (0.15M at pH 4.0) in a cellulose-powder poultice was effective when applied for 30 minutes. The surface was then rinsed with pH-adjusted water (pH 4.0).

VERY EFFECTIVE: Oxalic acid (0.15M at pH 4) **EFFECTIVE:** Acetohydroxamic Acid (0.15M at pH 9.2)

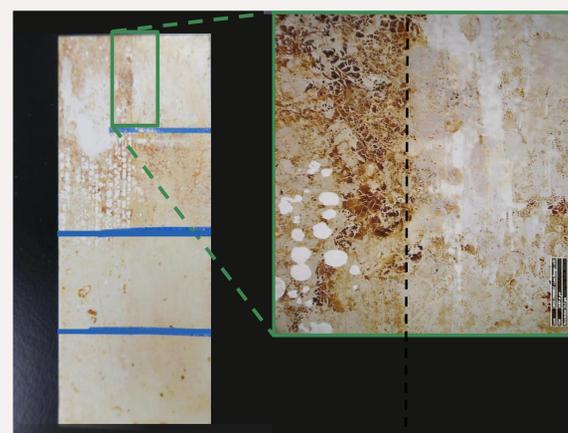
Acetohydroxamic acid in DI water (0.15M at pH 4.0) in a cellulose-powder poultice was effective when applied for 60 minutes. The surface was then rinsed with pH-adjusted water (pH 9.2).

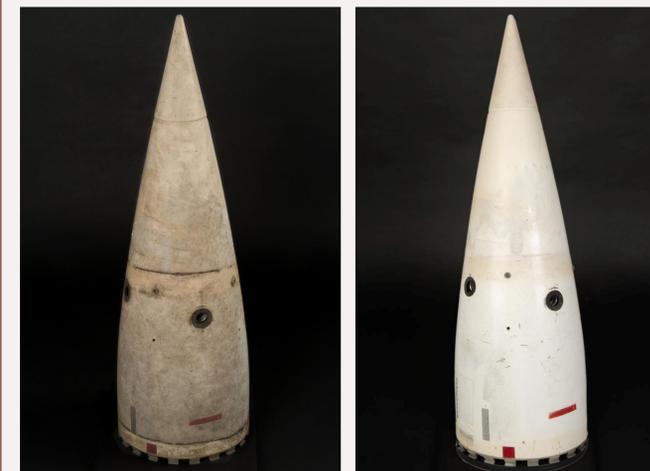
BT, nose cone (left). AT, following oxalic acid (right).

The Bullpup missile was successfully treated with 7% oxalic acid (w/v) in DI water on a TEK-wipe poultice.

Colorimetry was performed to describe stain reduction following poulticing. Above, L*a*b* values are visualized as HEX codes to show color change and a visually significant ΔE value. Additionally, analysis of the poultices detected iron species removed during treatment.

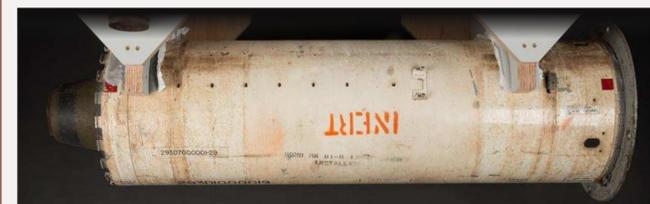
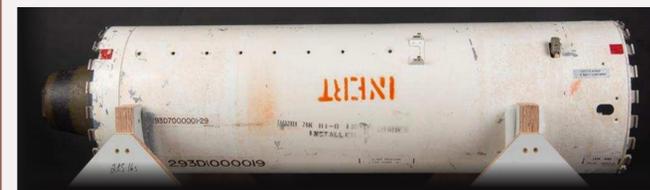
BT, segment (top). AT, following oxalic acid (bottom).
