When Modern Materials Fail: Rehabilitation of a Taxidermy Orangutan

Fran Ritchie, Graduate Student, Buffalo State College; Jonathan Thornton, Objects Professor, Buffalo State College; Dr. Aaron Shugar, Conservation Scientist, Buffalo State College

Introduction: This juvenile female orangutan died at the Buffalo Zoo in 1966 and was mounted by an amateur taxidermist. The specimen was given to the Buffalo Museum of Science in Buffalo, NY, where it was on display until 2002. Damage occurred during de-installation due to the failure of non-traditional materials added to the mount. The specimen was conserved in the Spring of 2012 at Buffalo State College.

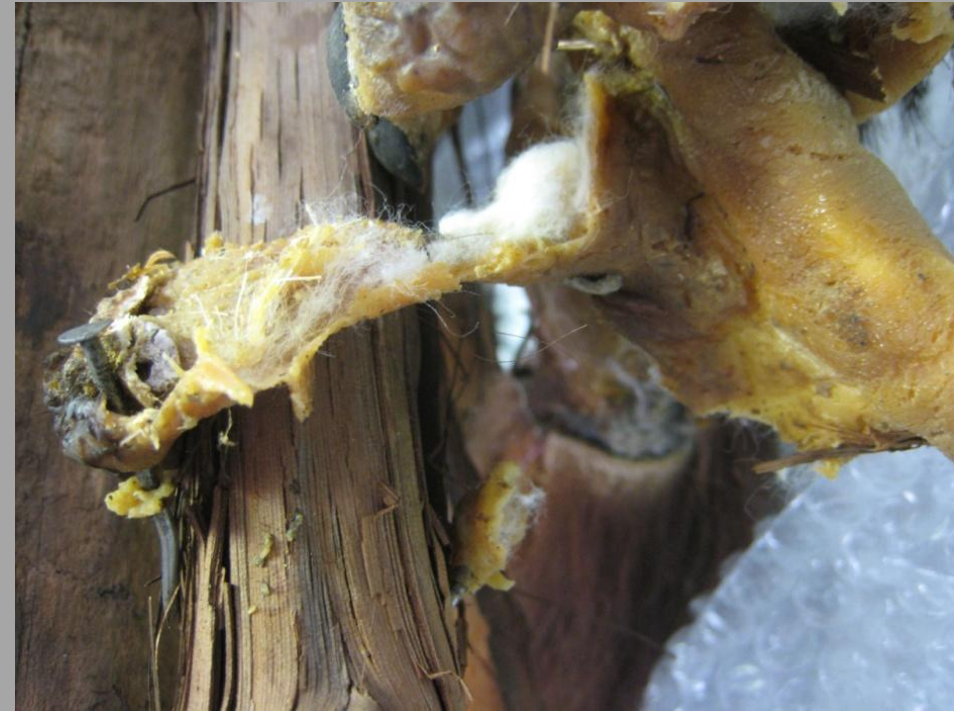
Investigation: The original display mounting method failed causing extensive damage to the joining features. The specimen required removal; the materials and construction required investigation prior to treatment.

Left: Specimen on original driftwood display mount; Right: Proper left hand torn and pulling from mount.

Response: The specimen was removed from the display mount by prying out nails and collecting broken finger fragments. Running ATR-FTIR on skin samples confirmed that the taxidermist replaced the palm skin and pads of feet with latex rubber. X-radiography revealed the internal support.

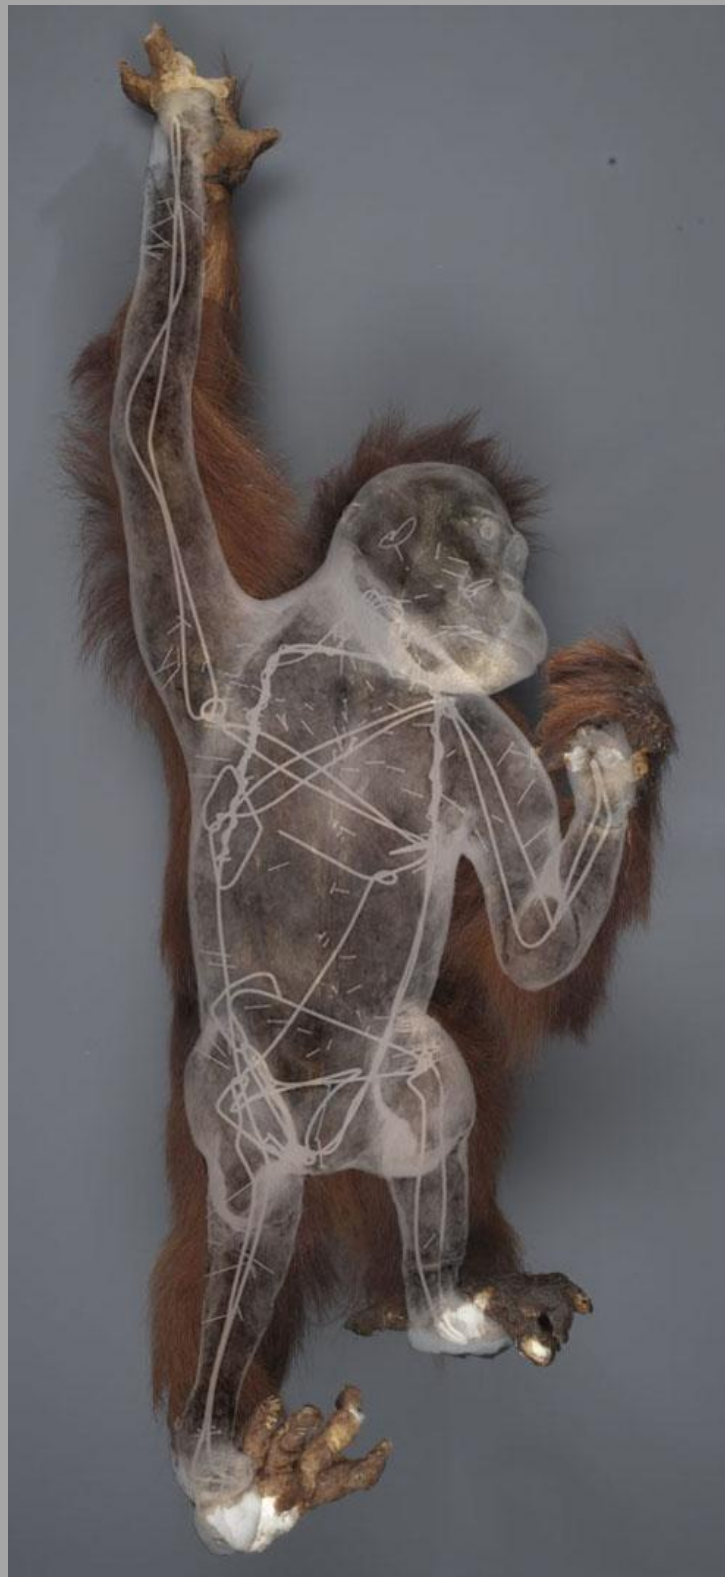
Above: X-radiograph superimposed on normal illumination photograph.

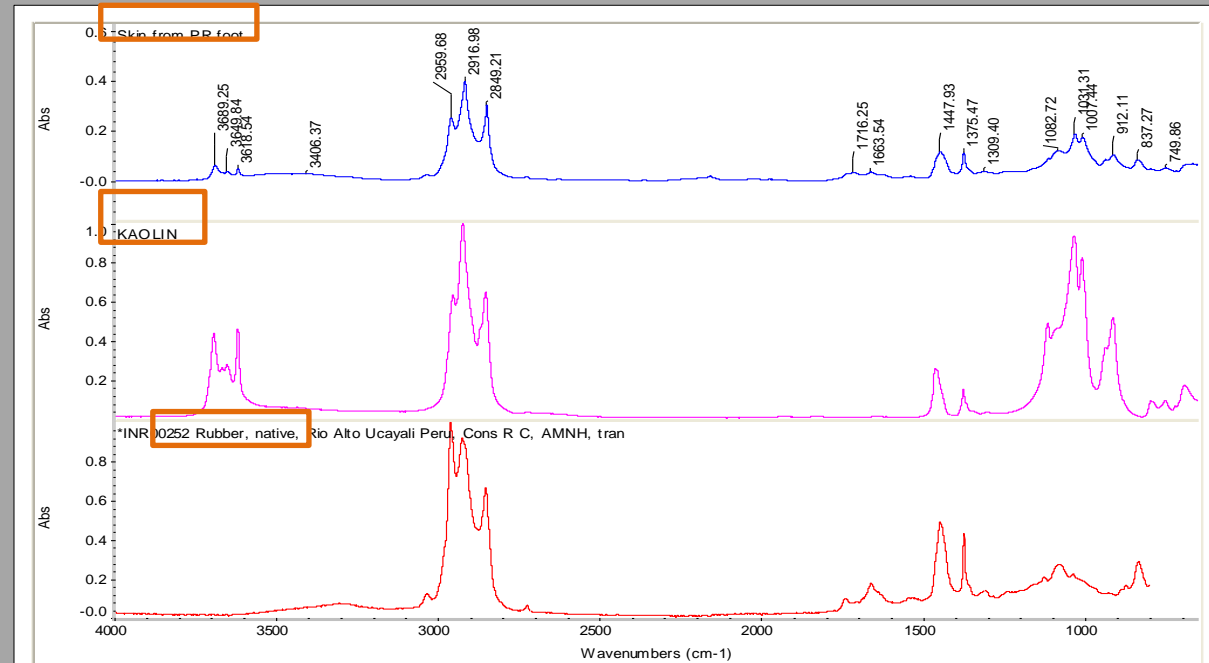
Above left: Rubber pulling away from original skin

Above right: ATR-FTIR spectra comparing specimen sample, natural rubber, kaolin.
