# Blinking Outside the Box: The Treatment of Sol LeWitt's *Wall Structure in Nine Parts, Each Containing a Work of Art by Other Artists*, 1963

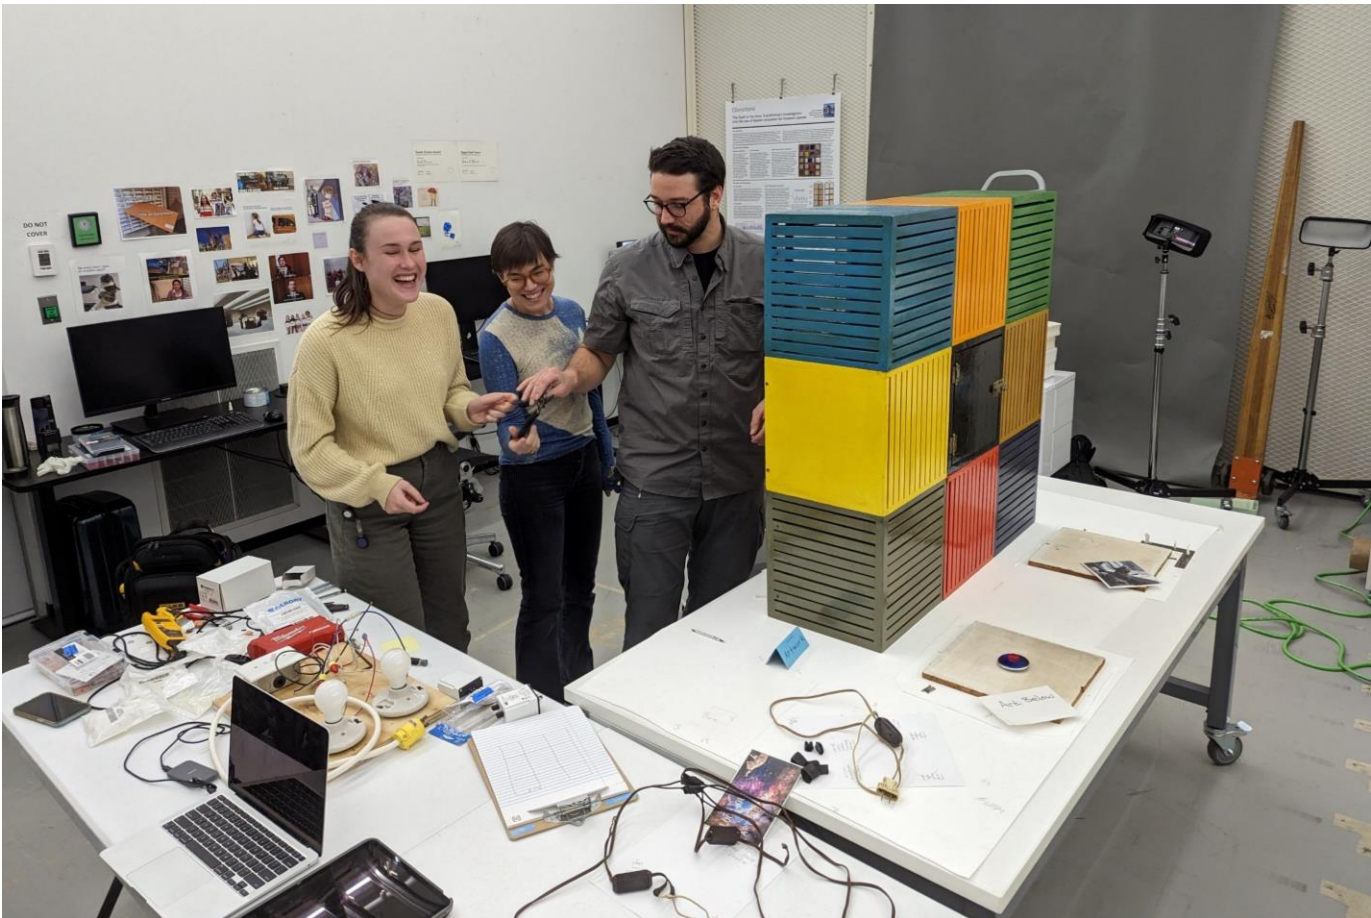
FIGURE 4 Kaela Nurmi, Elisse Brautigam, and Nick Ecker during treatment.

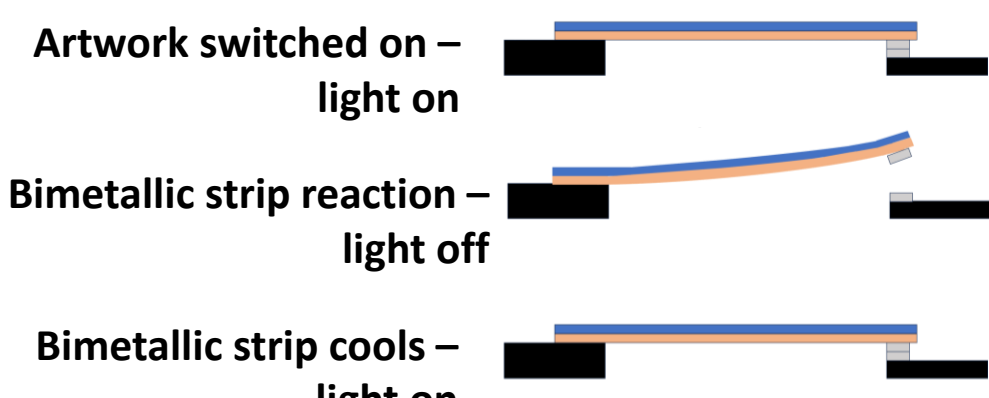
FIGURE 5 Diagram of thermal flasher

**Thermal Flashers:** The original flashers use a bimetallic strip made of two different conductive metals that expand and contract at different rates when a current passes through. This causes the bottom strip to bend and break the connection, so the light goes off. As the current dissipates, the metal contracts back into place, turning the light back on (Figure 5).

**Timing:** The work was turned on for three hours to time the existing flashing. The corner lights settled into a consistent rate of 2 seconds on, 2 seconds off, but the central light took longer to consistently flash, finally settling at about 2 seconds on, 3 seconds off. The inconsistent flashing was likely a result of material degradation due to age or quality control during manufacturing. Any slight difference in metal (length/thickness) between the two flashers, would result in a noticeable change in the flashing sequencing.
