Structural Treatments of Textile Supports: Tear Repair of A Church Painting In 1889 -- The Use of Low-Cost Heated Needle

Wing yi Cheung, Master of Cultural Materials Conservation, University of Melbourne

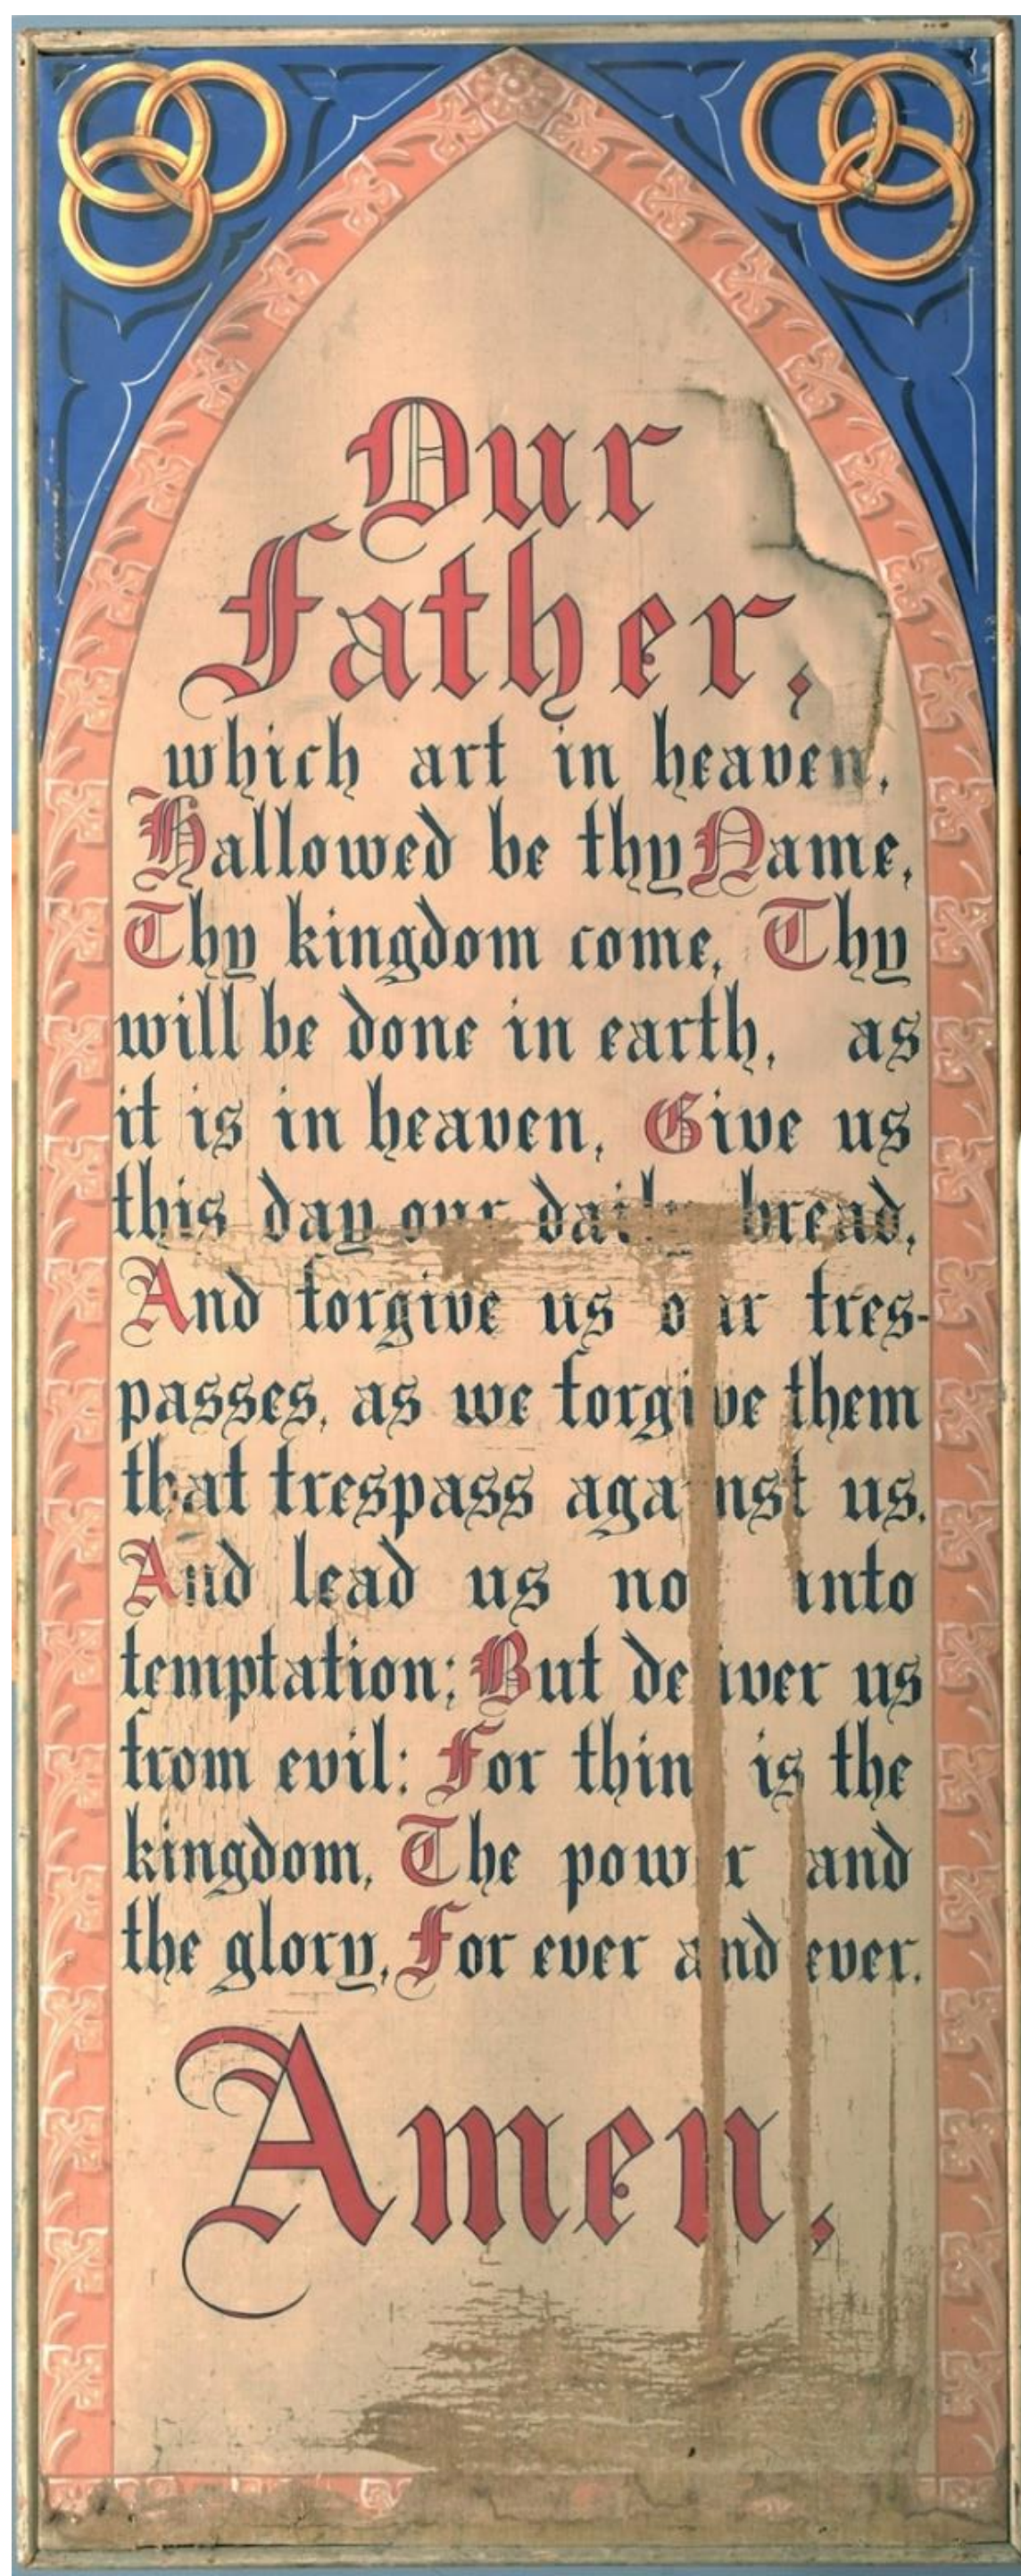
Figure 1

The Church Painting 1, possibly painted in 1889 by an unknown artist, is framed with a four-membered wooden frame. Together with Church Painting 2 is the collection of St Columb's Church Hawthorn. The owner sent the painting to the Grimwade Centre of the University of Melbourne as a teaching and research object. The painting was in poor condition, with a major tear of approximately 300mm noted at the top right of the canvas.

1. Dry cleaning, testing (solubility, pH and conductivity) and consolidation.
2. Unframing and Stretching bar detaching.
3. Humidification and flattening of tacking edges.
4. Local humidification and flattening of the tear and hole by sandwich approach.
5. As the tear located too close to the stretcher, the 'Trecker' was not adoptable. The position of the tear was fixed by sandbags and weights. Masking tapes helped to hold the gap on areas that were not marked with inscriptions.
6. A minimal amount of molten polyamide was applied to the original canvas, which was attached to one end of the foreign thread.
7. Tightened (tensioned) the thread with a micro point tweezer and applied the molten adhesive to the other end of the thread.
8. The threads were then immediately left dried under weight.
9. Continued steps 6 to 8 until the tear and hole were completely treated.
