Source: *Objects Specialty Group Postprints, Volume Fifteen, 2008*

# FROM MARBLE TO MUSSELS: A SIMILAR TREATMENT APPROACH TO DISSIMILAR MATERIALS

JUDY OZONE AND ABIGAIL MACK

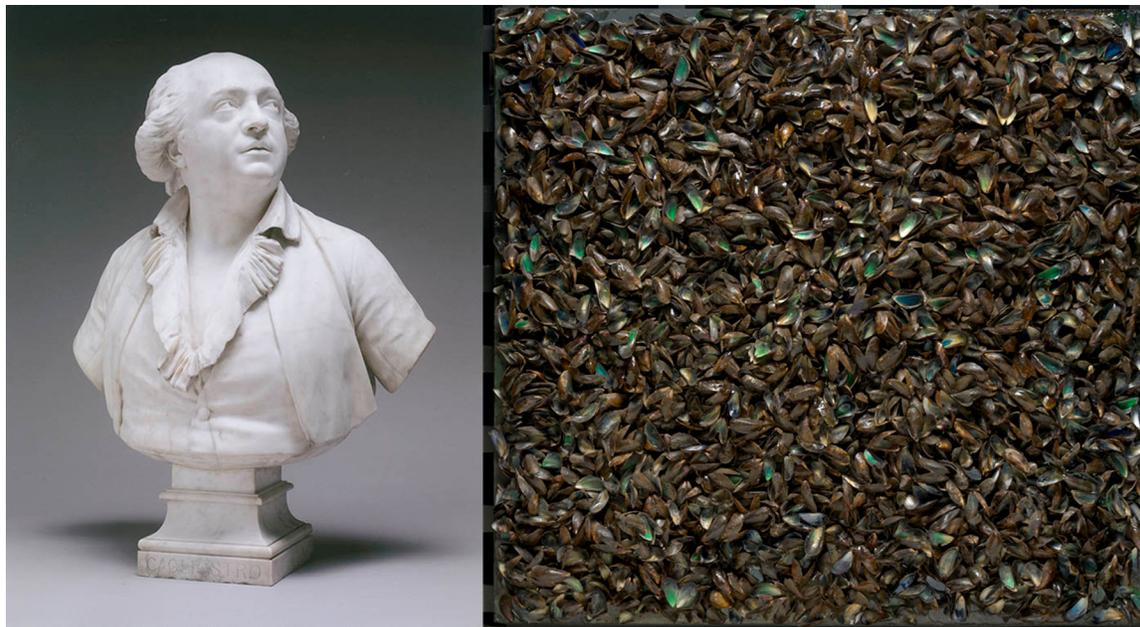
At first (and even second) glance, these objects have very little in common (fig. 1). Composed of vastly different materials and made nearly 200 years apart, each was created for a different purpose and represents a wholly different era in art history. The Houdon bust was commissioned to honor Cagliostro at the height of his popularity, before he was exposed as a criminal and charlatan. By contrast, Broodthaers used his work to challenge the mind more than the eye, often using everyday objects that defied cultural status. The culmination of this concept came in a 1972 exhibition in which every object carried the label, “This is not a work of art.”<sup>4</sup>

The critical condition of each sculpture led the authors to devise individual treatments that ultimately united the objects in unexpected ways. Their initial similarity was simply that the structure of each object was so weakened that neither could be exhibited without a comprehensive and potentially intrusive treatment that might significantly alter its appearance. Though conservation treatment of the Broodthaers followed that of the Houdon by over a year,

Fig. 1. (left) Jean-Antoine Houdon, Giuseppe Balsamo, Comte di Cagliostro. Collection of the National Gallery of Art (1952.5.103). (right) Marcel Broodthaers, Panneau de Moules Collection of the National Gallery of Art (2005.36.1). (Photographs by Lee Ewing)

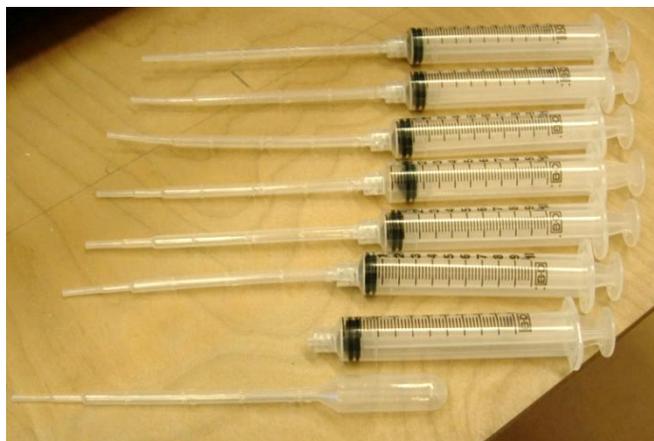
Fig. 13a. Modified syringes (Photograph by Abigail Mack)

Using powerful illumination, areas were located where the support board was visible between the mounds of mussels. These potential injection ports were temporarily marked with bamboo skewers. The use of disposable syringes that worked so well in the Houdon treatment proved to be the best epoxy delivery system for the Broodthaers panel as well. For this treatment, the syringes were modified to form a hybrid of the syringe body fitted with a wide and flexible plastic pipette tip (fig. 13a). The goal of the treatment was to create a web of consolidant, with the expectation that the epoxy would flow over, around, and hopefully underneath the existing resin (fig. 13b). As with the marble treatment, the use of a free flowing adhesive required damming the edges of the panel prior to its application. To create this barrier, more viscous epoxies were first injected along the edges and allowed to set.

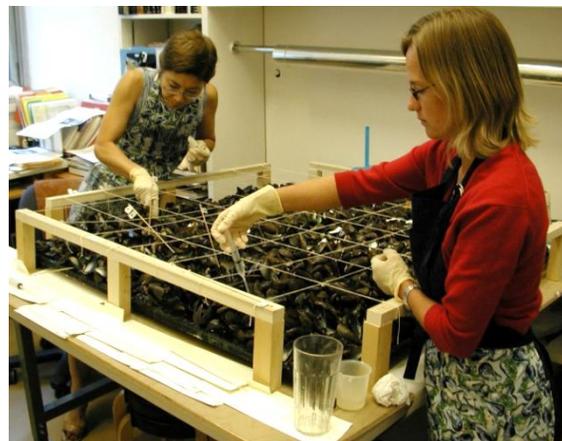
Fig. 13b. Injecting epoxy (Photograph by Katy May)

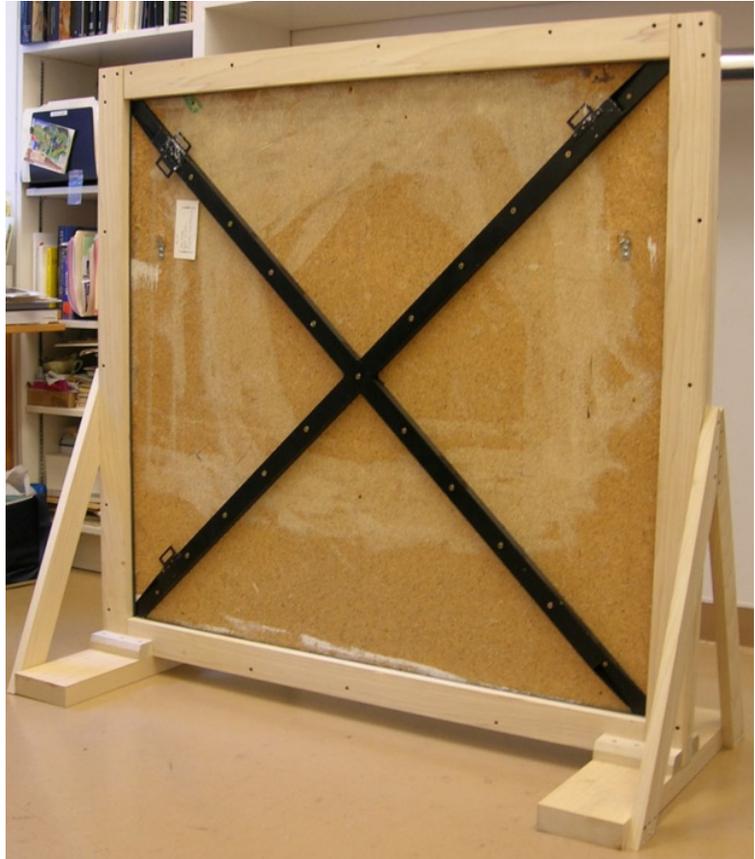
Fig. 16b. Extant aluminum brace on back of *Panneau de Moules* (Photograph by Judy Ozone)

With the front of the work successfully consolidated, the panel was turned upright and placed in a temporary vertical wooden frame to gain access to the reverse (fig. 16a). This was necessary to accomplish three steps: 1) remove the existing inadequate hanging device (small metal rings attached with short screws) and an aluminum X-shaped brace from the back of the particleboard (fig. 16b); 2) consolidate the entire back of the porous particleboard; 3) attach a rigid support that would inhibit flexing and incorporate a new hanging method.

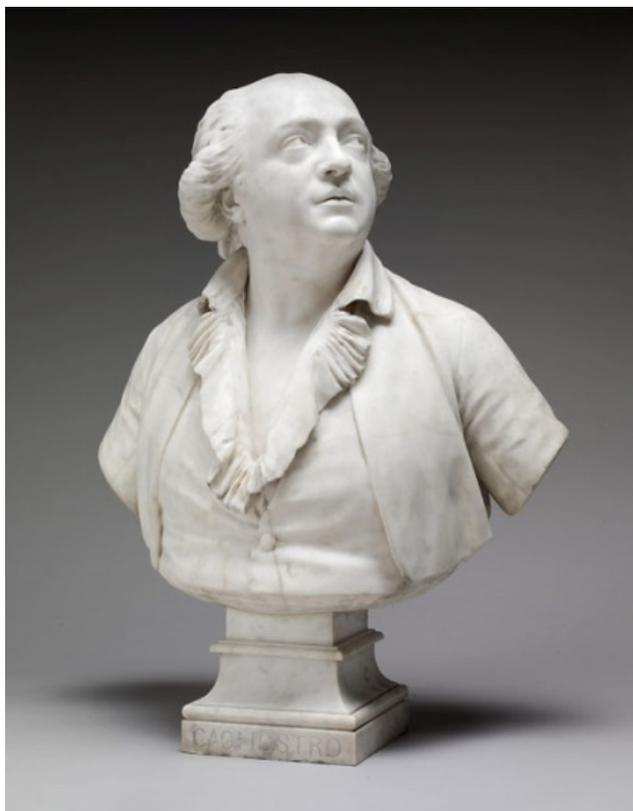
Fig. 20. After Treatment: Jean-Antoine Houdon, *Giuseppe Balsamo, Comte di Cagliostro* (1952.5.103); Collection of the National Gallery of Art. (Photograph by Lee Ewing)

The treatments of two seemingly incongruous works of art were brought together by their like limitations. Having previously tested a wide range of adhesives, adapted various tools, and worked out handling logistics for the marble treatment, the authors were able to apply much of the same methodology in the treatment of the composite mussel panel, executed more than a year later. These extensive though ultimately successful treatments made it possible to install two works that otherwise would have been considered too fragile or disfigured to be exhibited (figs. 20 and 21).

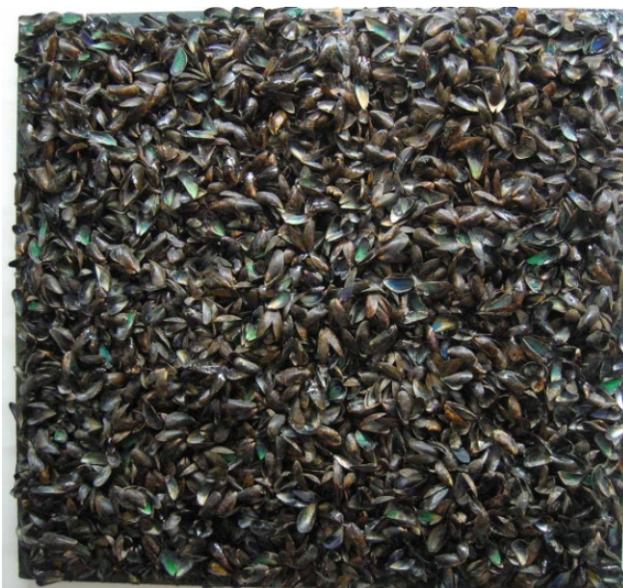
Fig. 21. After treatment: Marcel Broodthaers, *Panneau de Moules* (2005.36.1); Collection of the National Gallery of Art. (Photograph by Lee Ewing)
