# **An Extreme Case of Byne's Efflorescence:** A Novel, Two-Pronged Approach to Consolidation Claire Curran and Bruno Pouliot

Society for the Preservation of Natural History Collections Annual Meeting, Gainesville FL • May 2015 American Institute for Conservation 43rd Annual Meeting • Miami, Florida • May 2015

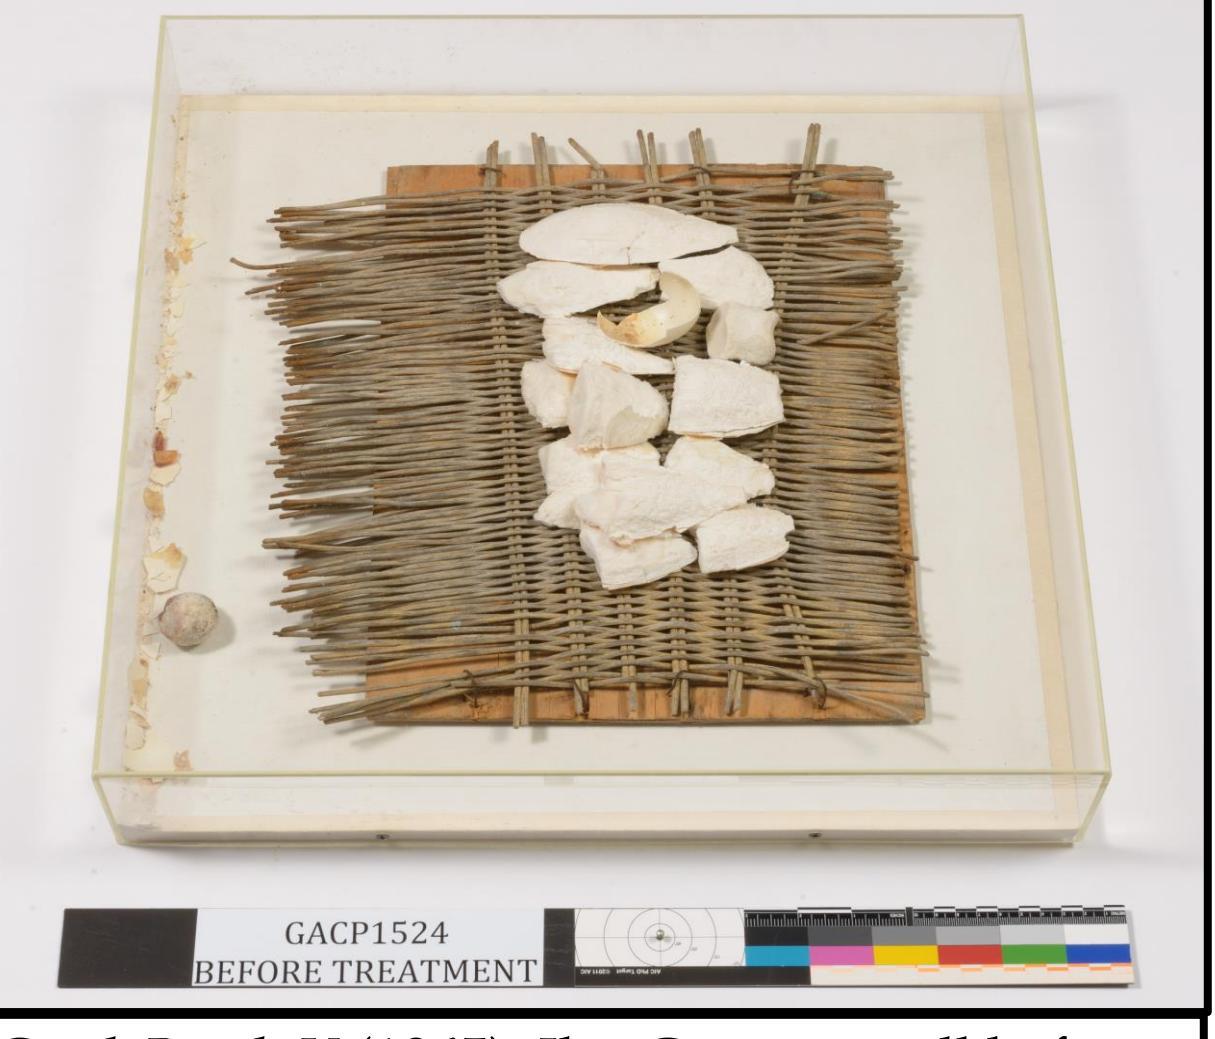
*Greek Beach V* (1965), Ilse Getz, overall before treatment in Plexiglas display case.

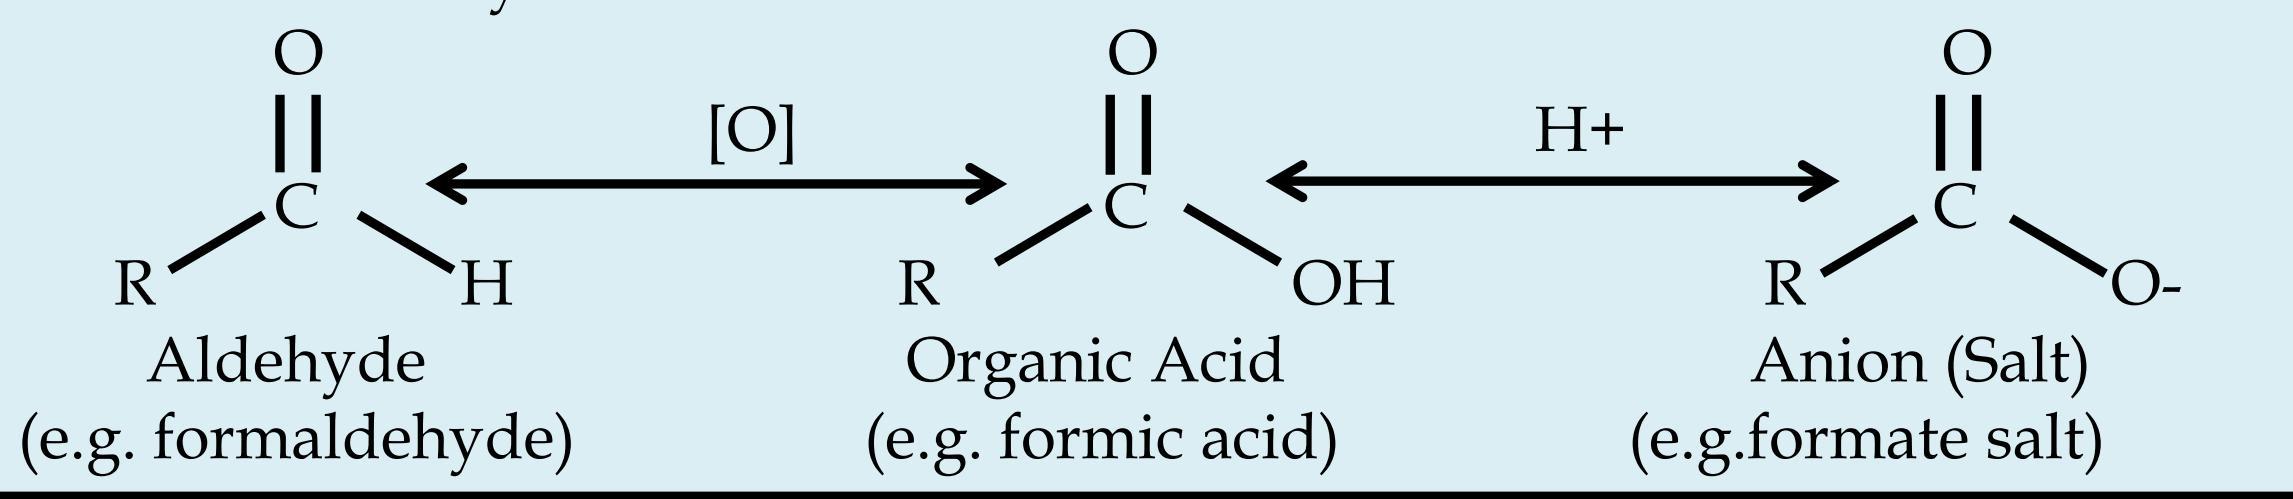
Byne's efflorescence (also called Bynesian decay or Byne's disease) occurs when organic carbonyl pollutants attack shells. This typically happens when shells are stored in poor quality wooden cabinets that off-gas formaldehyde and other organic acids such as acetic acid. Especially when moisture is present, these react with the calcium carbonate composing the shell to form watersoluble salts. While appearing at first as a whitish film on the shell, as the reaction continues the accumulation of efflorescence can lead to complete disintegration of the shell. The reaction mechanism from formaldehyde to a salt is indicated below.

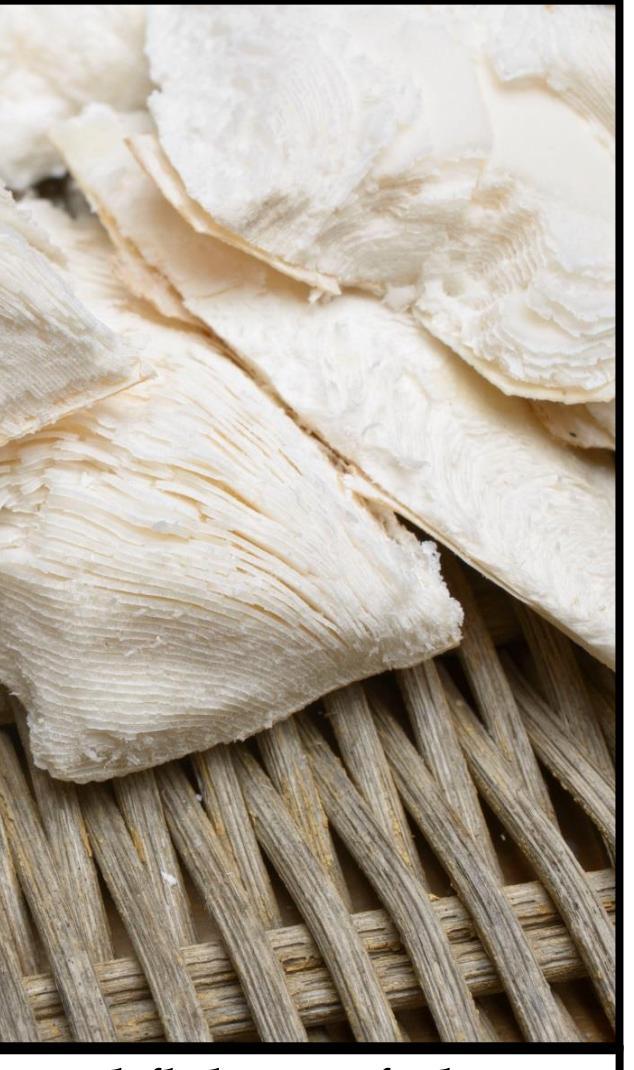
Detail showing active delamination and flaking of the cuttlebones; minute powdery losses were everywhere.

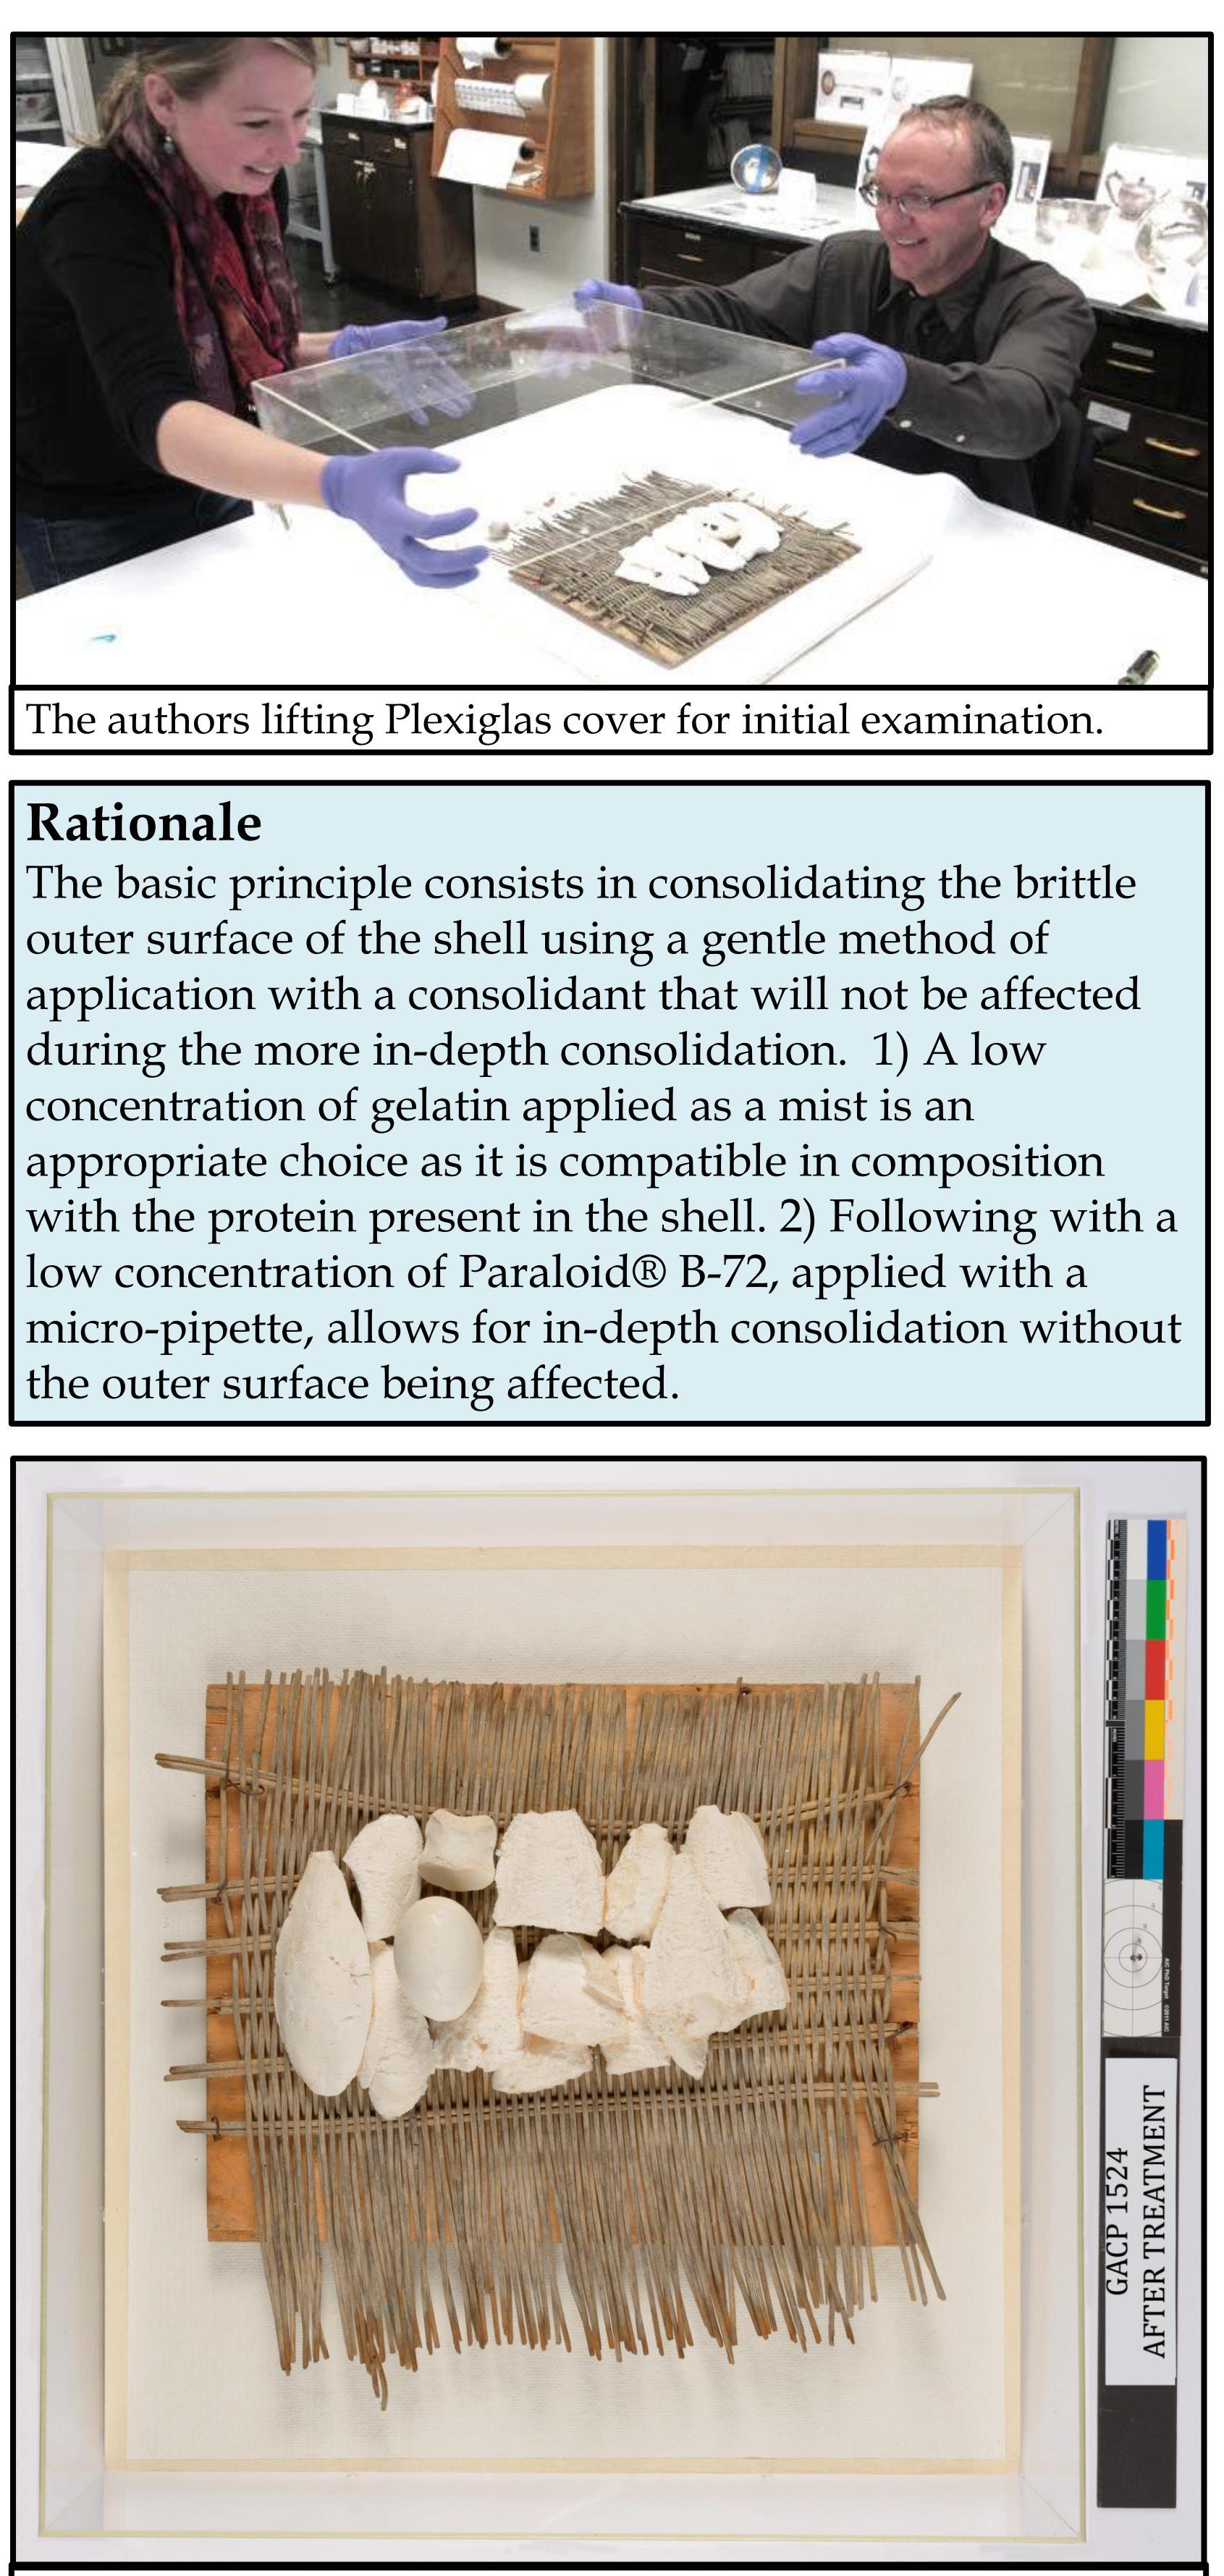
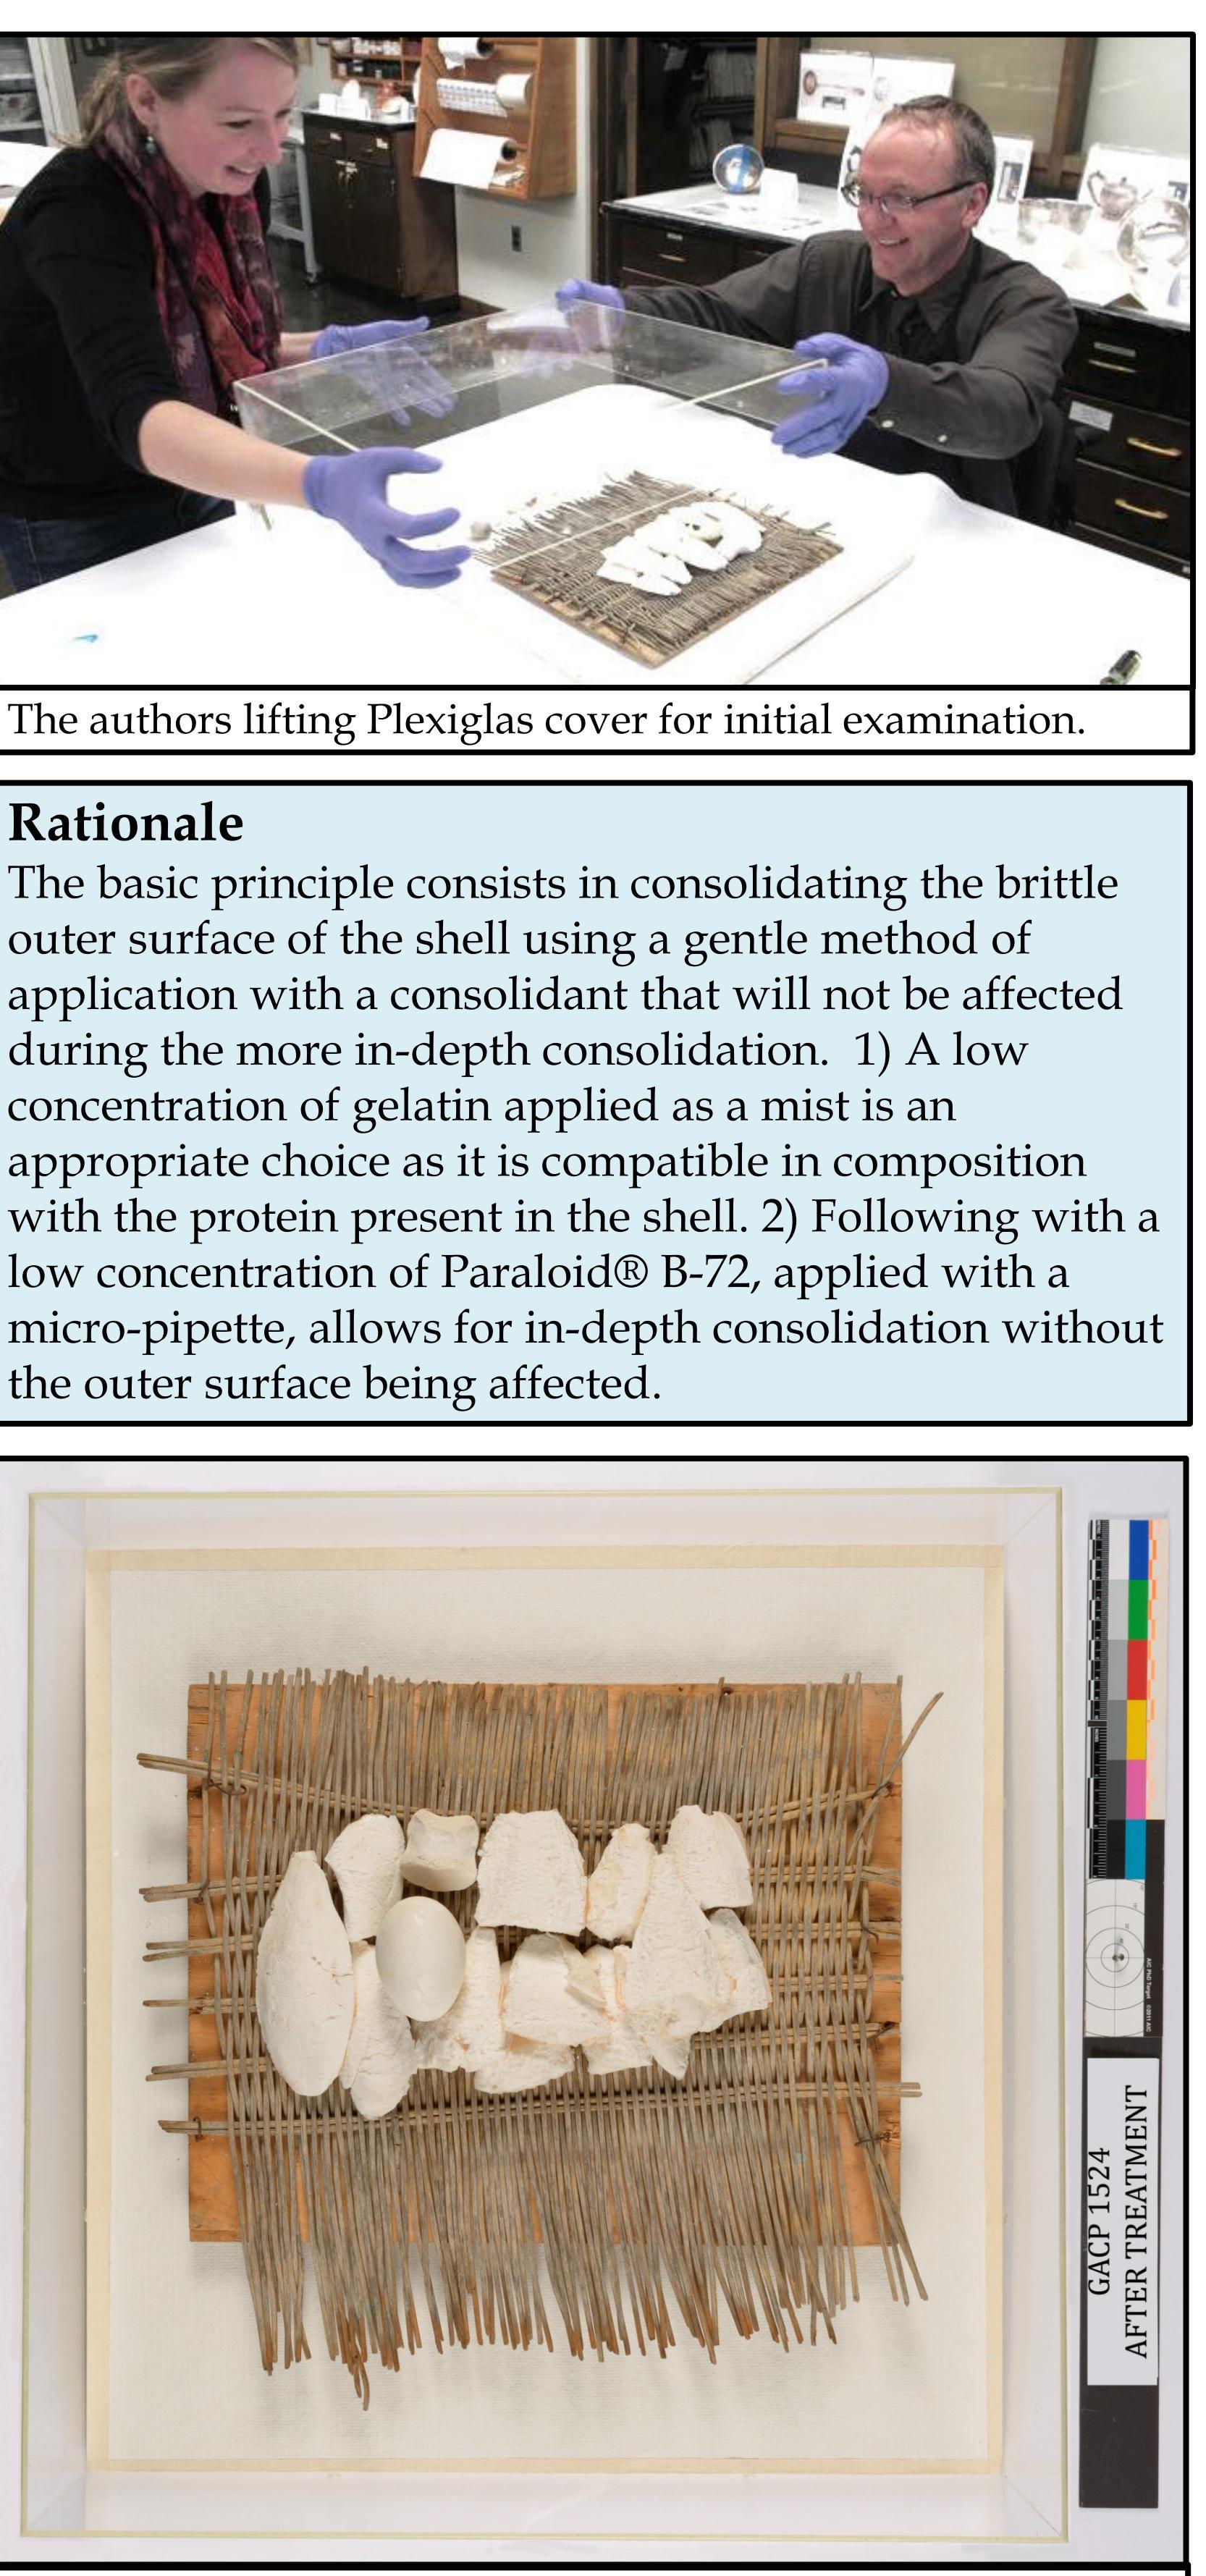
*Greek Beach V* (1965), Ilse Getz, overall after treatment. Note

how eggshell was also reassembled as part of this project.
