Flags and pigments:

the conservation treatment and the analysis of two flags from Costa Rica, 1921.

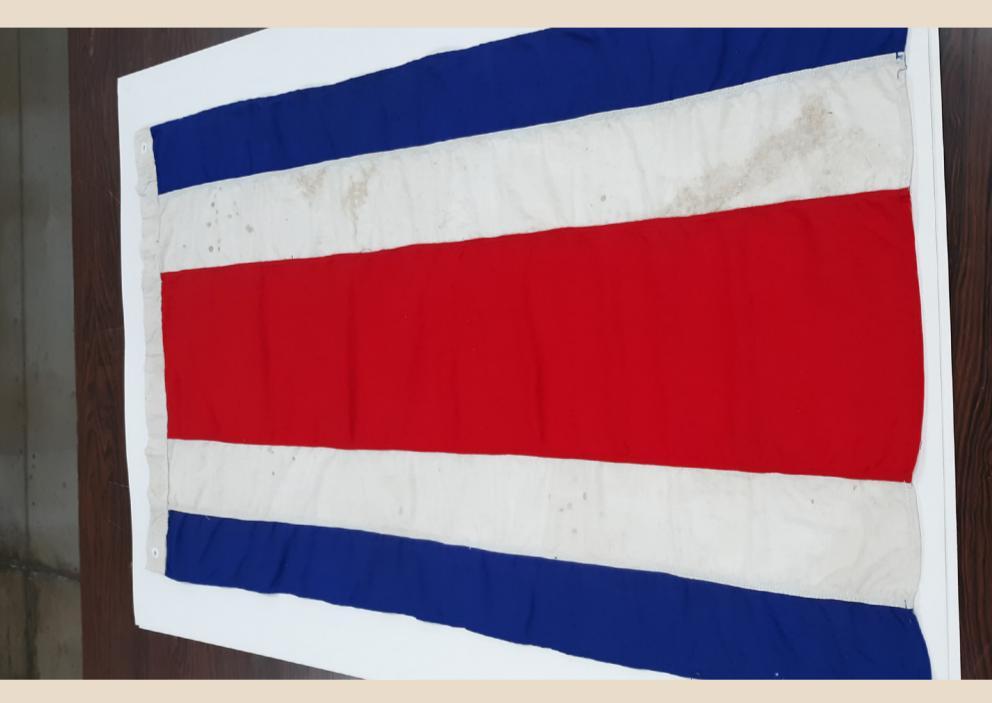
Final result

The treatment was successful – the objects are now clean and stable.

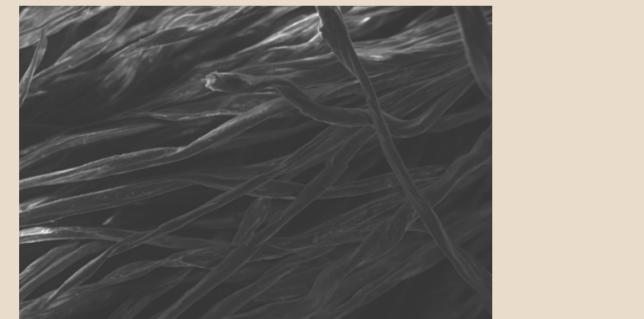
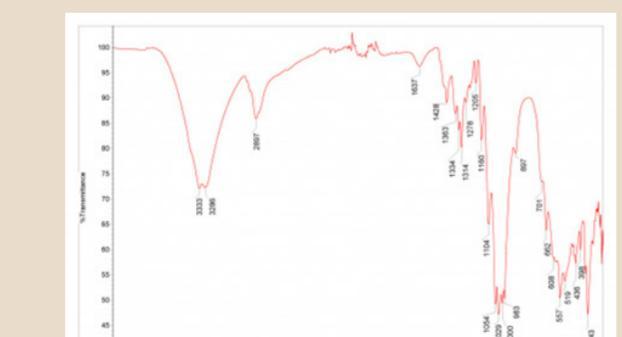
FTIR and RAMAN spectroscopy- showed a spectrum that matches cellulose (either cotton or linen). Cotton was confirmed with SEM images that provided data on morphology.

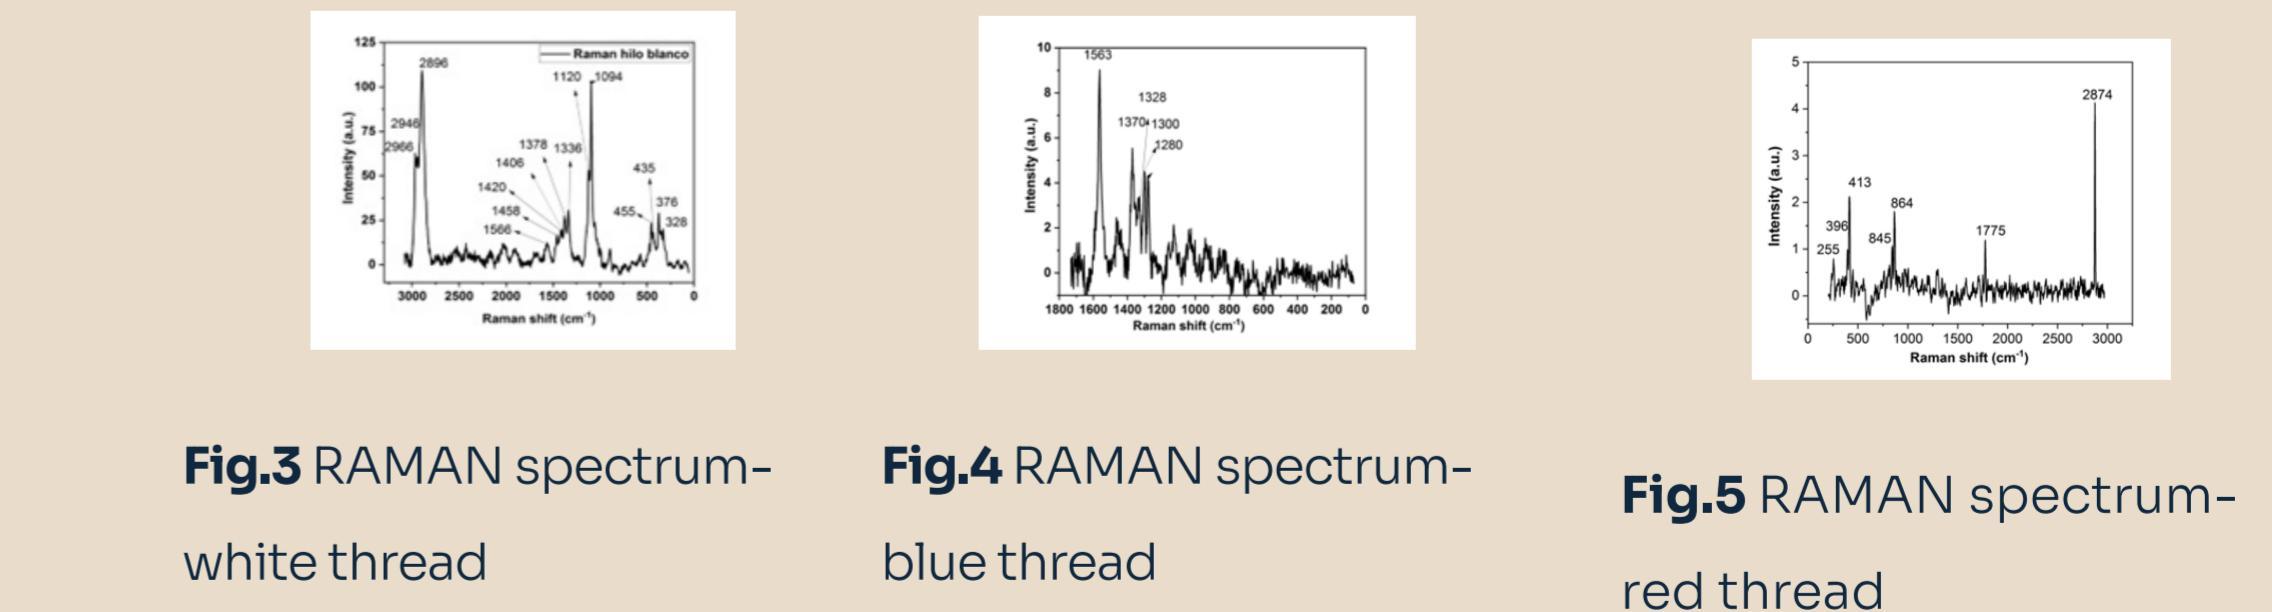
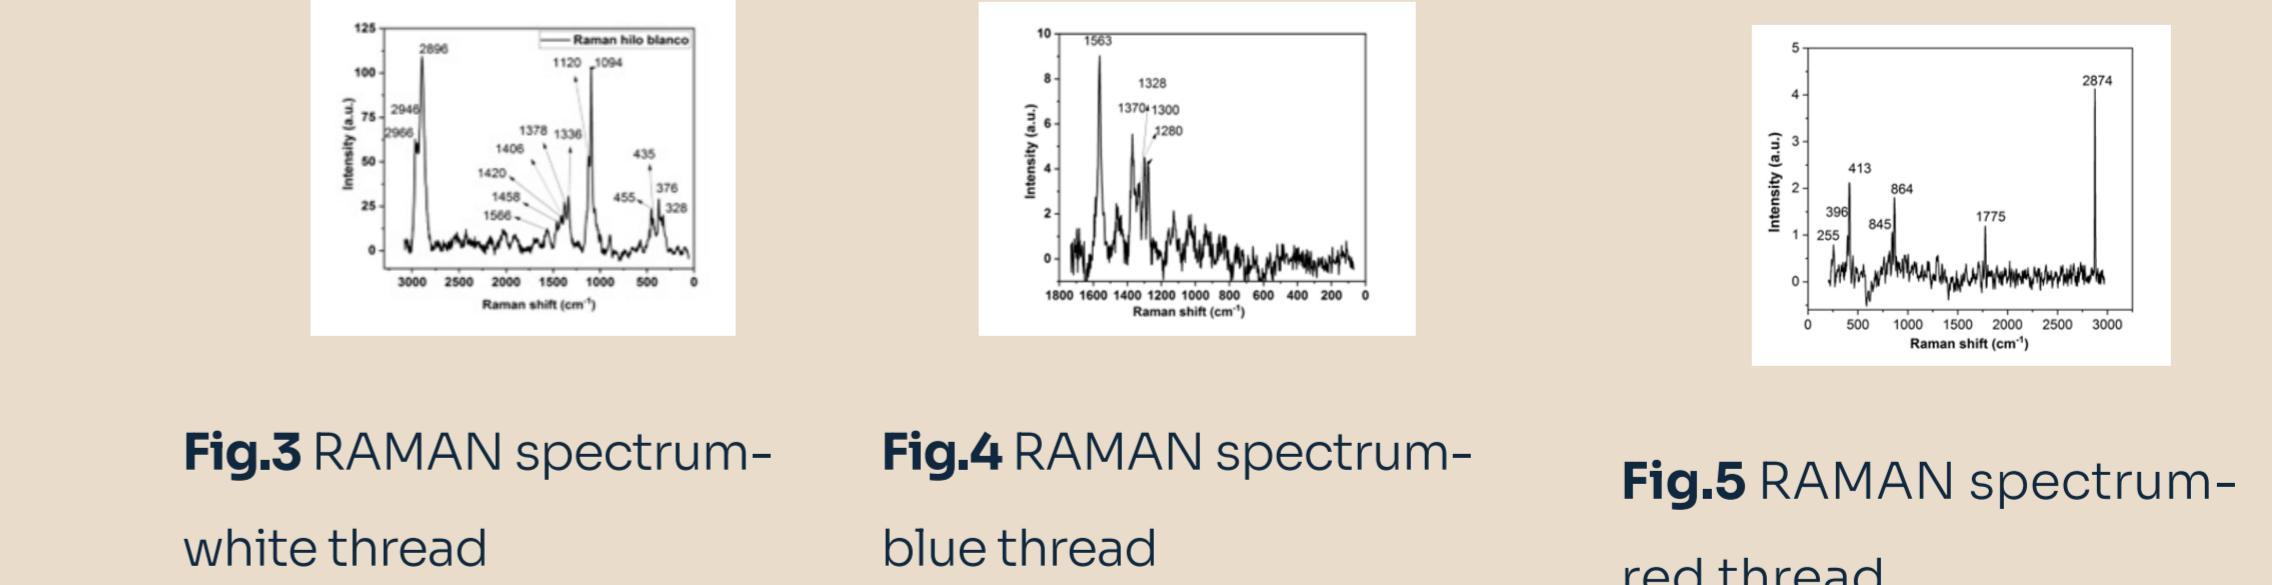
Fig2. SEM from blue Fiber and FTIR cellulose spectrum

Blue: could be compared with indigo.
