Postprints 2008

WOODEN ARTIFACTS GROUP

Presented at the 36th Annual Meeting of the American Institute for Conservation Denver, Colorado

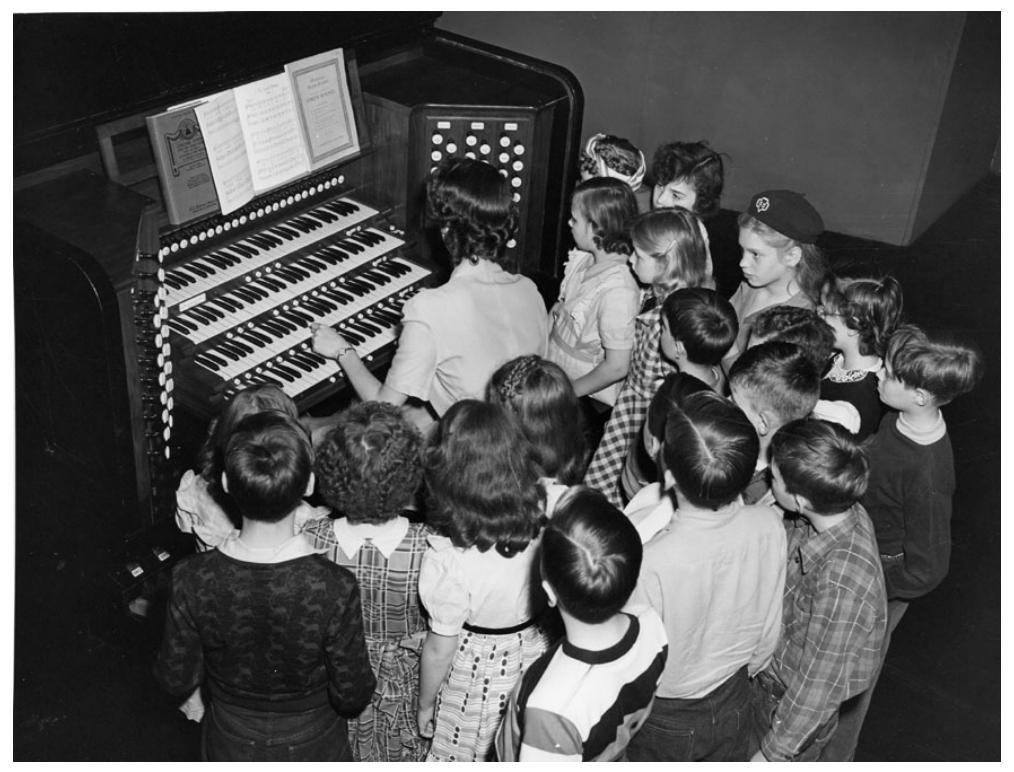
Figure 2. The organ console.

The console is the brain of the organ and is located on a moveable dolly to be rolled on and off stage. (fig. 2). It is truly a computer. This one has four keyboards, called manuals, plus the pedals, which are in effect

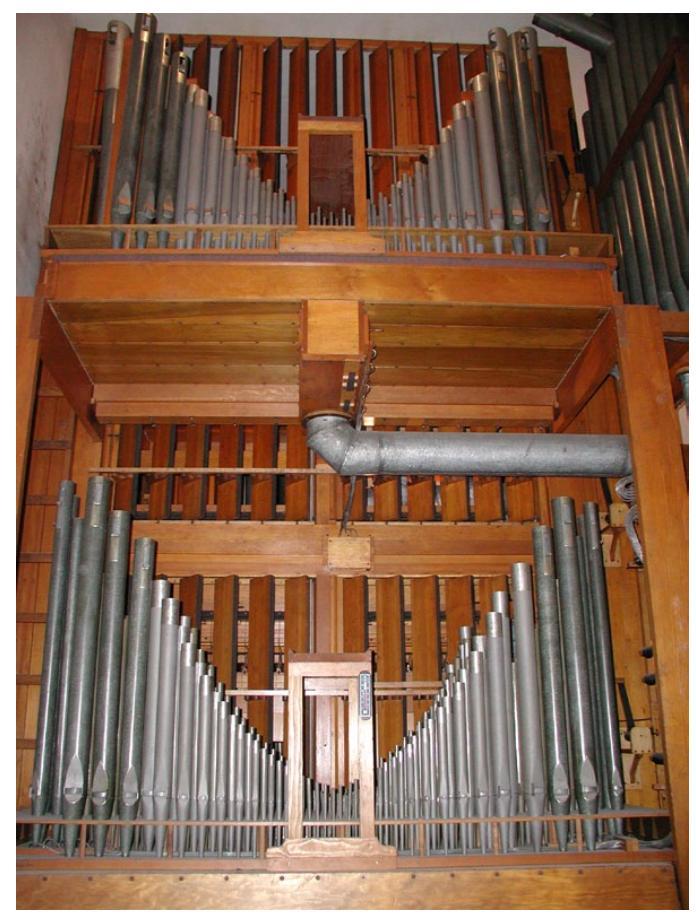
Figure 4. Chamber detail with pipes.

The Opus 603 was left in a state of benign neglect until 2002, when the museum applied for and received a grant from The Joseph G. Bradley Foundation with matching support from Toledo benefactors to restore it.² Benign neglect in this instance was beneficial in that it was not subjected to the modernization which befell many organs. The organ restoration firm A. Thompson-Allen Company was selected. Actual work had already begun by the time the museum's first full-time staff conservator arrived in 2003. The conservator was placed in charge of the project after Nick Thompson Allen and Joe Dzeda, partners of the A. Thompson Allen Company had already dismantled one of the organ chambers containing over 1,200 pipes. (Fig. 6, compare with fig. 4 before pipes were removed).

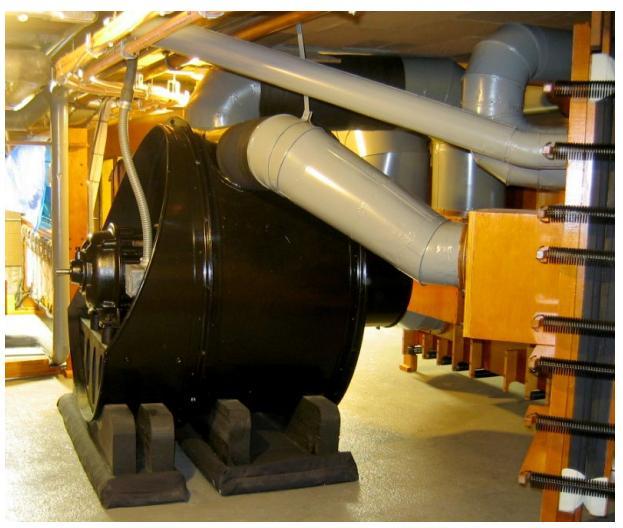
Figure 5. The blower motor.

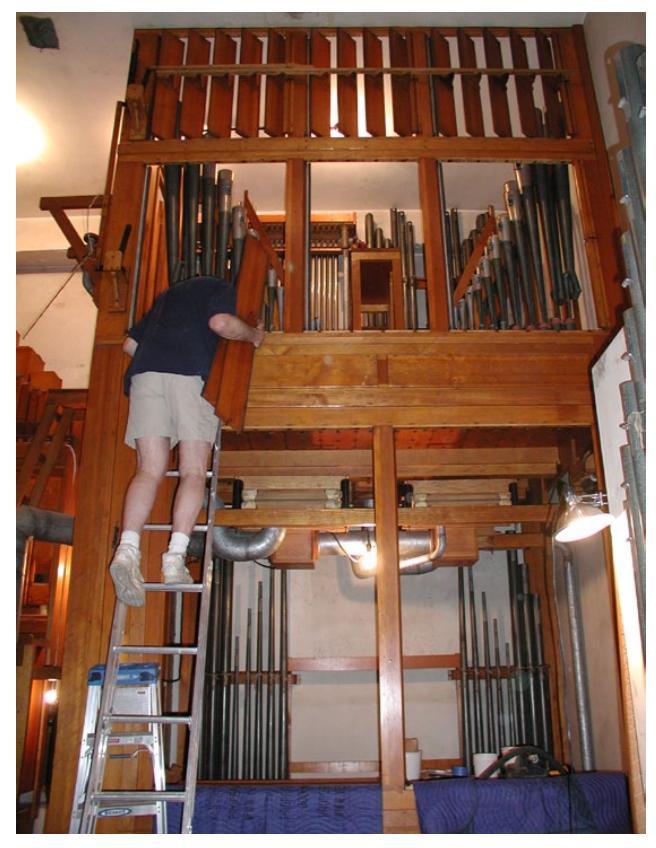
Figure 6. Pipes being removed from chamber (see fig. 4).

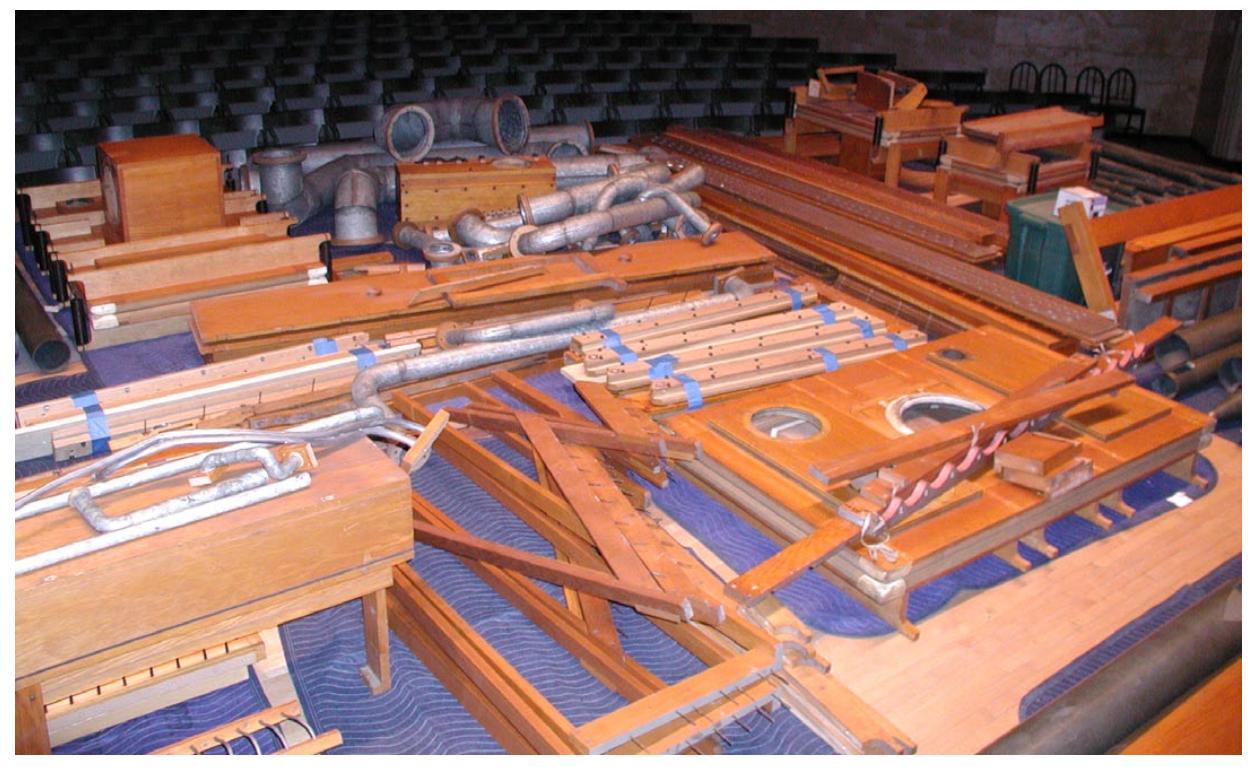
Figure 7. Disassembled chamber on Peristyle stage before packing.

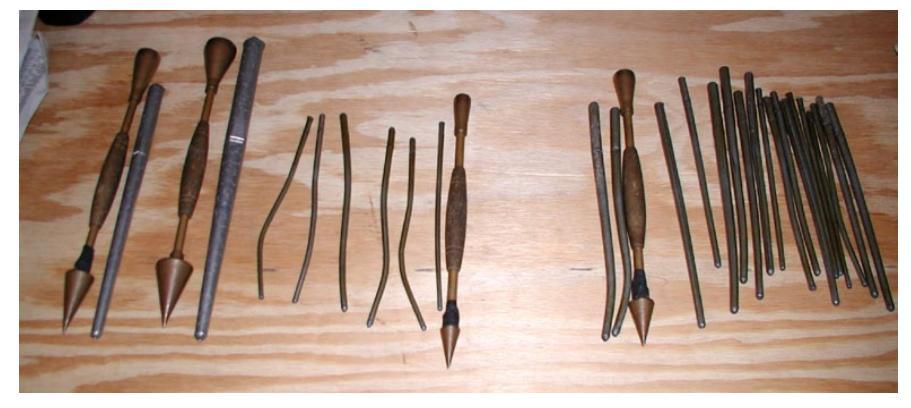
Figure 8. Tuning cones with bent pipes.

Wood pipes and surfaces were given a fresh padded on coat of shellac. In New Haven, Conn. other components such as the deteriorated leather had to be replaced with new similar leather to insure an airtight fit. Damaged metal pipes from prior overzealous tuning had to be repaired. Traditionally, tuning was done using tools called tuning cones. (fig. 8). One end of the tool is conical, the other end concave. Pipes were tuned by hammering the top of metal pipes to make it either wider or narrower to alter the pitch. The pipes were torn or

bent in the process. Treatment involved straightening pipes where possible, or repairing/replacing damaged sections. In other instances metal pipe mouths contain metal rolls like a sardine tin where the mouth is rolled or unrolled to tune which can result in tears. For the Opus 603, all the original pipes were retained and repaired and voiced to render them functional.

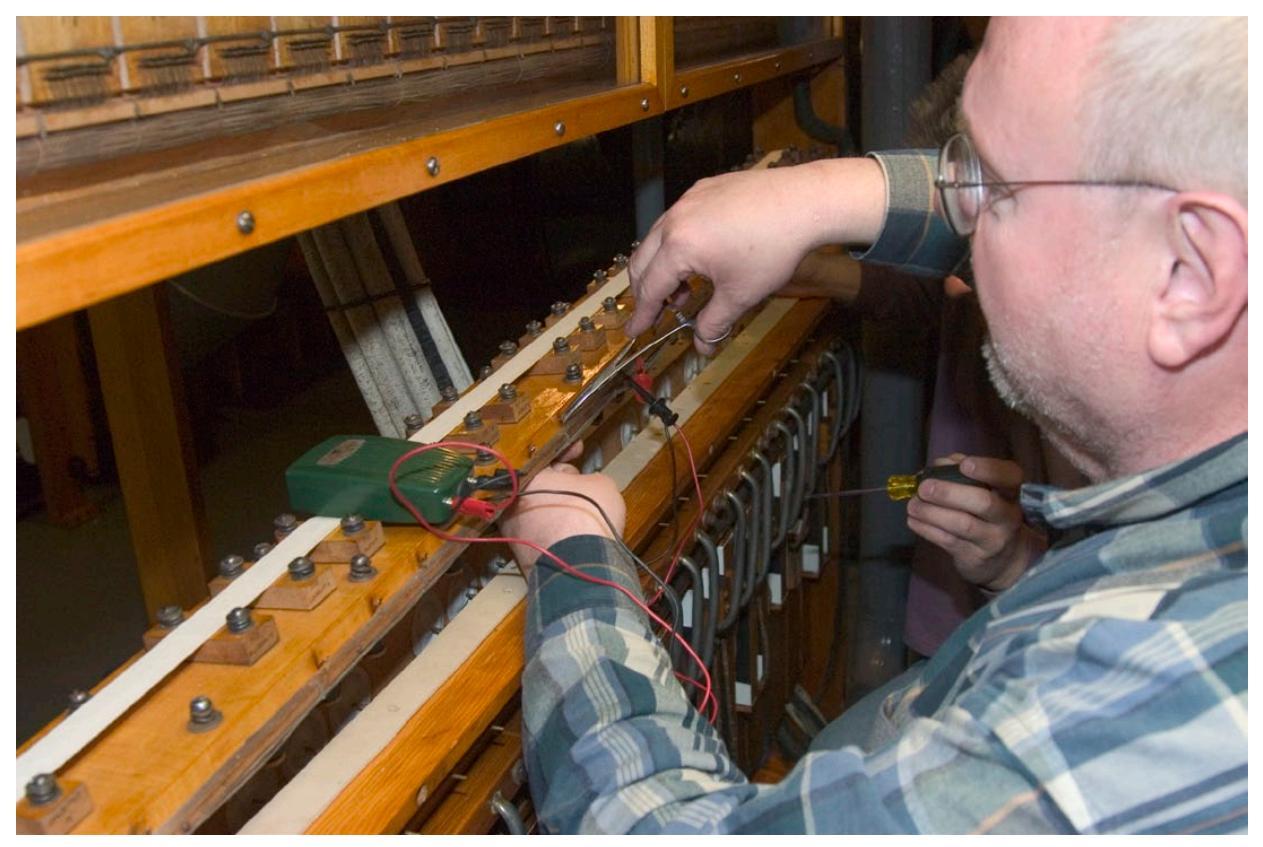
Figure 9. Testing relay wiring

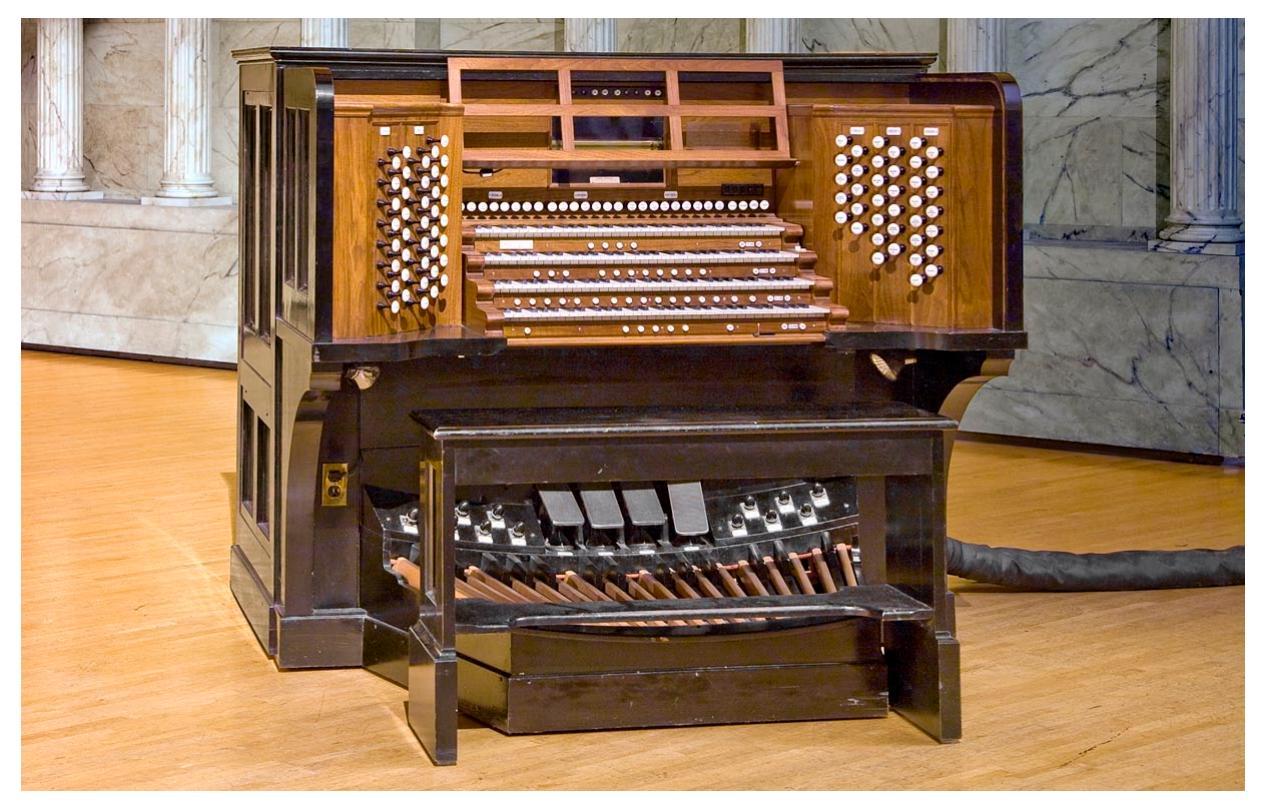
Figure 10. Organ console after treatment.

return visit, A. Thompson Allen Co. staff cleaned, patched and repainted the organ spaces. Below stage, the severed wind line and electrical cable were refabricated and reconnected. In the motor room the blower motor was removed and rebuilt. The electric starter had to be replaced to meet building code since it was a fire hazard. A waterdamaged area by the relays was plumbed to drain a seasonally damp corner and a water alarm was added. An unforeseen circumstance was the extent of corrosion caused by water damage to relay wiring for the roll playing mechanism. Thousands of relay wires had to be reconnected by an organ specialist. (fig. 9) Each wire had to be circuit tested to find the correct location, as no wiring diagrams existed. The organ console had been painted black, a departure from the varnished quarter sawn oak typically visible in Skinner organs. Photos indicated the paint was most likely applied early in the organ's history to make it "concert black" to match symphony equipment. The conservator/ project manager decided not to have it removed.

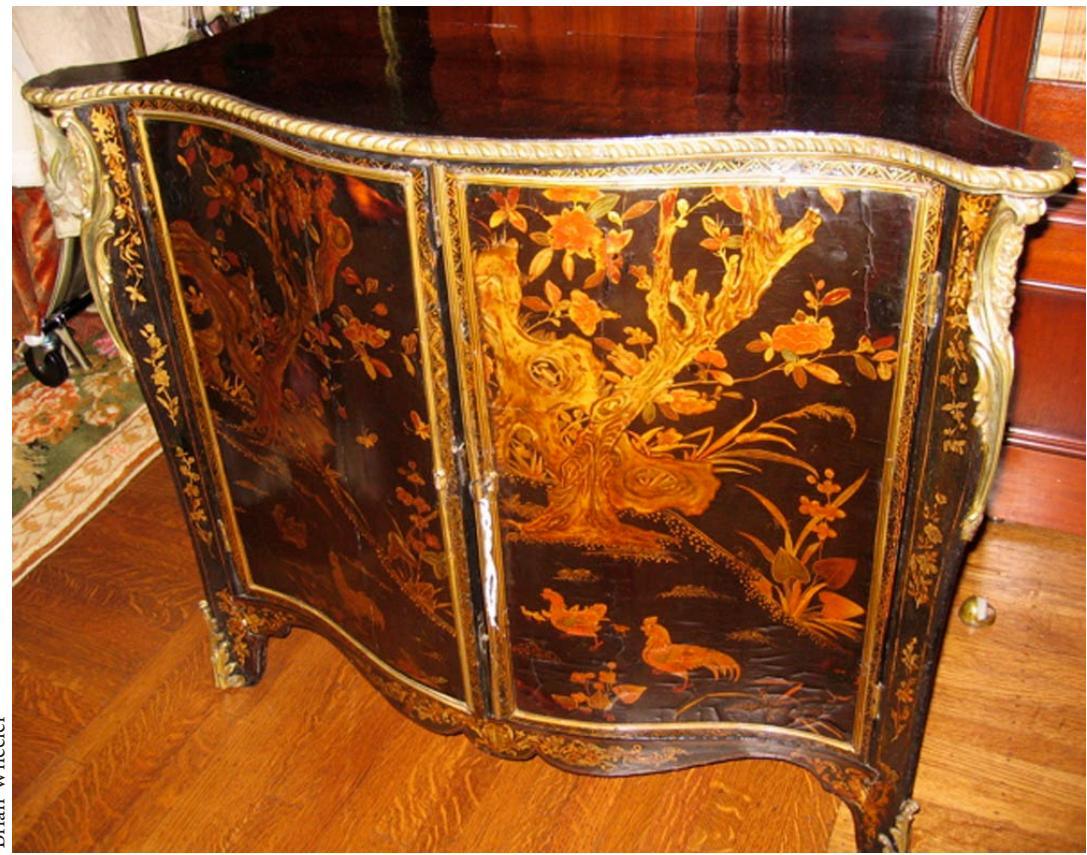
Figure 1. Commode 1986-42, before treatment.

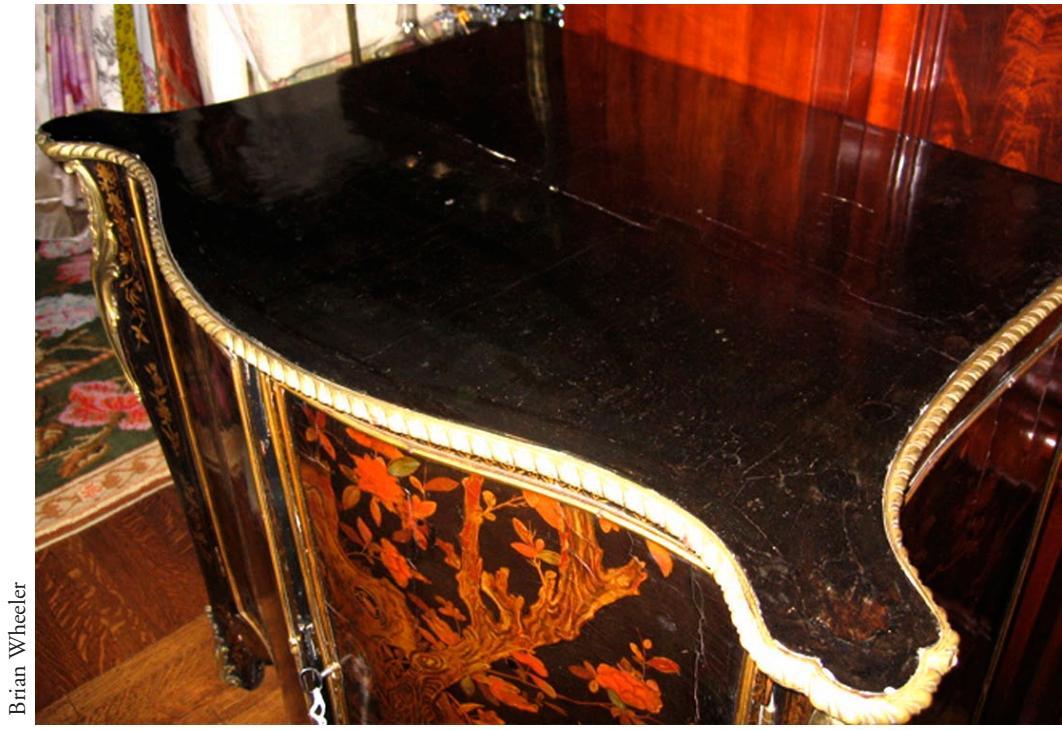
Figure 2. Commode 1986-42, top before treatment.

• There was no evidence of any fragments of the original design underneath the top layer, which consisted of black varnish mixed with brass or bronze powder. The surface was badly cracked and abraded.

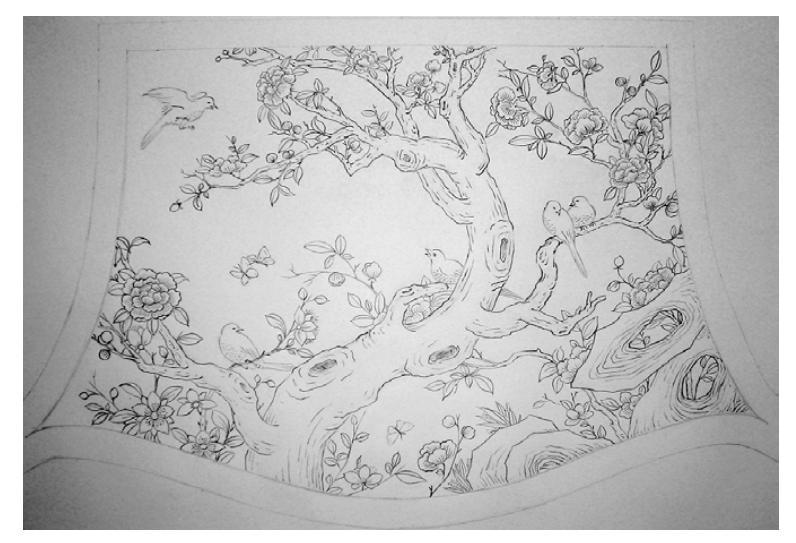
Figure 4. Design for the top of commode 1986-42.

Prior to any treatment both commodes were studied to gain a deeper understanding of the original decoration's "vocabulary." This stage involved producing design probes, study of various motifs and color composition, and sketches, which resulted in an initial half scale drawing for the top of commode. This drawing was submitted to the owner's curator for feedback and served as a guide in creating the lacquer top. (fig. 4) Following completion

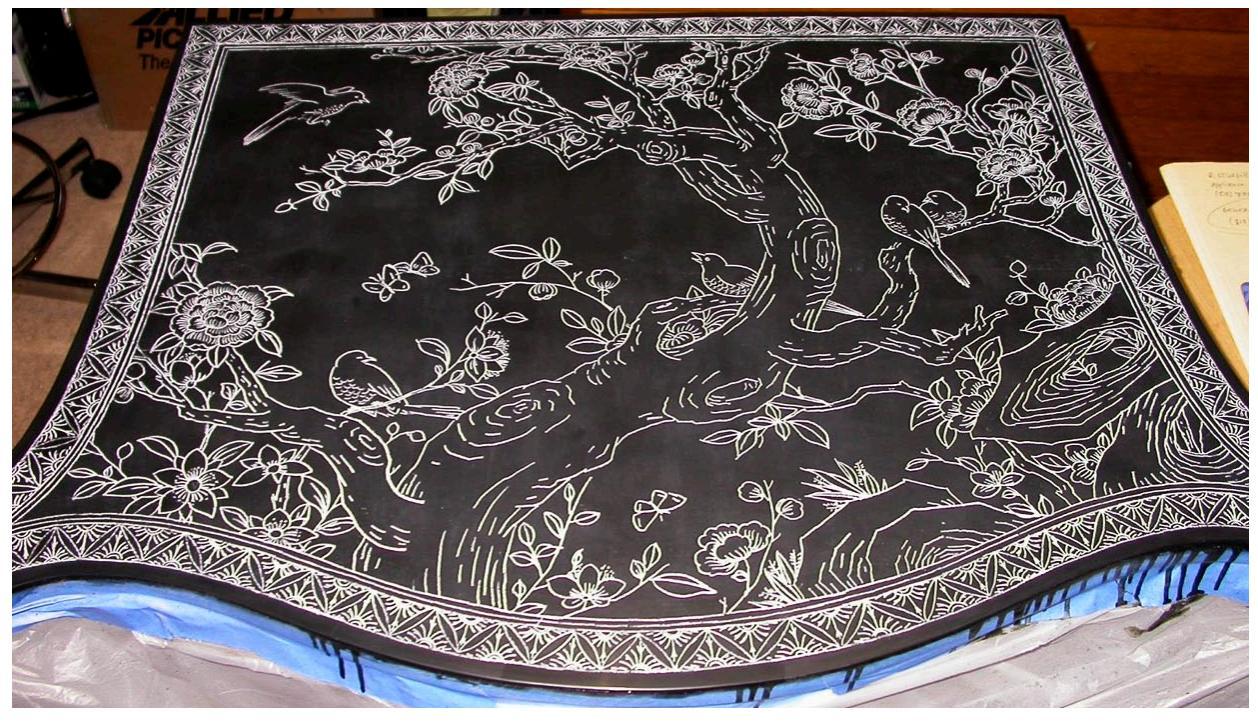
Figure 6. Commode 1986-42, design transfer completed.

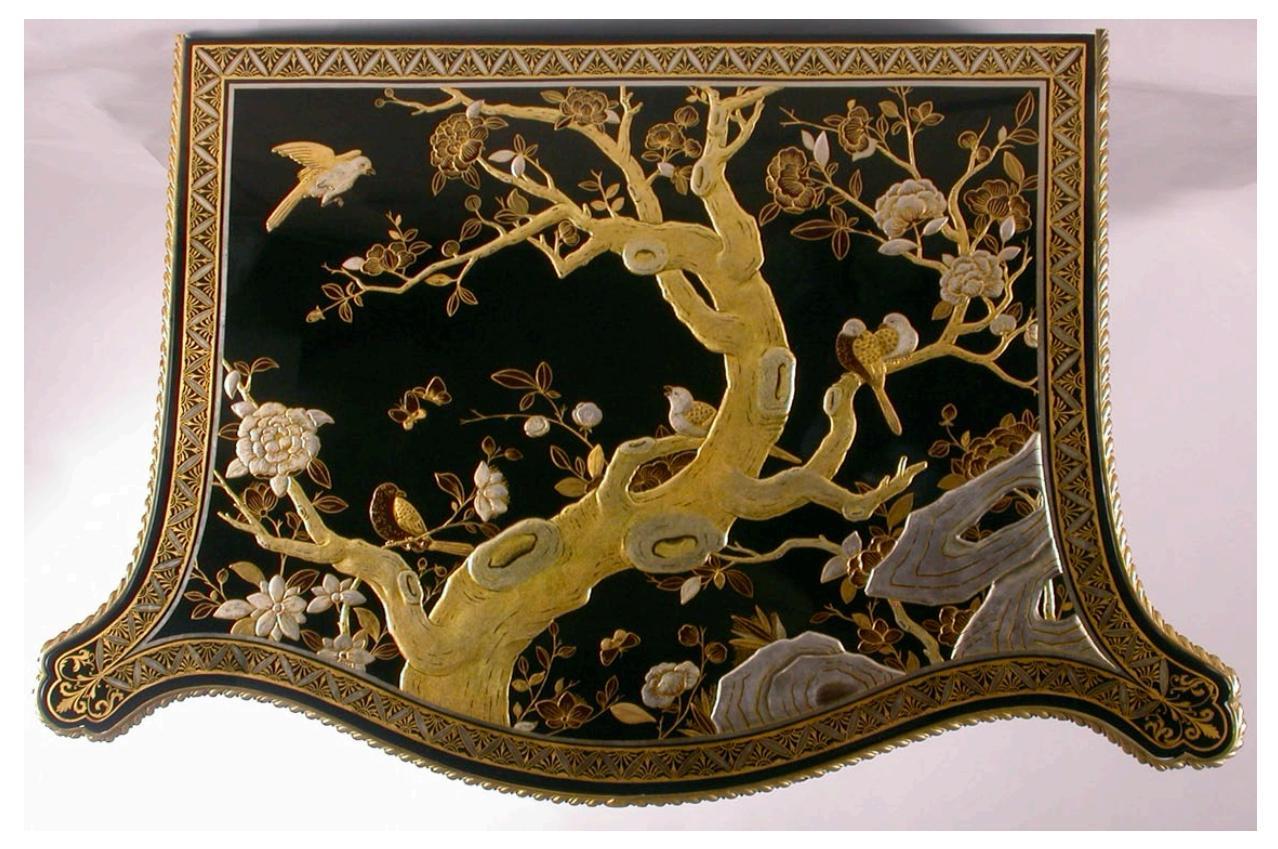
Figure 7. Commode 1986-42, top after treatment.

Gilding: The gilding and silvering (with Palladium leaf) was done with oil size, and the process involved various steps. In order to create a vibrant Japanning, different colors and types of gold were used in the design. While pale gold was used as a base on tree trunks and branches, dark gold was used on most of the foliage. Palladium leaf was used on some of the flowers and on areas representing Chinese scholar rocks. Some elements, such as the foliage, were gilded in a variety of ways and in different steps; in some cases, first the entire leaf received gold and, second, veins were painted on top. Others received a gilded outline and gilded veins, keeping the red base color exposed. Chinese scholar rocks were enriched with fine, custommade palladium powder, and received highlights and shadows added with gold leaf and black paint. This powder was made by putting palladium leaves in a glass container filled with ethanol and placing in a small ultrasonic cleaning tank; after several hours of immersion the ultrasonic action disintegrated the leaves to powder.

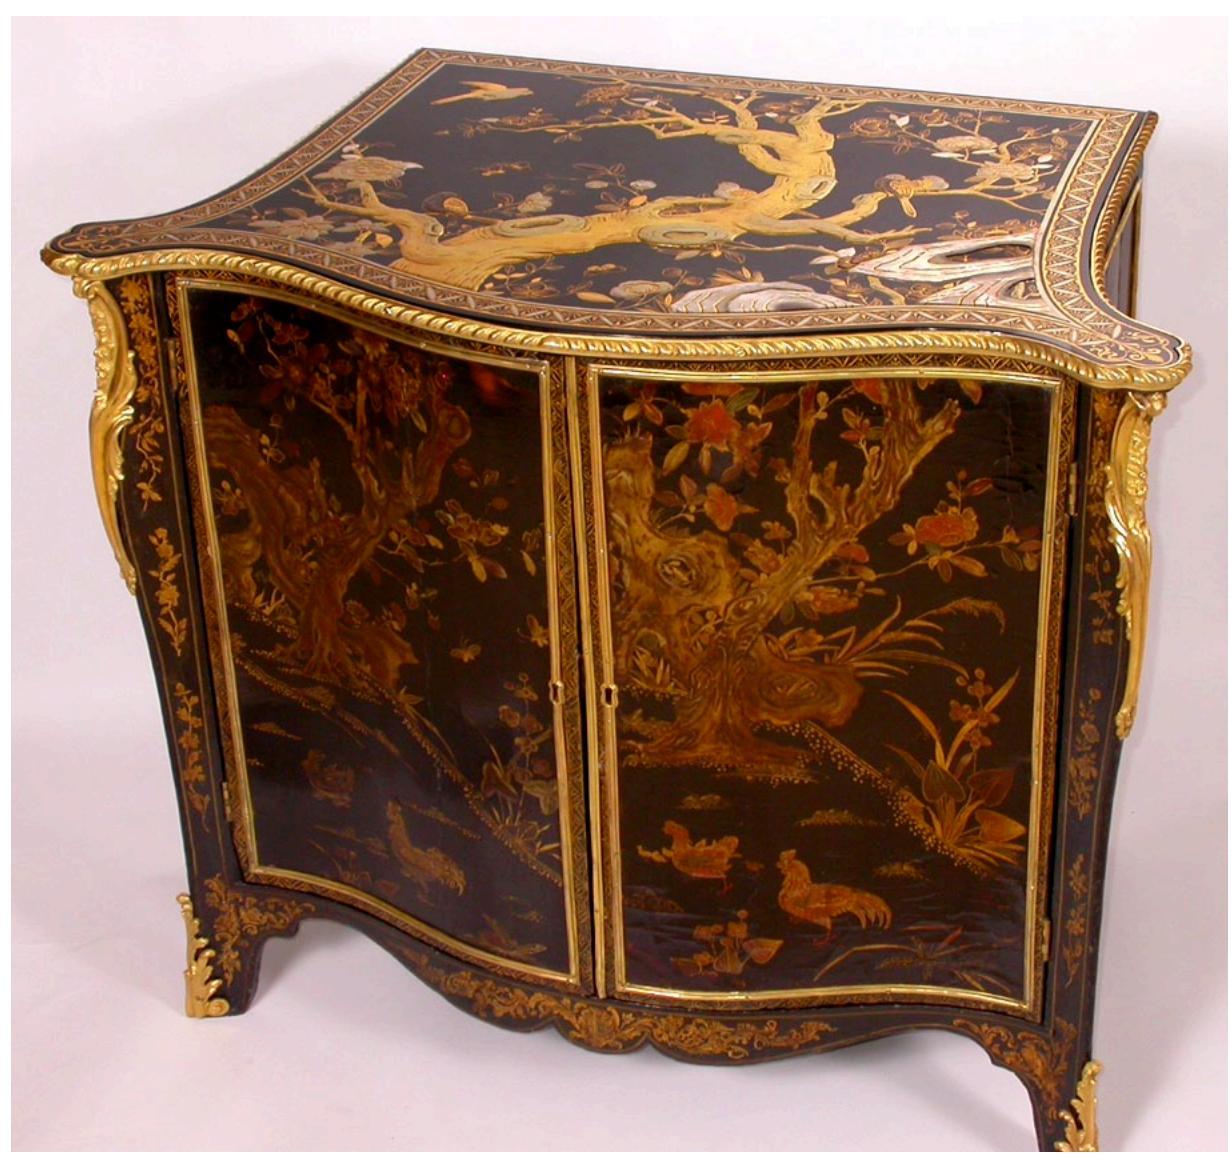
Figure 10. Commode 1986-42, after treatment.

The bronze mounts: After the bronze mounts had been removed, they were shipped to Mr. Deville in Paris for repair and re-gilding. They were repaired and fire gilt so that they would match the mounts on commode '05. Mr. Deville also cast two handles for the newly fabricated bottom drawer. The handles were toned with Orasol dyes in shellac to match the original handles on both commodes. (fig. 10)

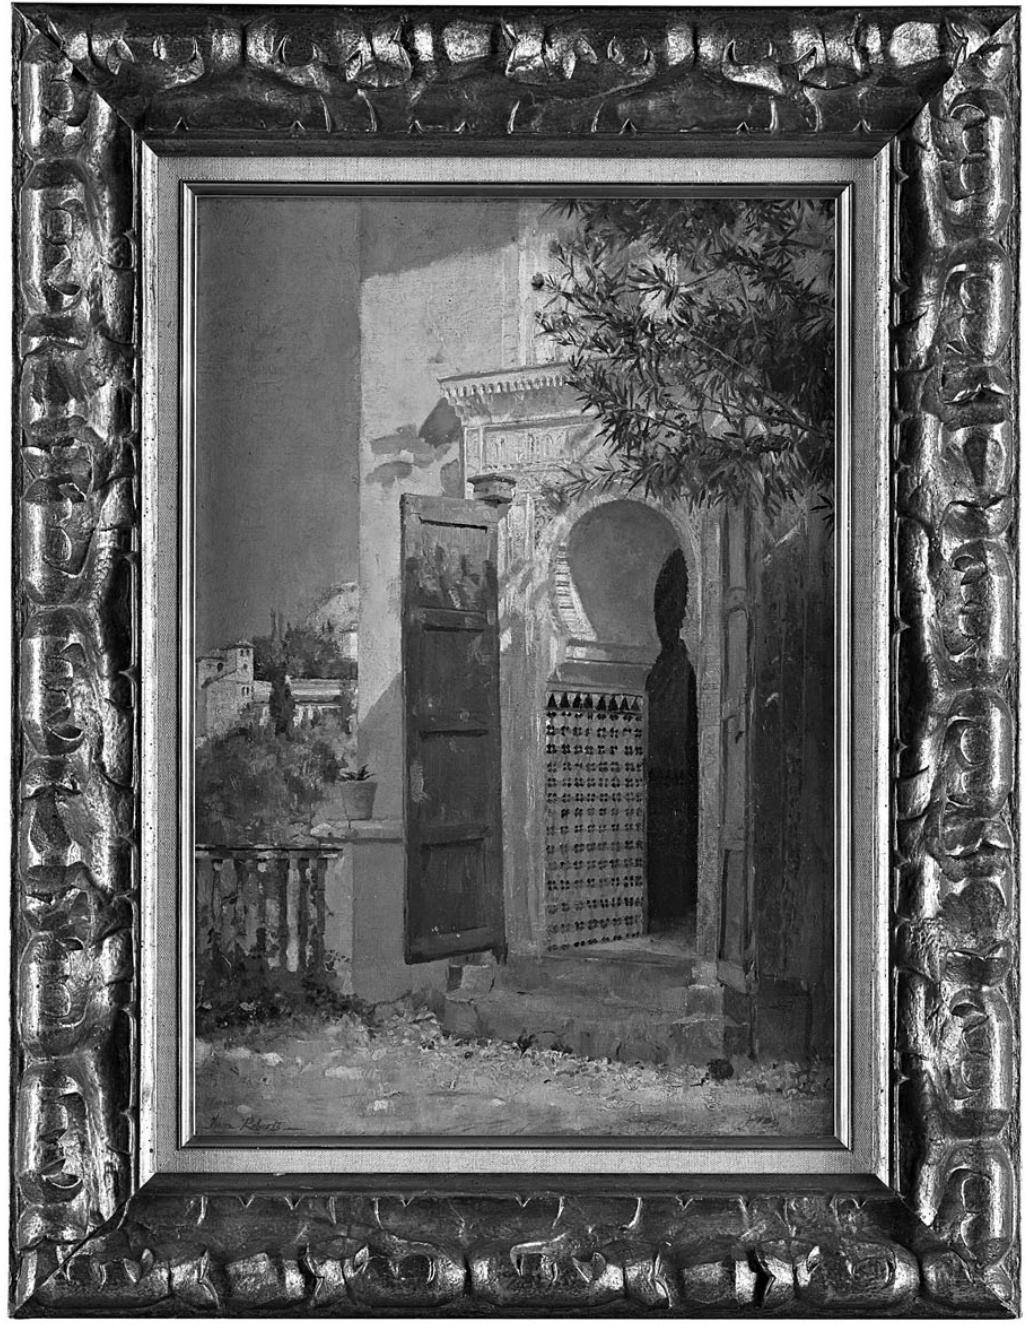
Figure 1. The commercial frame on *A Moorish Doorway*, a modern re-framing that aims to reflect the Spanish theme of the work.

A Moorish Doorway came into the NGV collection in 2004 through the generous bequest of Dr. Joseph Brown, as part of some 150 works that comprise the Joseph Brown Collection. As is sometimes the case with private collections, many of the original or period frames in the Joseph Brown collection were replaced and housed in late 20th century style frames reflecting the age of the collection rather than individual artworks. More particularly, *A Moorish Doorway* was housed in a schlag metal, commercial moulding with linen slip (fig. 1).

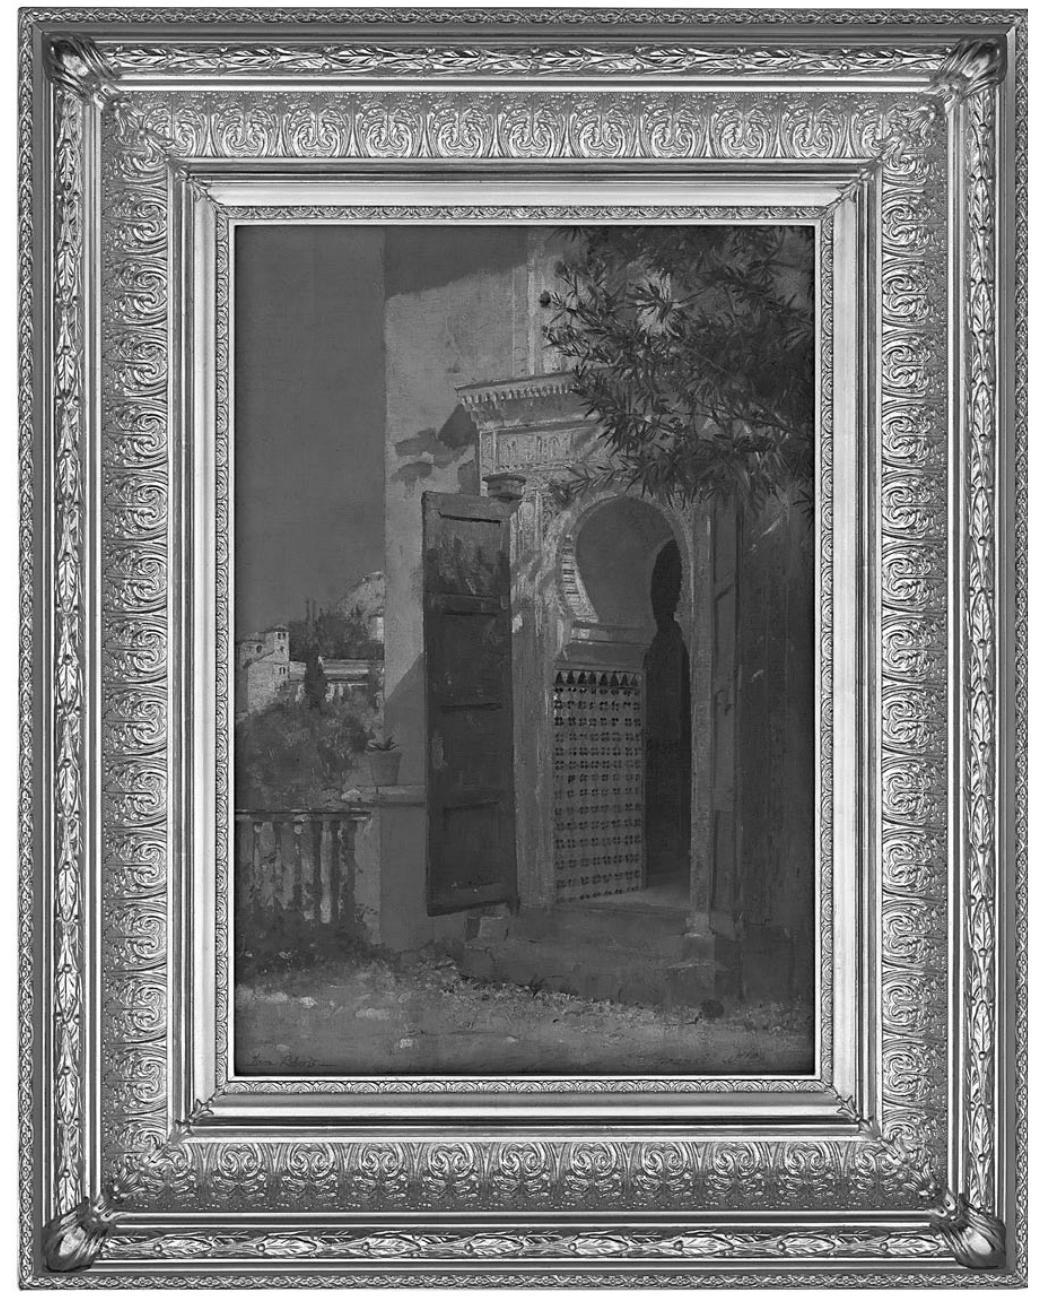
Figure 2. A Moorish Doorway following re-framing with a Thallon prototype based on Roberts' Una Muchacha.

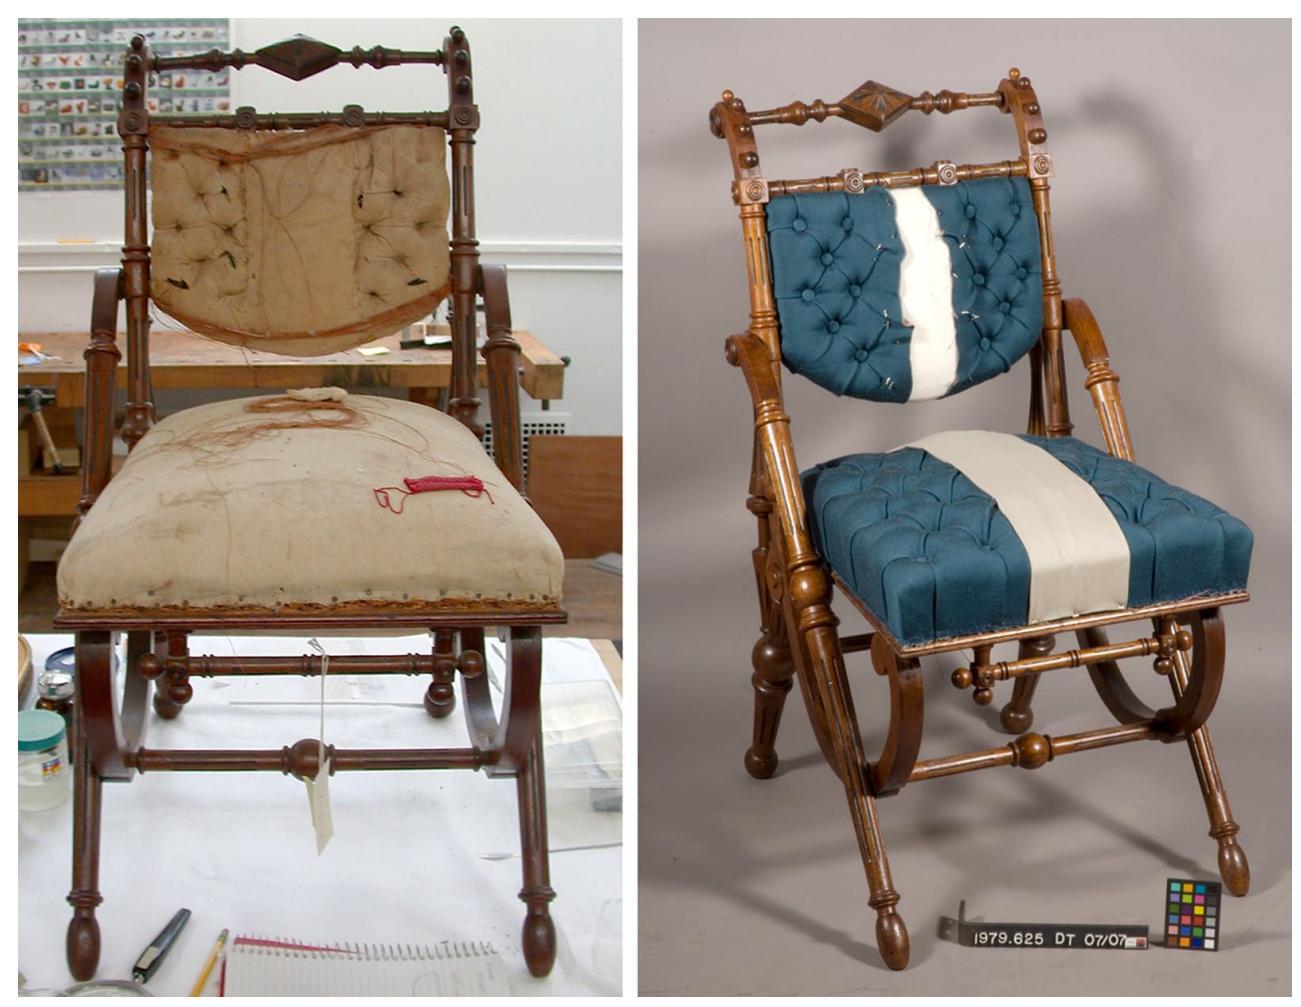
Figure 1. Chair designed by Hunzinger ca. 1860 (MFA 1979.625). Condition as received by the MFA in 1979 with the original back underupholstery, the seat materials are all 20th century. Image on the right shows the chair with the new removable buttoned seat and reproduction showcover (the embroidered vertical panels and trims will be added to complete the treatment).

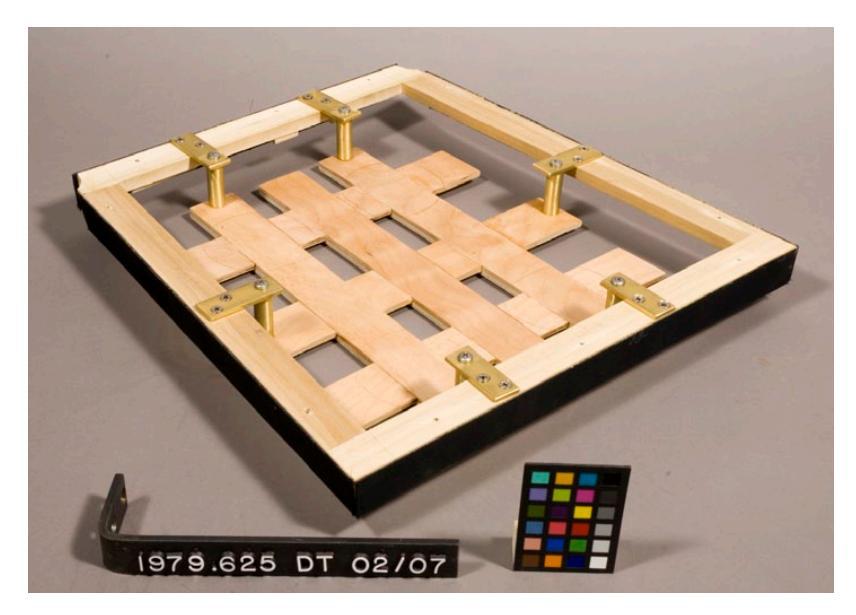
Figure 2. Removable system with plywood lattice "webbing" to support the seat springs and a poplar frame to sit onto the chair rails with muslin-covered plywood edges for stitching. Frames are joined together with brass plates and posts, screwed together.

In order to connect the wood frame and the plywood lattice together to make one finished system, two-part brass brackets were designed and fabricated. For each a brass plate was screwed into a brass post and the assembled brackets were secured to both wood sections with screws.⁵ The removable structure is lowered down and sits on top of

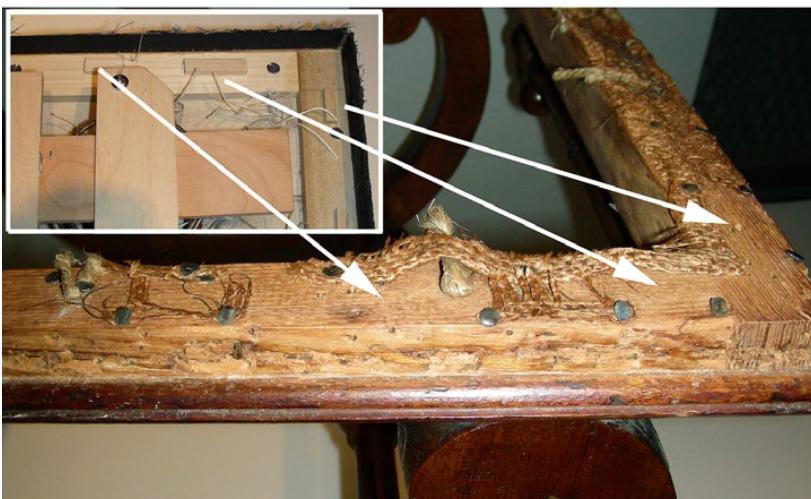
Figure 3. Seat rails with fragments of original lashing cords and jute spring cover cloth. Detail shows the little pieces of wood on the underside of the frame, positioned in between the fragments to raise the new system above the original materials.

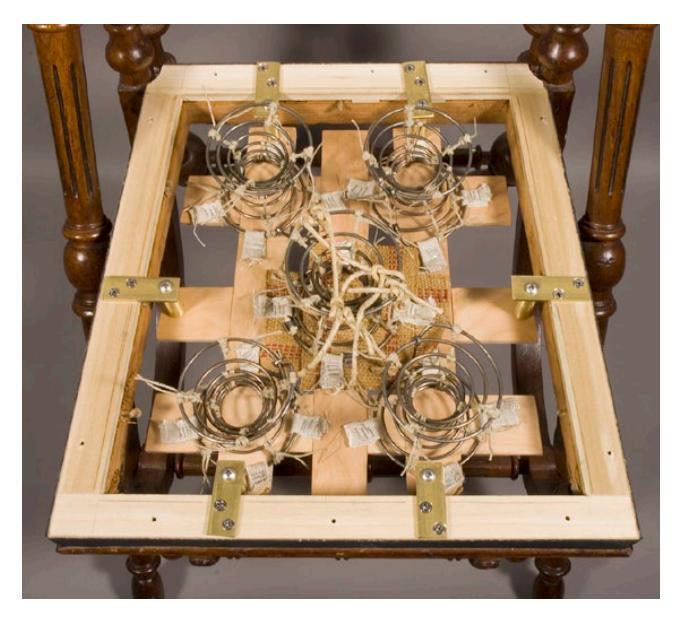
Figure 4. View from the top of the new system in position on the chair, shows the plywood is level with the original webbing, the springs are secured with folded linen and stapled. The centre spring retains a piece of the 20th century webbing and lashing cords for documentation.

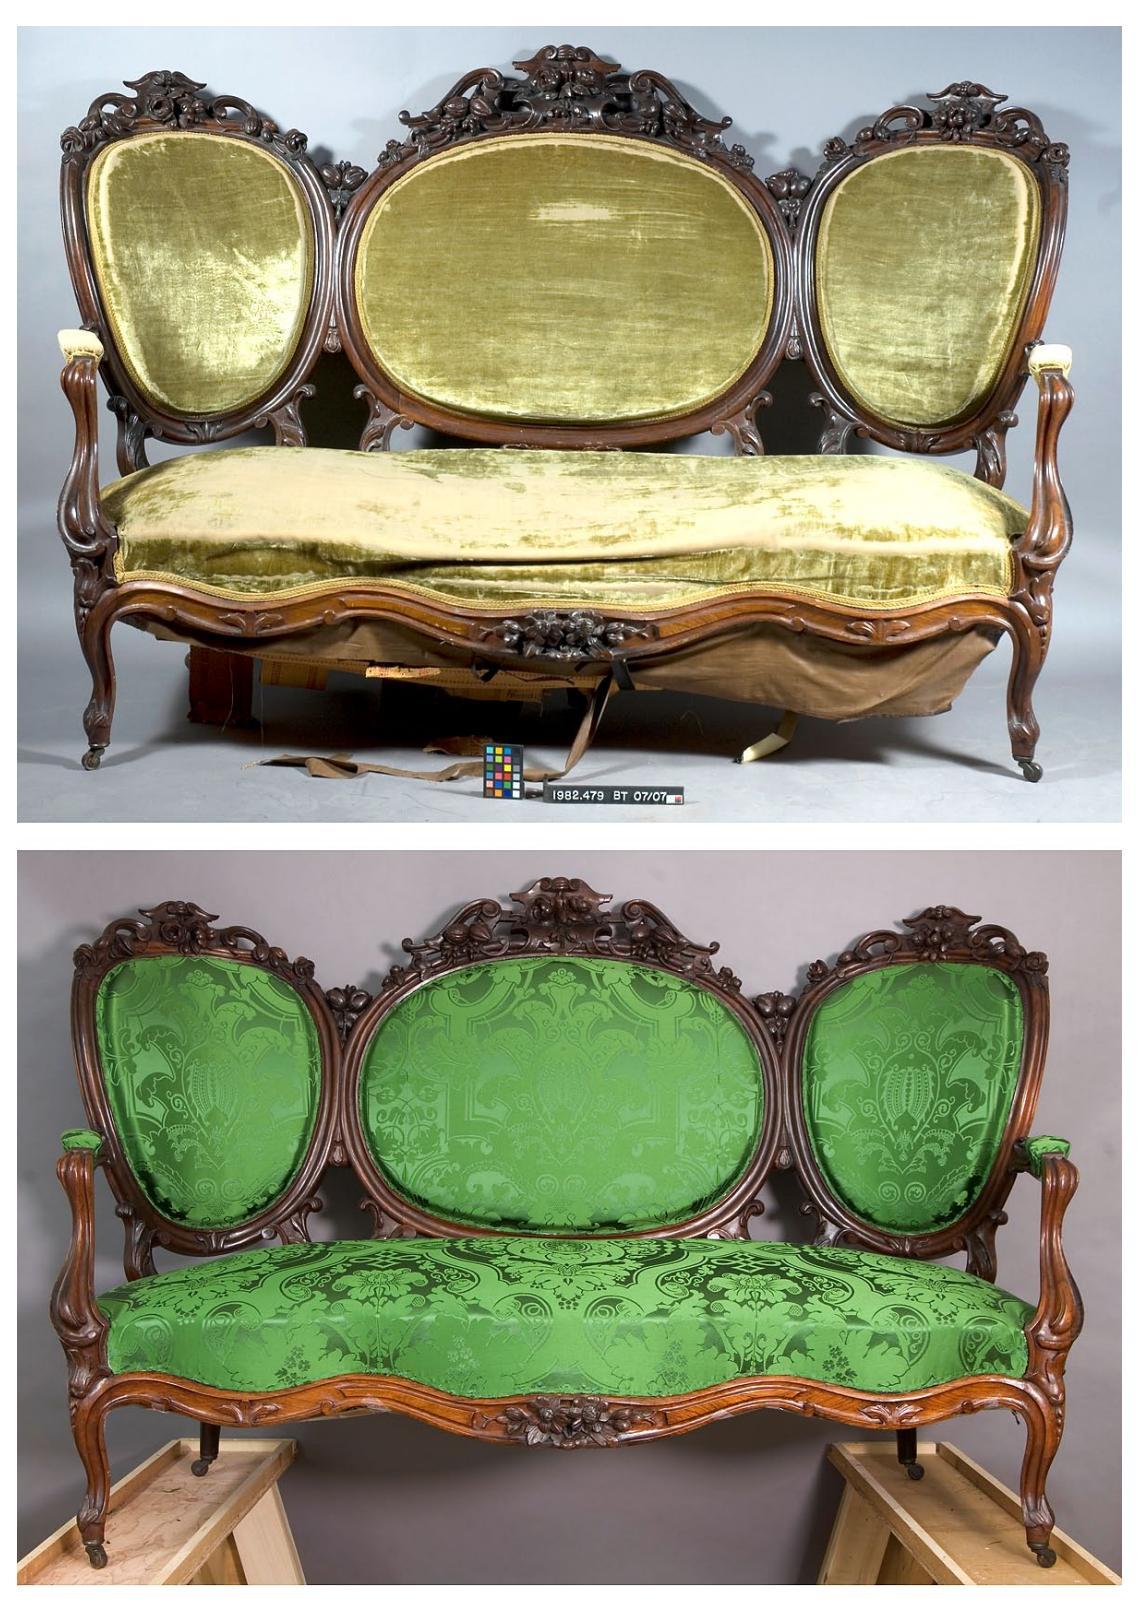
Figure 5. Sofa (MFA 1982.479) before treatment, at the top, the seat materials are falling down and the front stitched edge has collapsed. After treatment, at the bottom, the seat is supported and returned to its original profile with the new damask showcover.

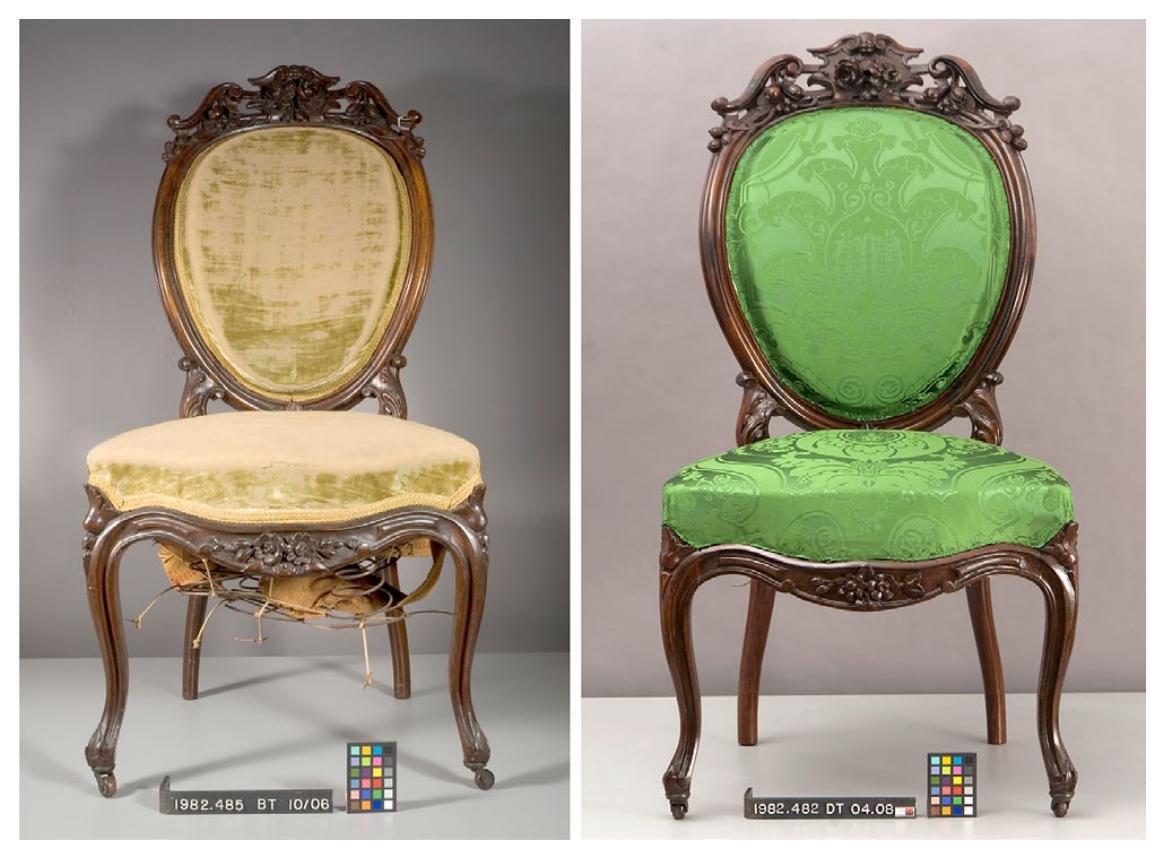
Figure 6. Side chairs (MFA 1982.482 – 1982.485) before treatment, on the left, the 20th century jute webbing tacks are loose and the seat is falling down. After treatment, on the right, the seat is well supported and the new damask showcovers are in place.

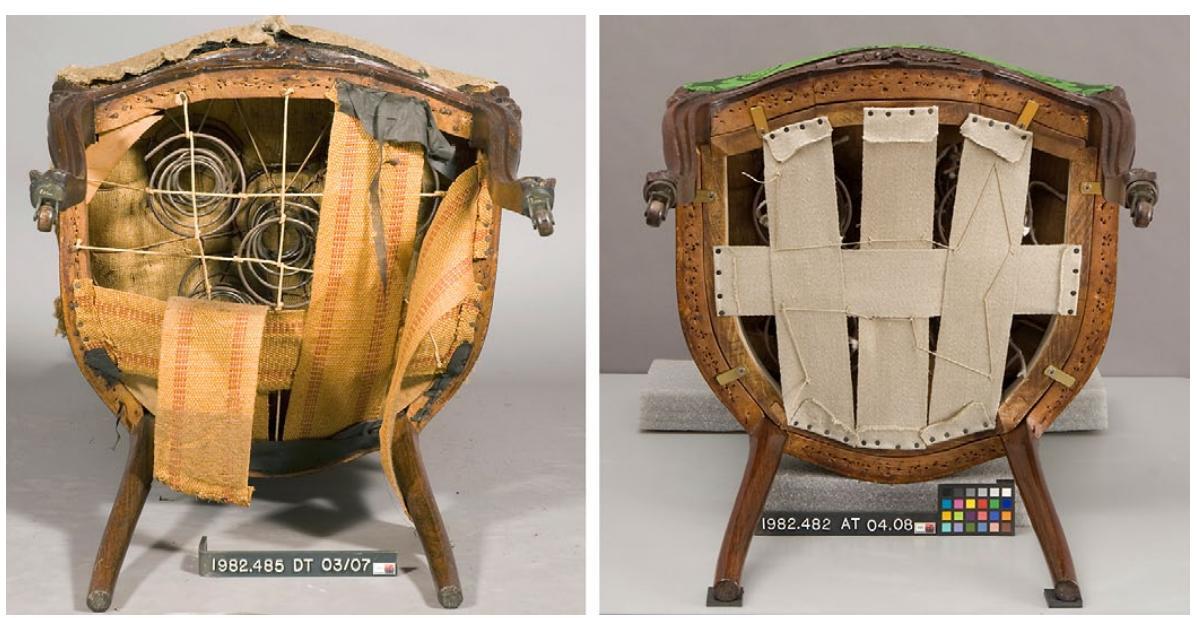
Figure 7. Side chairs (MFA 1982.482 – 1982.485) before treatment, on the left, shows the 20th century jute webbing and lashing cords tied to the bottom of the springs. After treatment, on the right, the new linen webbing is tacked to the poplar frame and the brass plates of the brackets are visible on each side.

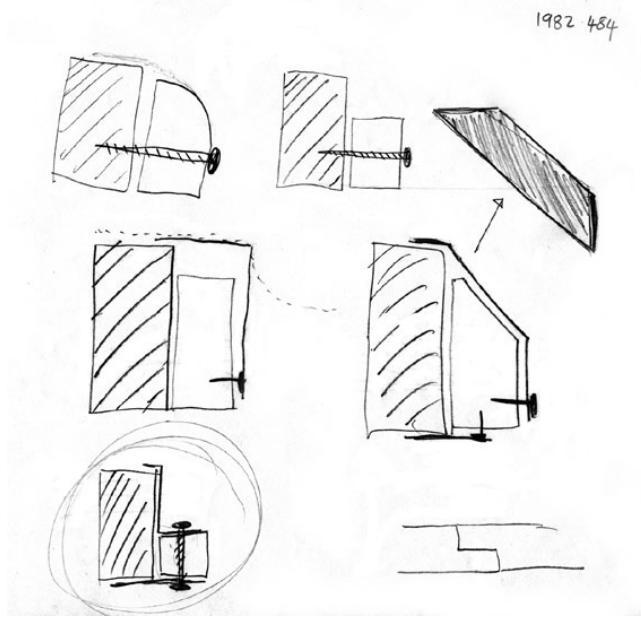
Figure 8. Working sketch shows the options explored for the brackets, the chosen design is circled at the bottom left.
