Postprints 2008

WOODEN ARTIFACTS GROUP

Presented at the 36th Annual Meeting of the American Institute for Conservation Denver, Colorado

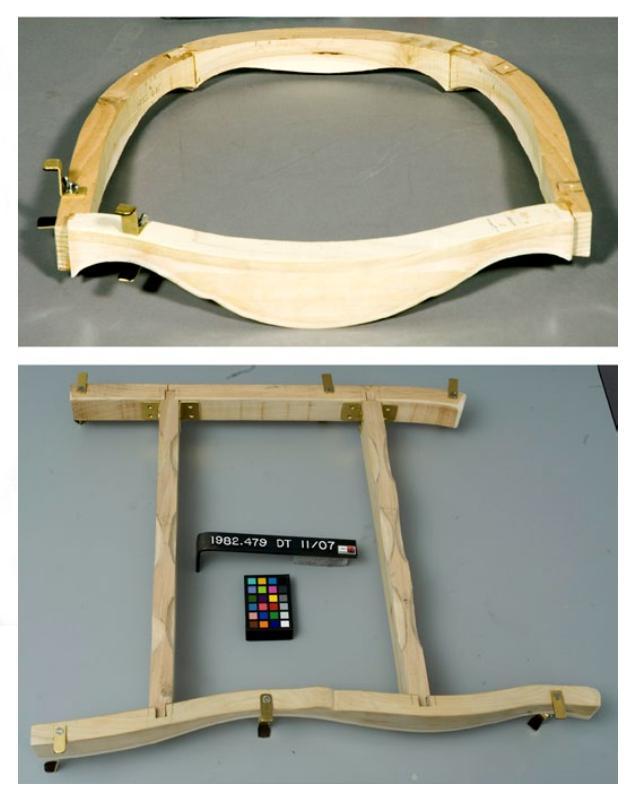
Figure 9. Poplar frame, at the top, for the side chairs, with sliding tenons at the back joints and notches cut at the front joints. The lower profile follows the shape of the chair rails. The frame for the sofa is shown at the bottom, with a straight rail at the back, a curved rail in the front and two straight rails between held together with L-shaped brackets. The notches for the spring coils are visible. Both frames have Z-shaped top brackets and flat brass plates held together with a bolt and wing nut.

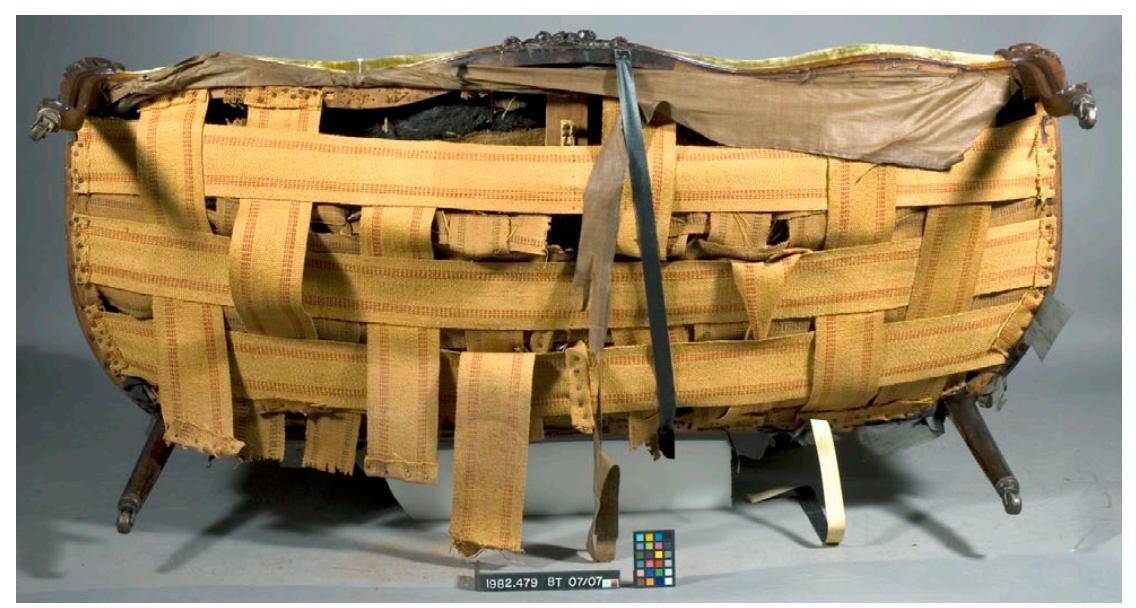
Figure 10. Underside of the sofa (MFA 1982.479) before treatment, shows the original webbing below later jute webbing, a piece of the original dust cover remains along the front seat rail. The horsehair filling that has fallen through the torn spring cover cloth is visible.

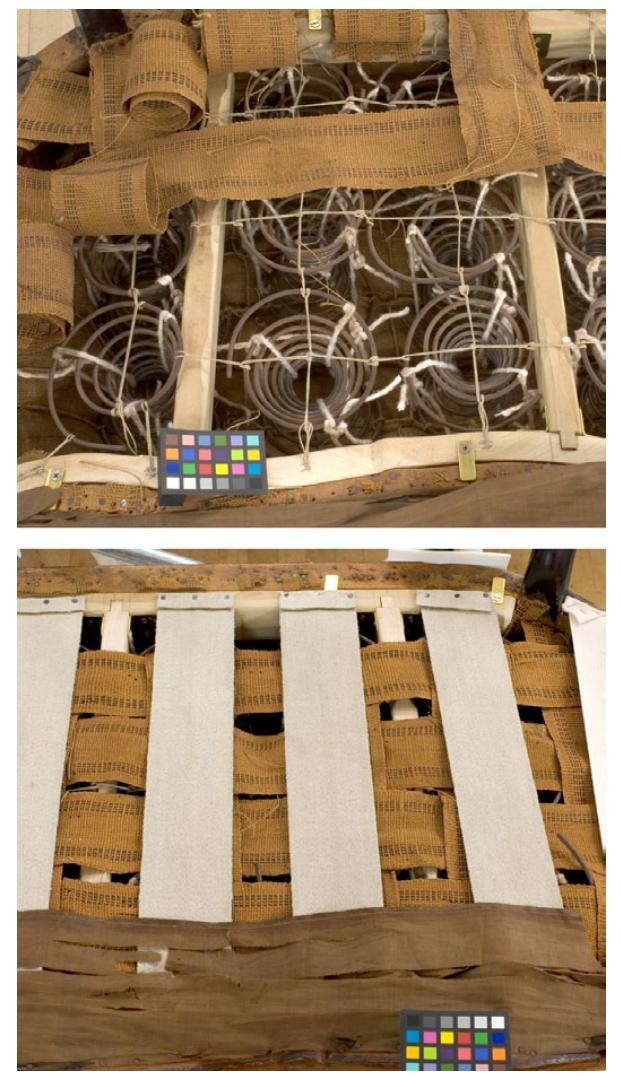
Figure 11. At the top, one of the two sofa frames in position, the later webbing has been removed, the original webbing has been rolled up for access, the springs are tied vertically and the linen cords are stitched front-to-back and side-to-side to keep the springs in position. At the bottom, the original webbing is unrolled into place and new linen webbing is stapled and tacked to the poplar frame. The piece of the original dust cover is laid down and will have a textile support to keep it in position.

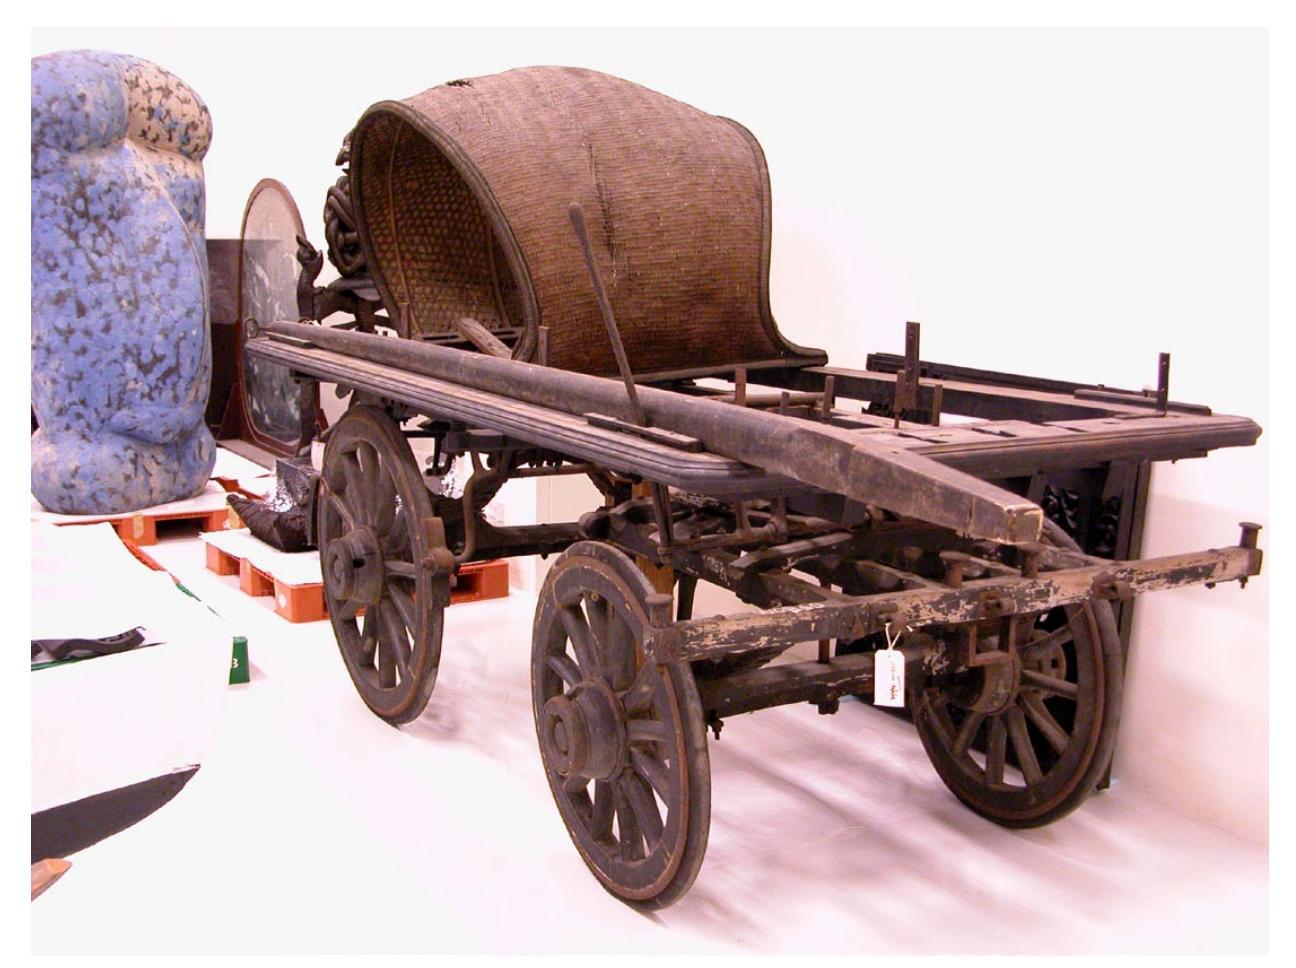
Figure 1. Condition of carriage in the store at the Heritage Conservation Centre. The rattan cover at the top was later found to be not part of the hearse.

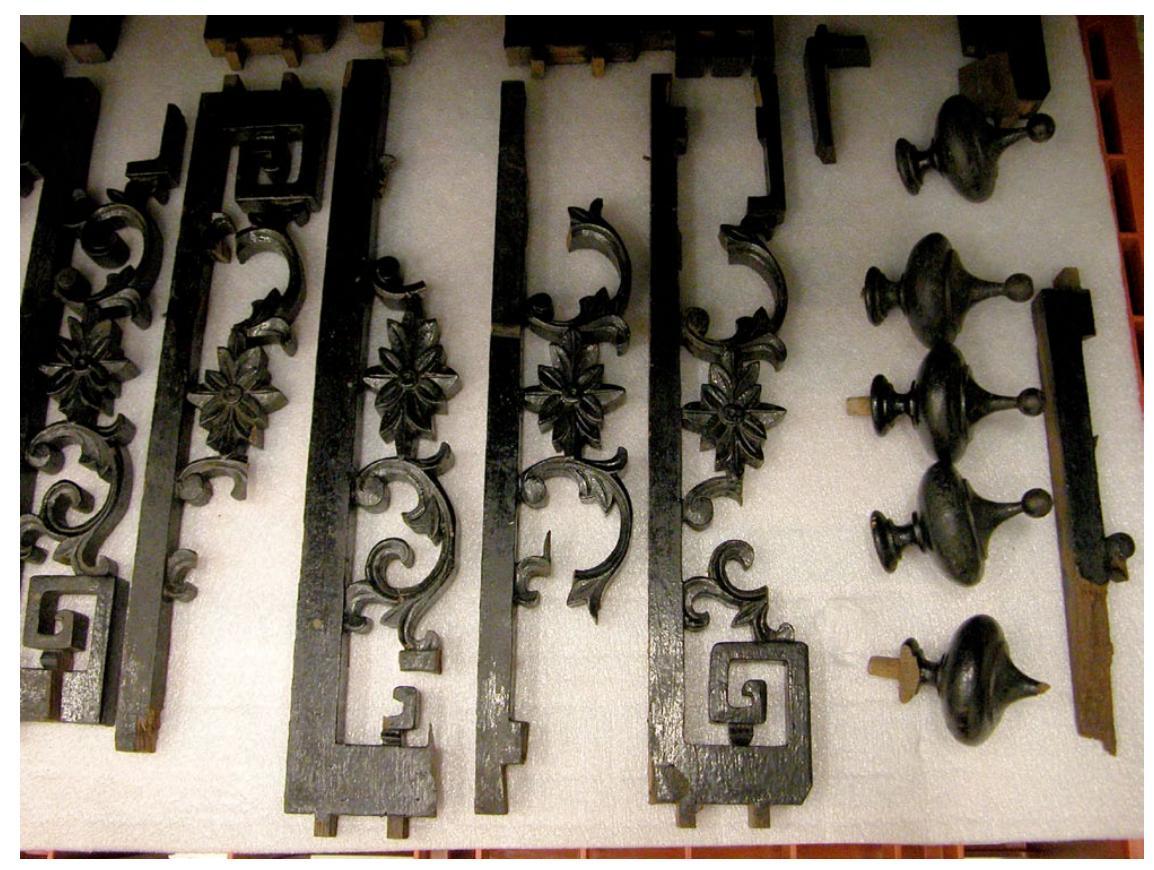
Figure 2. Example of broken carvings salvaged from the store.

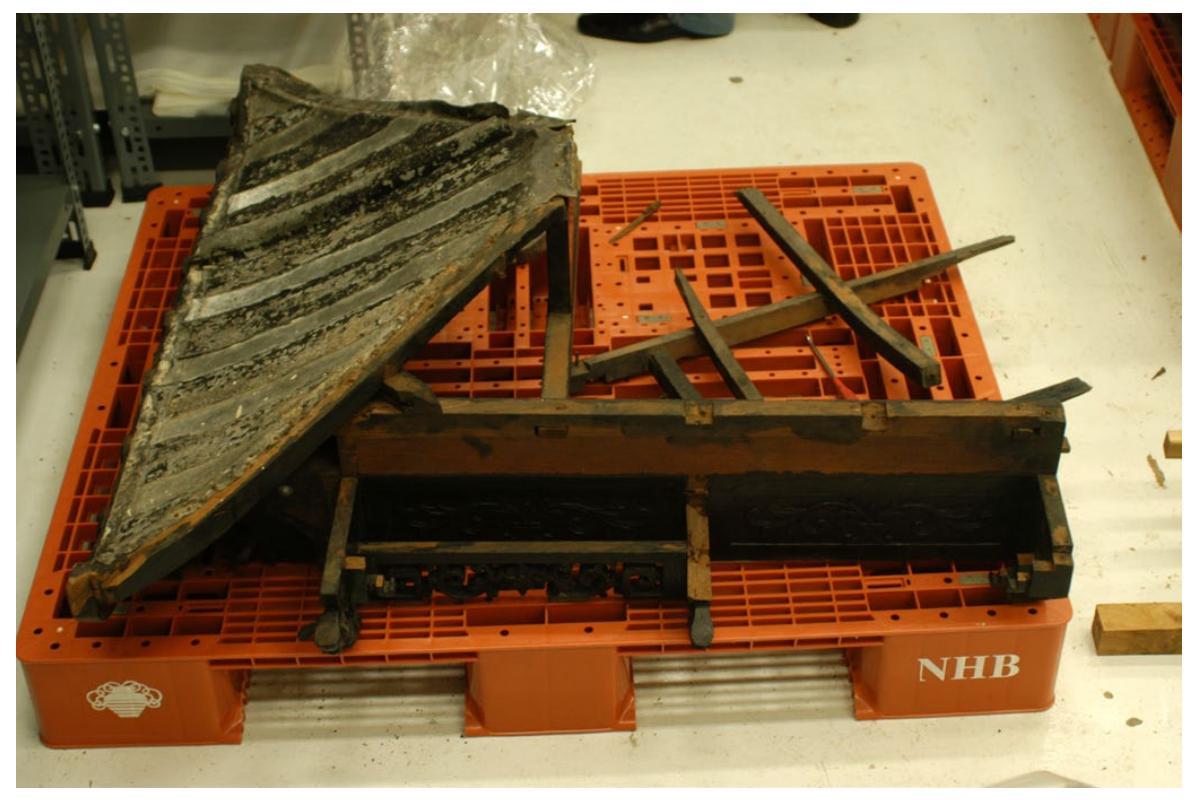
Figure 3. Damaged smaller upper-tier roof.

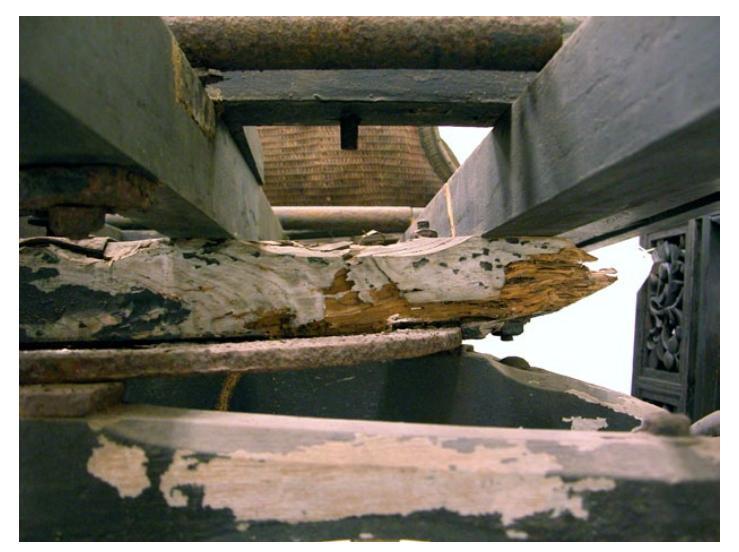
Figure 4. Aftermath of termites infestation.

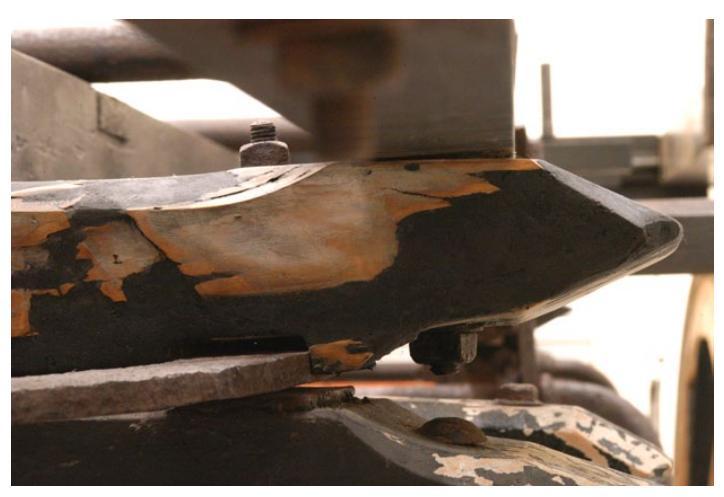
Figure 5. Treatment completed, filled with microballoons in Paraloid B-72 .

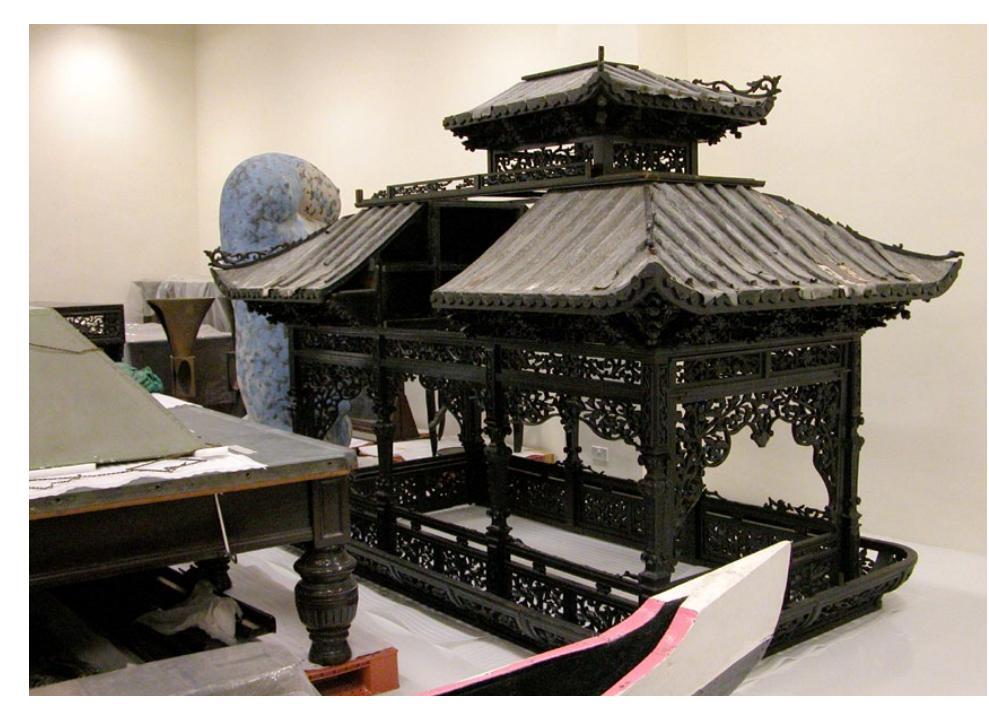
Figure 6. Trial assembly of the hearse without carriage. The middletier roof and smaller upper-tier roof are missing.

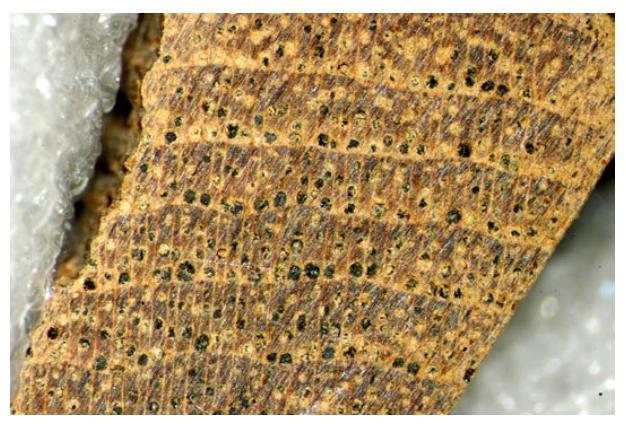
Figure 7. Cross section of *Tectona grandis* at 25X magnification.

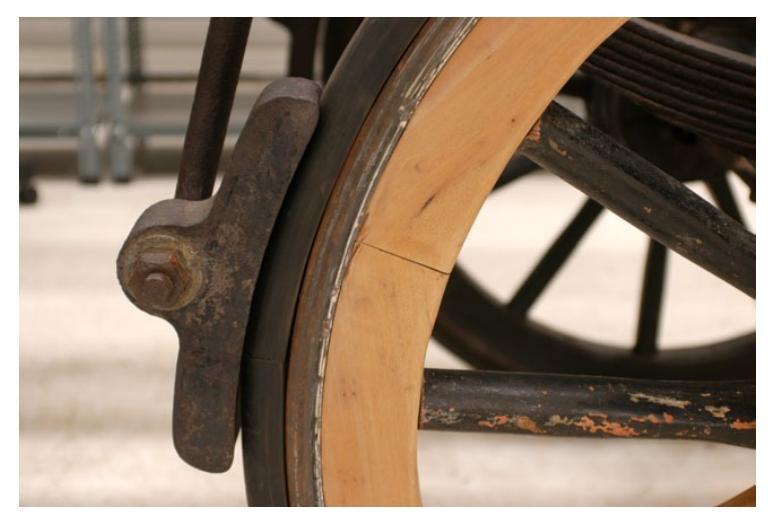
Figure 8. Reconstructed wheel for the carriage. Two original spokes were salvaged and incorporated into the new wheel.

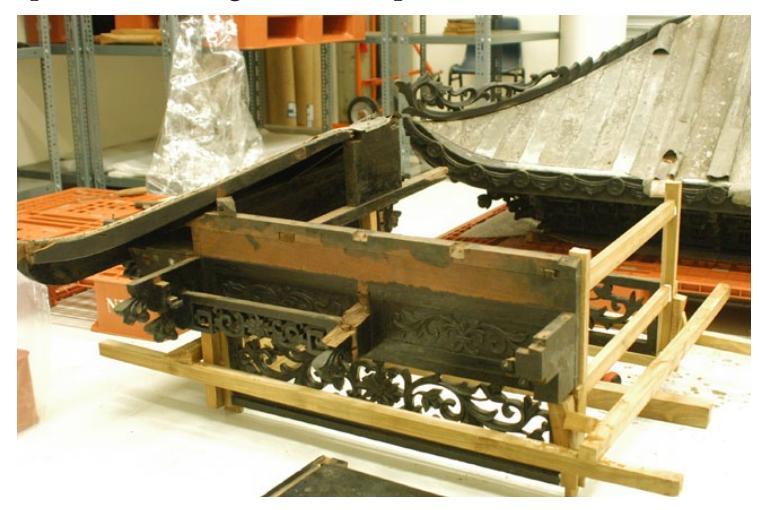
Figure 9. Reconstruction in progress. The contractor has skillfully merged the damaged small middle-tier roof with a new frame.

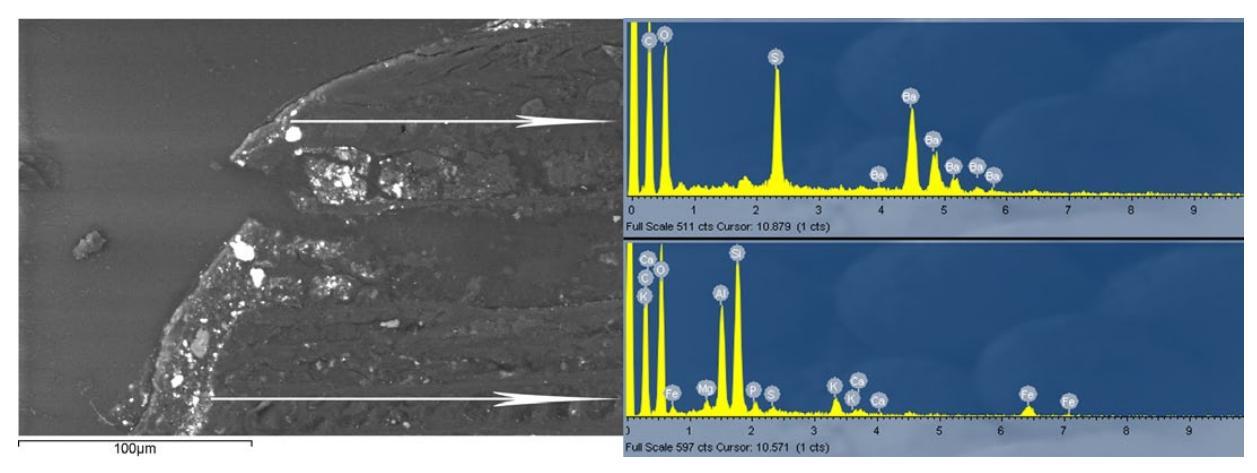
Figure 3. SEM-EDS spectra for sample 1 of box (MFA 40.723) showing aluminum (Al), silicon (Si) and iron (Fe) in the lower layer indicating the presence of red colored clay and barium (Ba) and sulfur (S) in the upper paint layer, indicating the presence of barium sulfate.

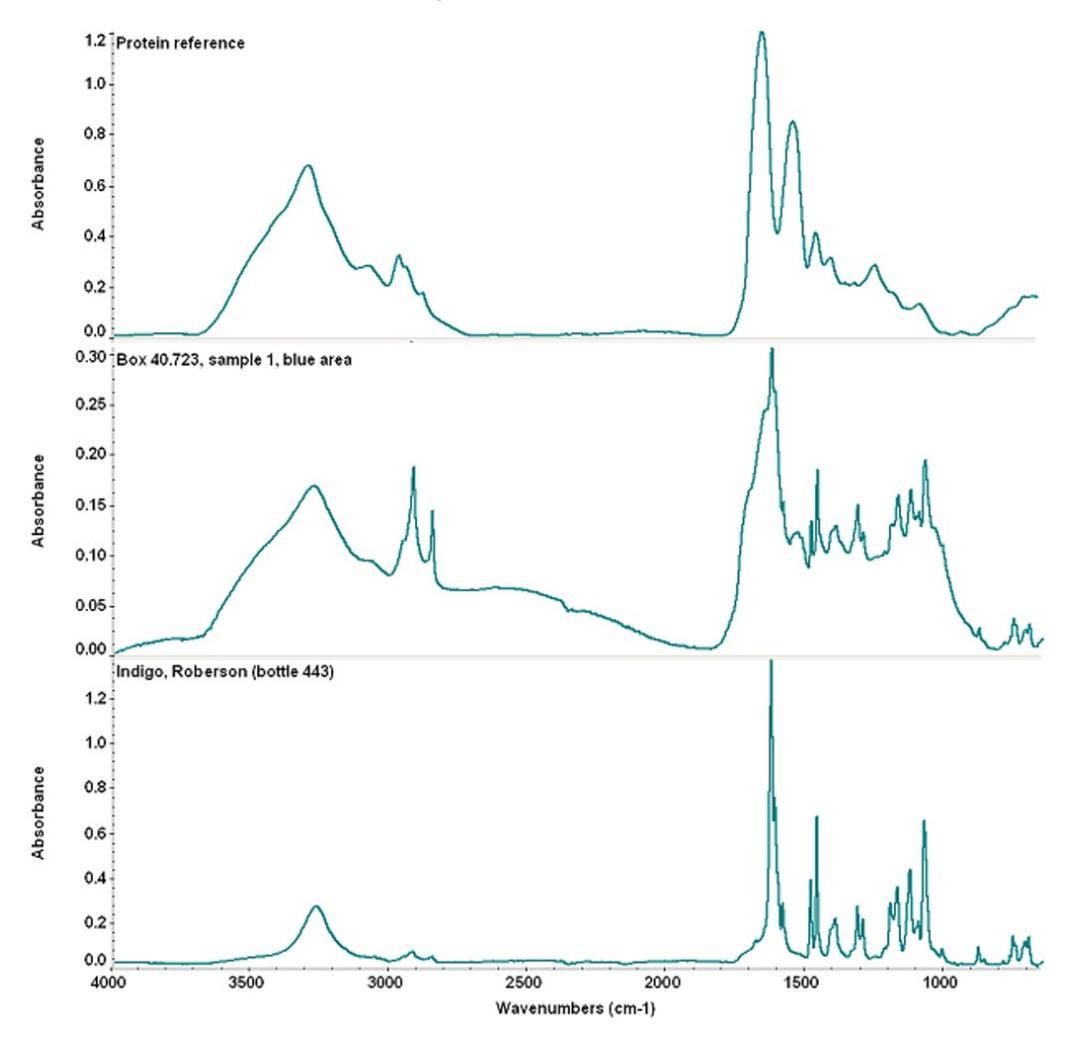
Figure 4. FTIR spectrum of sample 1 of box (MFA 40.723) removed from dark foliate shapes compared with references of indigo and protein.

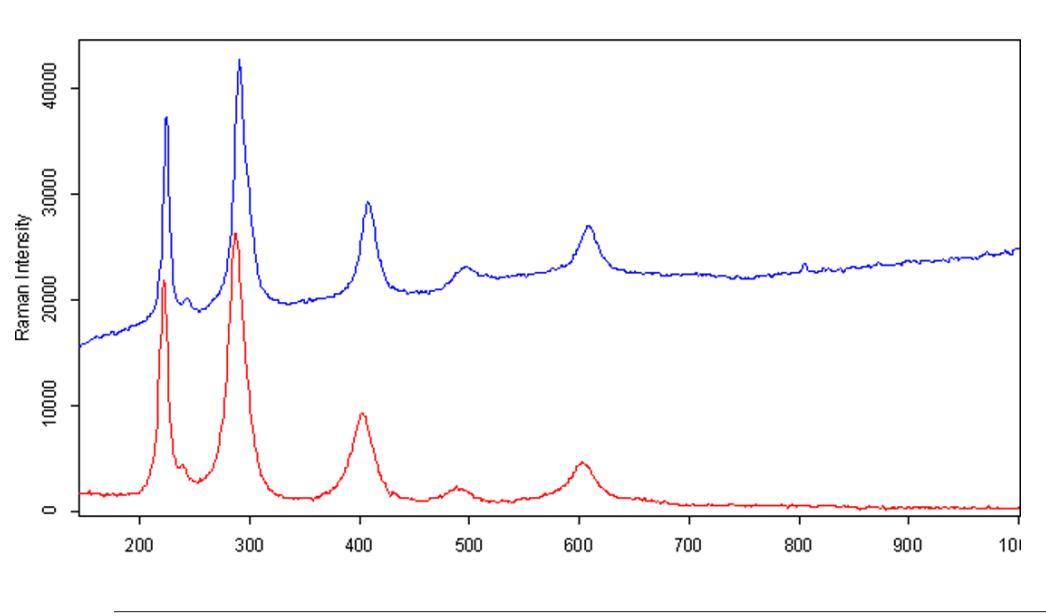
Figure 6. Raman spectrum for red paint on cupboard base (MFA 1990.337): The top line represents red particle lowest layer and the bottom line represents the hematite reference. Both red and yellow particles contained aluminum, silicon, and iron, typical for ocher. SEM images revealed the distinct difference in particle shape with the yellow particles being elongated, with sharp needle like edges. FTIR analysis made it possible to confirm goethite, a yellow natural earth mineral. SEM/EDS analysis of other cross section samples with dark particles dispersed in the red paint layer show manganese as a trace element which indicates the use of dark ocher like the earth pigment raw umber.

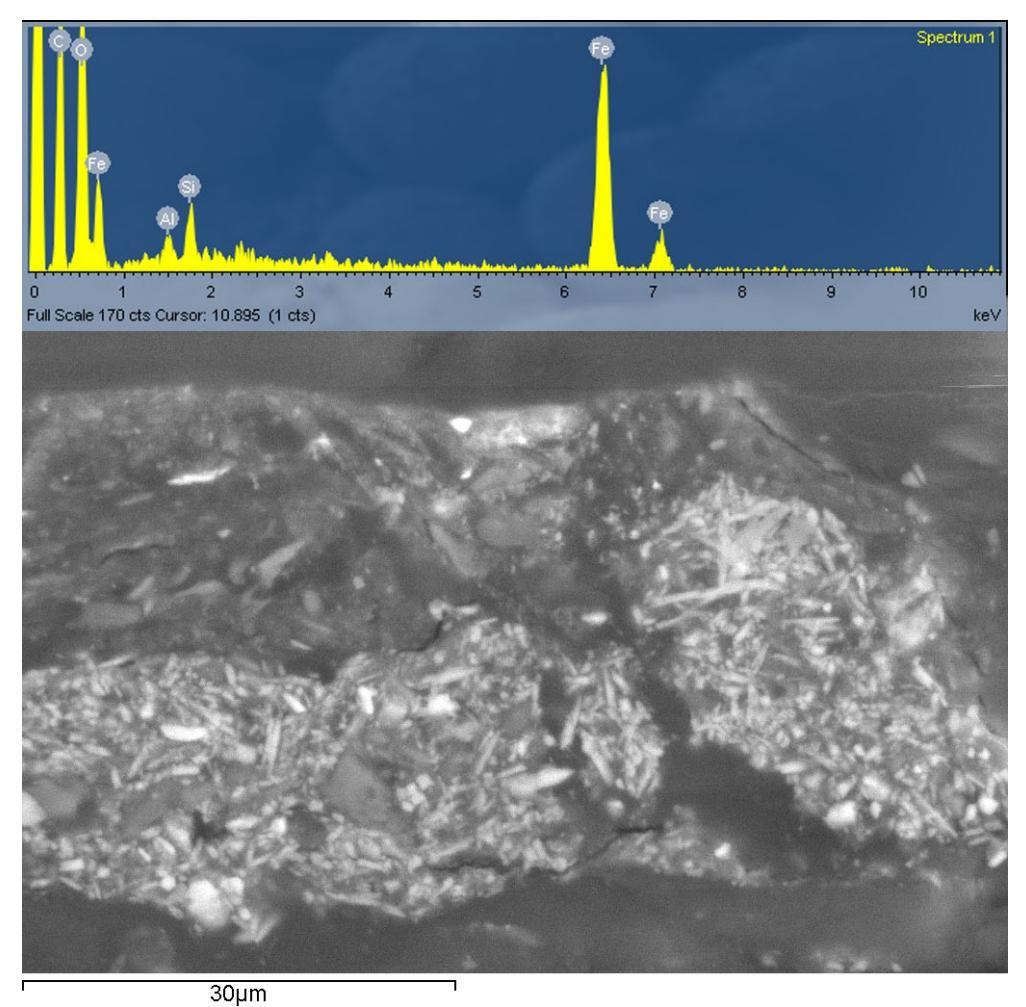
Figure 8. SEM image and spectrum of sample 2 of joined chest (1978.382) showing spectrum location and needle like goethite particles in the lower paint layer as well as the high peak for iron, (Fe) typical of pure iron oxide naturally occurring in many clays.
