Article: Saving Grand Canyon river running history

Author(s): Brynn Bender

Source: *Objects Specialty Group Postprints, Volume Fifteen, 2008*

Modern adventurers have been traveling through the Grand Canyon on the Colorado River since 1869. The Grand Canyon National Park Museum collection contains 18 boats that have made historic journeys on this amazing river from 1909 to 1965. The history of running such an important river is captured in this collection. This article will include an overview of the National Park Service's project to preserve and exhibit these boats. The project has been a highlight for the park and the river running community. It has involved numerous volunteers, river runners, architects, historians, and park staff over the past five years. Overall, the boats are in good structural condition but their surfaces were damaged from outdoor storage conditions. Getting the boats into appropriate storage posed interesting challenges due to their size and public interest. Treatments of the four oldest wooden boats have been undertaken over the past four years. Condition problems thus far have involved dirt, staining, excessive linseed oil, unstable paint, torn and dis

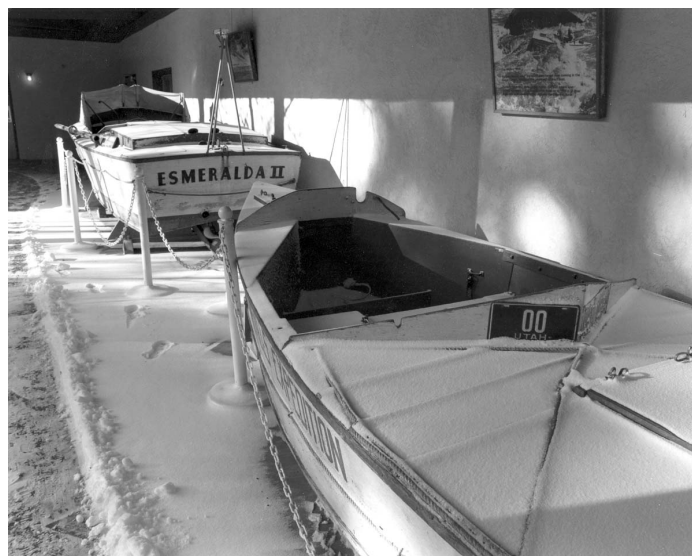
Fig. 4. Two boats in the courtyard with snow (Photograph courtesy of Grand Canyon NP collections)

The collection of boats grew at the park over many years through donations. Nine were placed in an open courtyard for display in the 1960s and there they sat for over 40 years, neglected due to budgetary constraints. With interest from concerned boat lovers and a newly appointed cultural resources manager, preservation efforts began in 2003. The boat lovers came from the existing river running community including boat enthusiasts, admirers, expedition companies and families of the historic people that were involved with these boats. As conservators dedicated to the parks in the Rocky Mountain region, the lab was called to perform a condition survey. This survey eventually enabled the park to acquire funds from the National Park Service and the river running community to stabilize all 20 boats. The lab started the ball rolling right away using this fan club to get the boats out of the courtyard and inside for storage, thorough examinations, and stabilization so they can be displayed again in the future. During the move the lab replaced their custom-made cradle mounts. The project gathered good press in the area with regional newspaper articles. The community really grabbed hold of the project. Construction drawings were made by an architect to document the design. This was a priority for the boating community. The drawings helped incredibly with boat terminology for conservation treatment documentation.

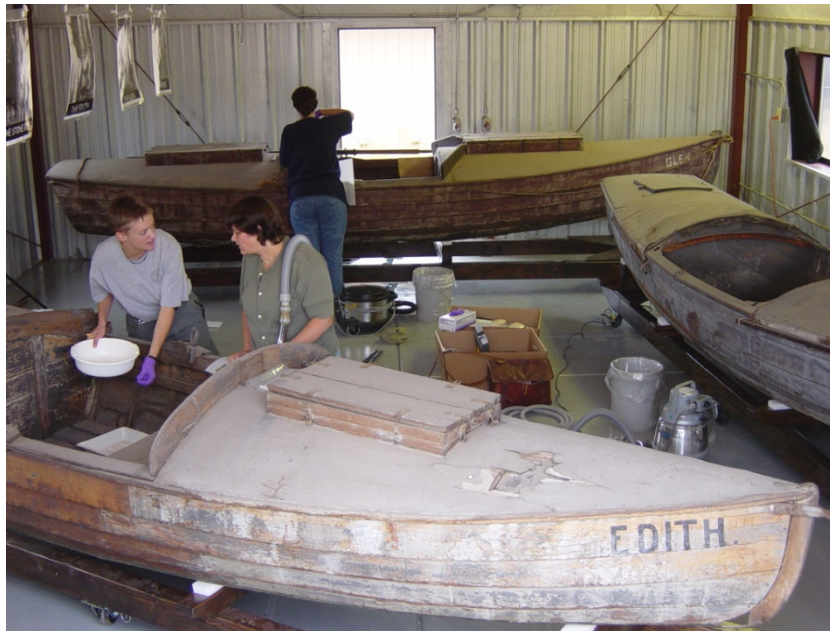
While in the courtyard, the boats suffered a lot of surface damage but luckily they were in great structural condition. The park museum staff began first with dry cleaning the three oldest wooden boats using a brush and vacuum. The boats were extremely dirty with loose dust, dirt, lint, and plant debris.

Fig. 5. Dry cleaning the wooden boats (Photograph by M. Quinn)

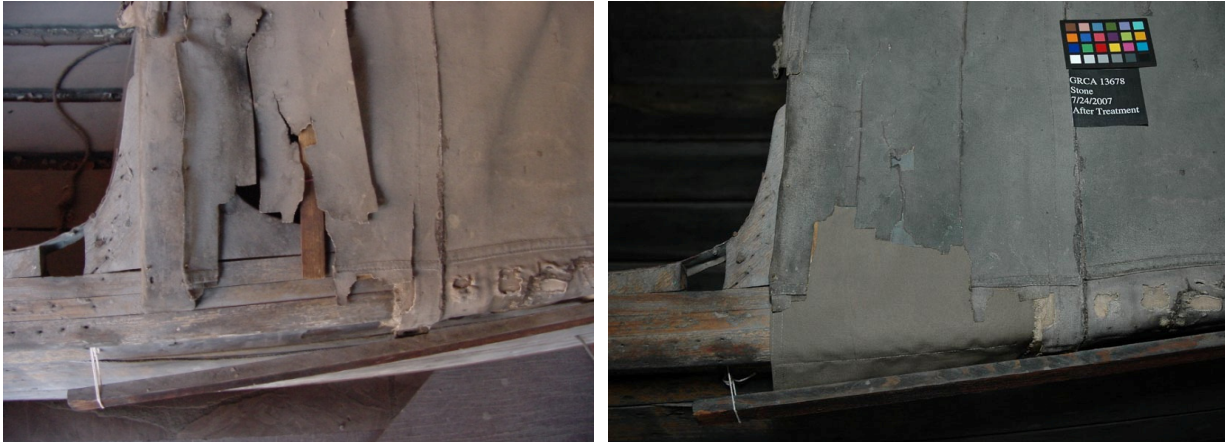
Two of the oldest boats had extensive tears to their canvas covered decks. One section had a severely torn and distorted tear. Humidification and flattening to realign allowed the area to be set in place with heat set BEVA film and muslin.

Fig. 6. Before (left) and after (right) treatment of the canvas deck on the *Stone* boat
(Photographs by Brynn Bender)

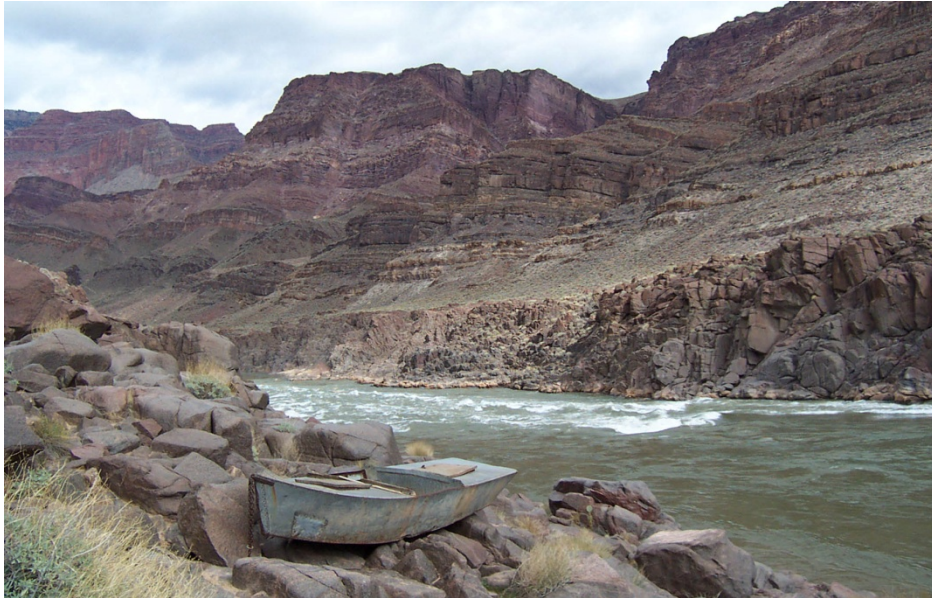
We are still deciding on treatment for some boats, like the 1915 *Ross Wheeler* that is still on the river. It is such a cultural landmark for boat tours that the park is reluctant to remove it. However, more recently, items from the boat have gone missing and graffiti has occurred. When visiting it in 2004, we discovered an inflatable raft stashed inside, boulders pushing in the bottom, and corrosion on the floor. So this is an ongoing process to balance our wishes to helicopter it out of the river with the community's wishes. Future plans involve getting the *WEN* boat on exhibit at the visitor's center, more treatments, including two boats at a river history museum in Utah, and filling the WWII inflatable neoprene raft with polystyrene beads. It has been wonderful to witness the attachment the community has to this collection and their strong desire to promote the history of their river running culture.

Fig. 8. Ross Wheeler boat on Colorado River, 2004 (Photograph by Brynn Bender)
